CONNECTICUT RIVER BASIN
AGAWAM, MASSACHUSETTS

**PROVIN MOUNTAIN RESERVOIR
MA 00528**

**PHASE I INSPECTION REPORT
NATIONAL DAM INSPECTION PROGRAM**

JUNE 1981

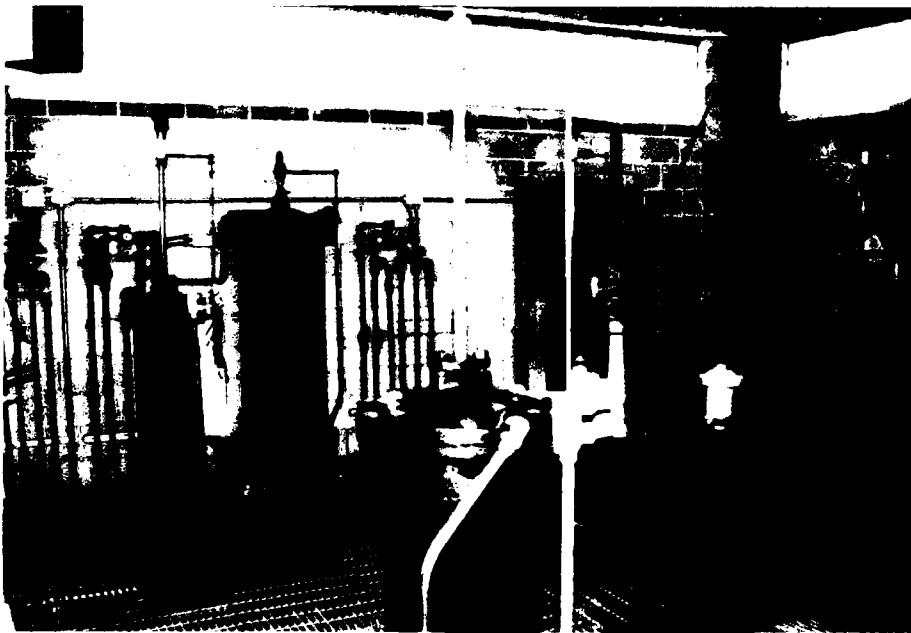
This structure consists of a reinforced concrete frame and roof with cement concrete masonry unit non-bearing walls. The floor consists of metal grating and the sub-floor is concrete (see Photos No's. 5 and 6). The structure is in good condition.

The building houses two hand crank operated bench stands manufactured by the Chapman Valve Mfg. Co. Both gates were opened by approximately 48-inches. The bench stands and stems are well maintained and in good operating condition.

The structure also houses eight additional gates and a compressor for operation of the aeration system. This system appears to be in good condition.

PHOTO NO. 6
VIEW INSIDE AERATOR CONTROL HOUSE

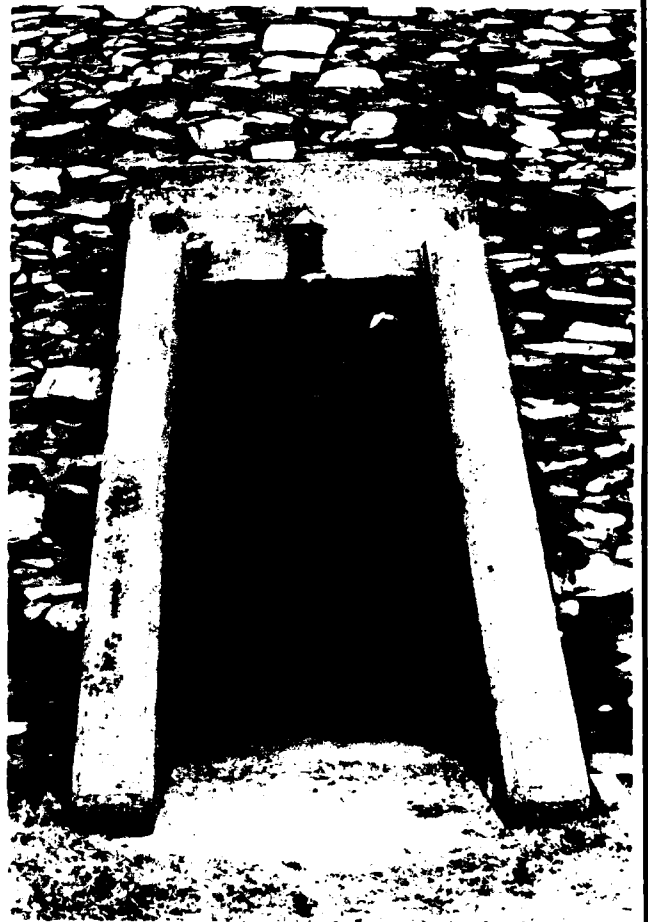
PHOTO NO. 10
VIEW OF ACCESS DOOR TO RESERVOIR
NO. 1 & NO. 2 ON WEST EMBANKMENT
