BLACKSTONE RIVER BASIN
GRAFTON, MASSACHUSETTS

FISHERVILLE POND DAM
MA 00577

PHASE I INSPECTION REPORT NATIONAL DAM INSPECTION PROGRAM

OCTOBER 1978

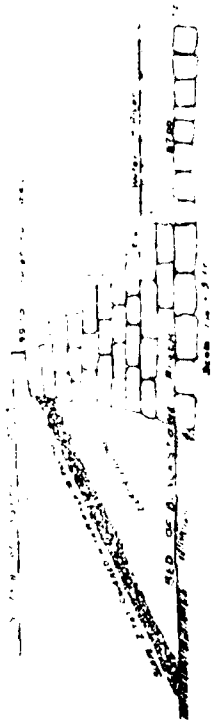
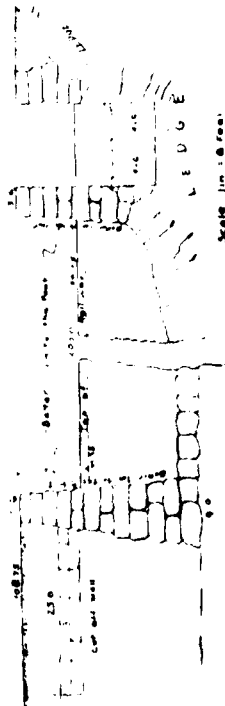
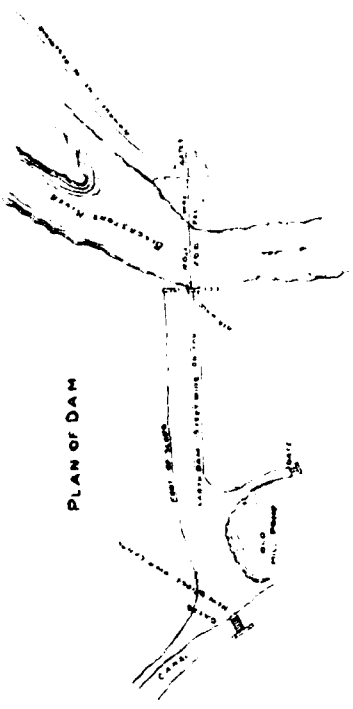
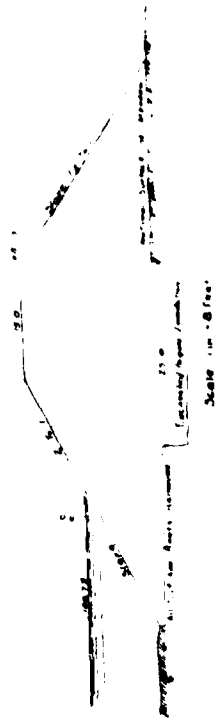
- d. Post-Construction Changes. The only recorded changes after 1882 were repairs undertaken by the Owner in 1945. At that time, washed-out portions of the stepped stone spillway were replaced. However Figure B-2 shows two 4-foot by 6-foot slide gates as the outlet in the east abutment. At the present time, there is one 6-foot by 6-foot slide gate.

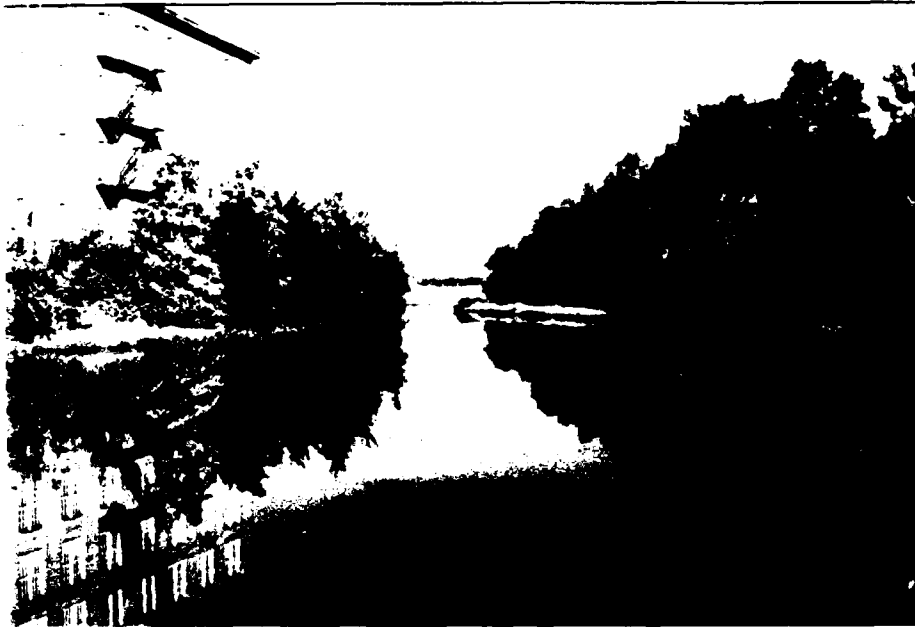
**NO. 7 VIEW OF BLACKSTONE RIVER
DOWNSTREAM OF SPILLWAY**

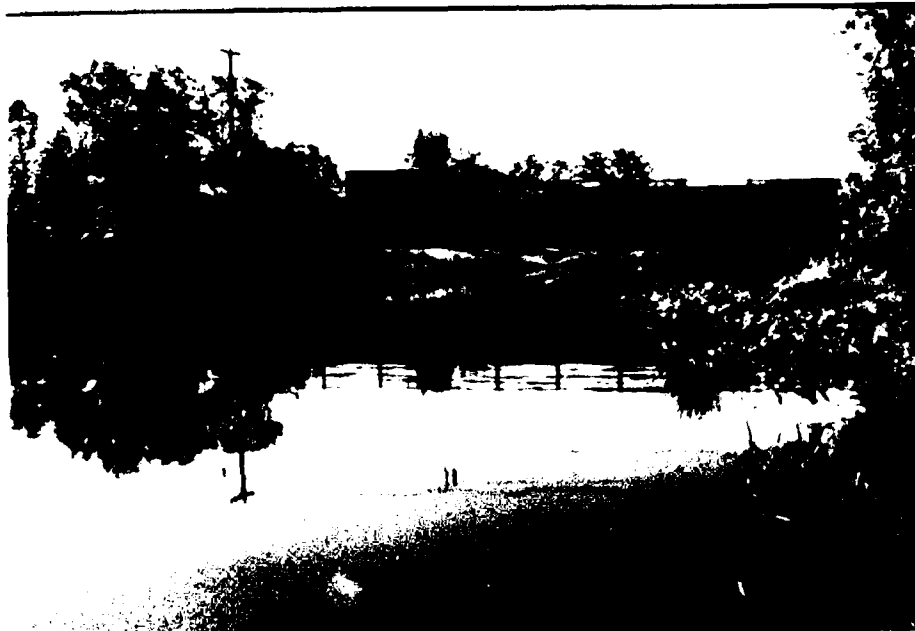
**NO. 8 VIEW OF MAIN STREET BRIDGE
OVER BLACKSTONE RIVER**
