NEPONSET RIVER BASIN
CANTON, MASSACHUSETTS

BOLIVAR POND DAM
MA 00807

PHASE I INSPECTION REPORT
NATIONAL DAM INSPECTION PROGRAM

FEBRUARY 1980

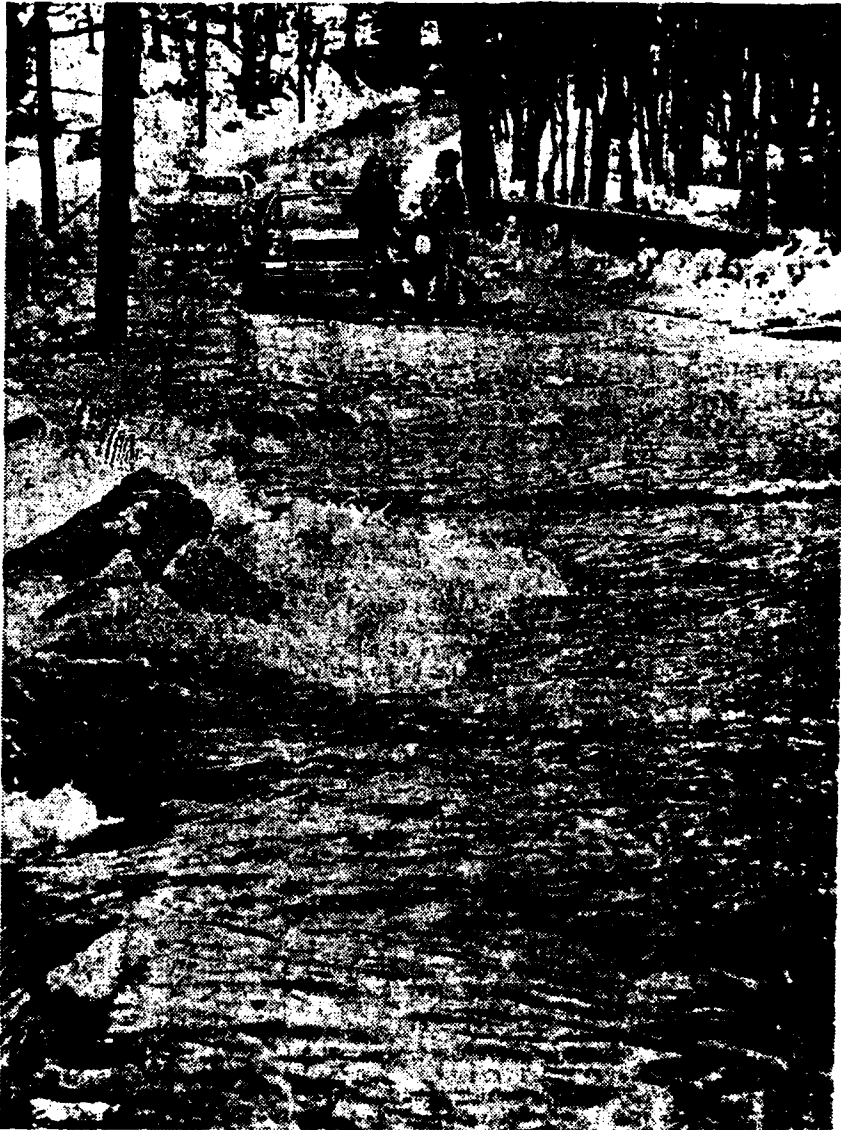
ROAD AWASH — Waters in Canton's Bolivar Pond washed out a sluiceway and flooded Bolivar Street, closing it early yesterday to all traffic. (Photo by Daniel T. Power)
