CONNECTICUT RIVER BASIN
WARE, MASSACHUSETTS

WINSOR DAM MA 00588
QUABBIN SPILLWAY MA 00589
GOODNOUGH DIKE MA 00590

PHASE I INSPECTION REPORT
NATIONAL DAM INSPECTION PROGRAM

SEPTEMBER 1978

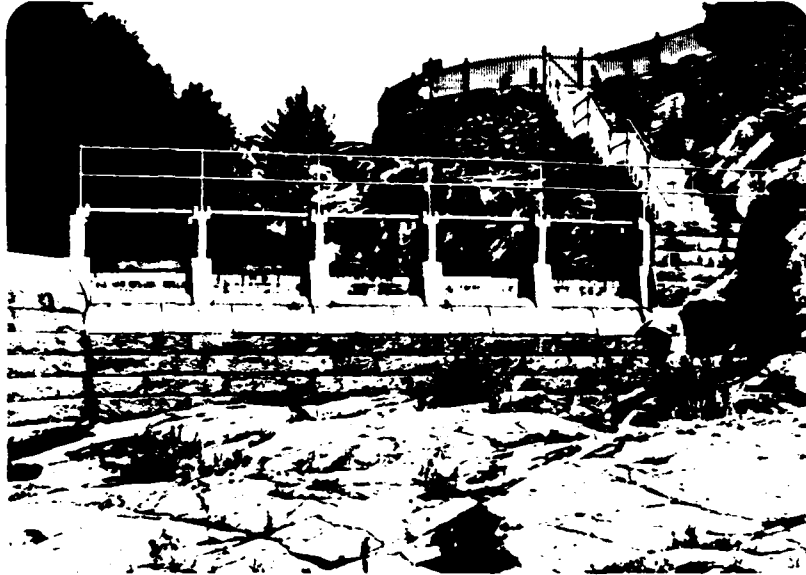
19. Side Spillway with Stoplogs

The access bridge to the flashboards and the flashboards are well maintained and in good to excellent condition, Photos No. 19 and 20. The flashboard guides are in excellent condition.
