MERRIMACK RIVER BASIN  
HOLDEN, MASSACHUSETTS

CHAFFIN POND DAM  
MA 00621

PHASE I INSPECTION REPORT  
NATIONAL DAM INSPECTION PROGRAM

FEBRUARY 1979

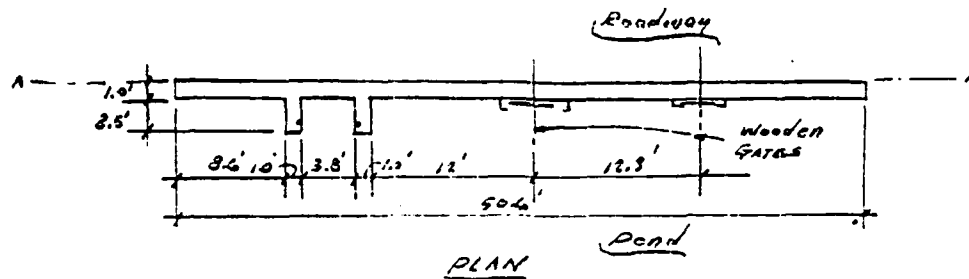
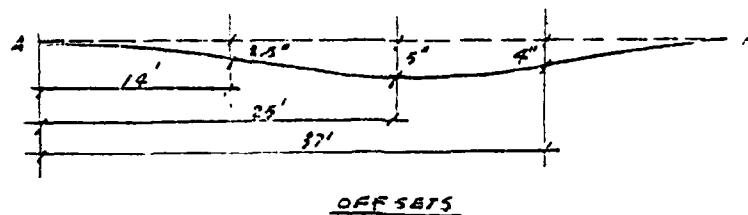
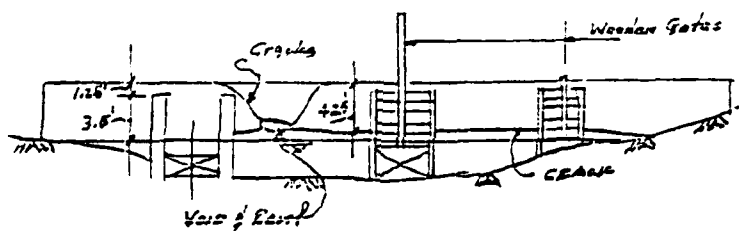
Upstream Headwall

a. <u>Approach Channel</u>	Not applicable. Discharge is directly from the pond
b. <u>Upstream Headwall</u>	Refer to field sketch, page B-17
Condition of Concrete	Concrete headwall is in very poor condition. There are very severe horizontal and vertical cracks in the wall. The top 3.5 ft. of wall was moved 5 to 6 in. upstream and is tilting severely. A large piece of concrete has broken off at the intersection of the major vertical crack exposing the re-inforcing.
Condition of Gates	The middle conduit has a wooden sluice gate which is open and in very poor condition. The right conduit is completely silted in and the wooden sluice gate is completely destroyed
Stop Logs and Slots	Stoplogs for the left conduit are not in place
<u>OUTLET WORKS - DOWNSTREAM HEADWALL</u>	Refer to field sketch, page B-18
General Condition of Concrete	General condition of the headwall is very poor. The concrete wall is badly cracked, settled in the middle and is tilting downstream

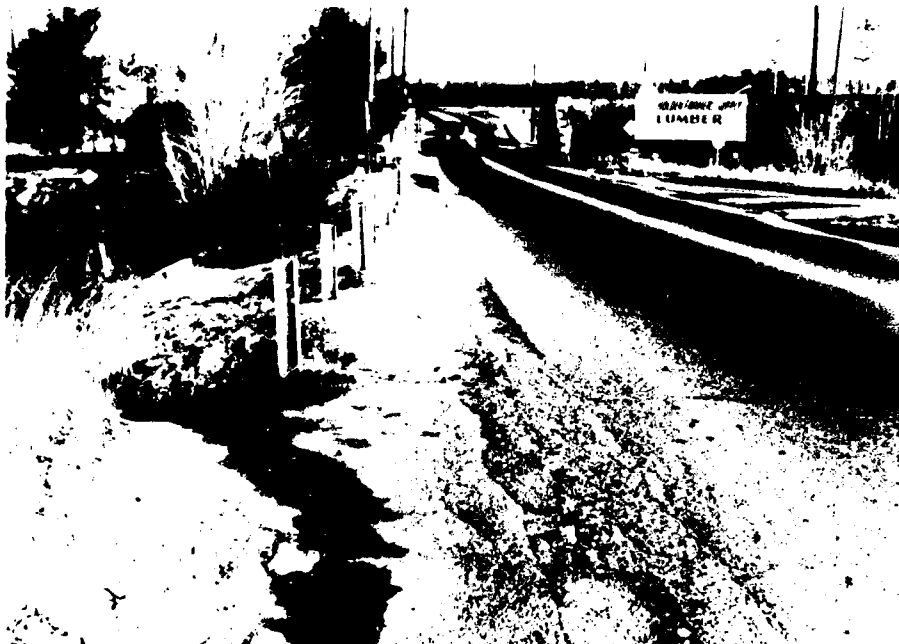
The crest of the dam, Photos No. 6 and 7, is the paved roadways of Route 122A and Zottoli Road. The Route 122A pavement has minor cracks on the upstream side but is generally in good condition. There is a long crack at the contact between the two roadways. The asphalt paving behind the headwall which forms the downstream face is broken and cracked, Photo No. 8. A 12-in. diameter void in the pavement behind the downstream fieldstone wall, Photo No. 9, indicates loss of fines from beneath the roadway, probably through the joints of the wall. There was no indication of seepage.

6. Upstream side of crest, Route 122A

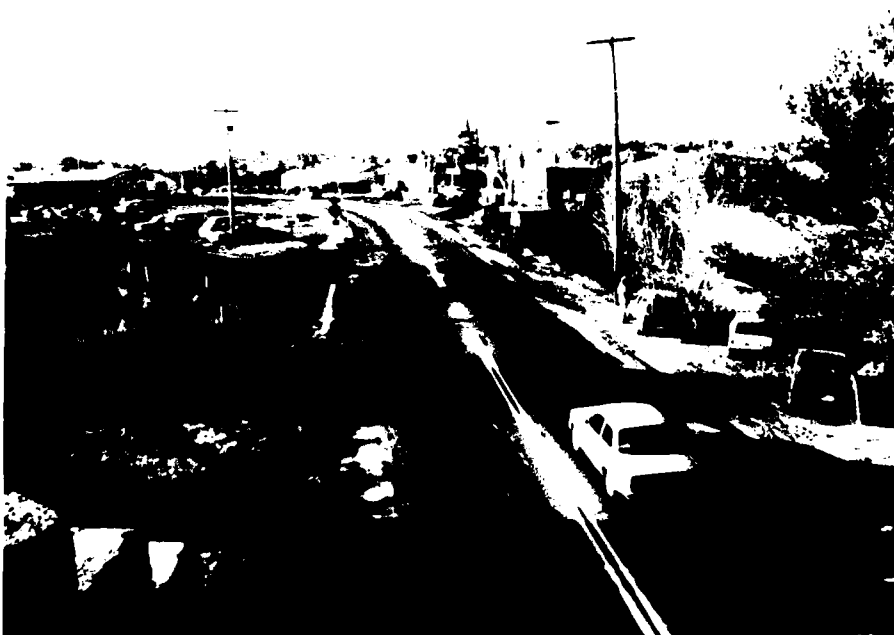
7. Crest of dam from top of railroad embankment underpass
