CONNECTICUT RIVER BASIN  
WESTFIELD, MASSACHUSETTS

WEST PARISH FILTER NO. 3 DAM  
MA 00610

PHASE I INSPECTION REPORT  
NATIONAL DAM INSPECTION PROGRAM

MARCH 1981

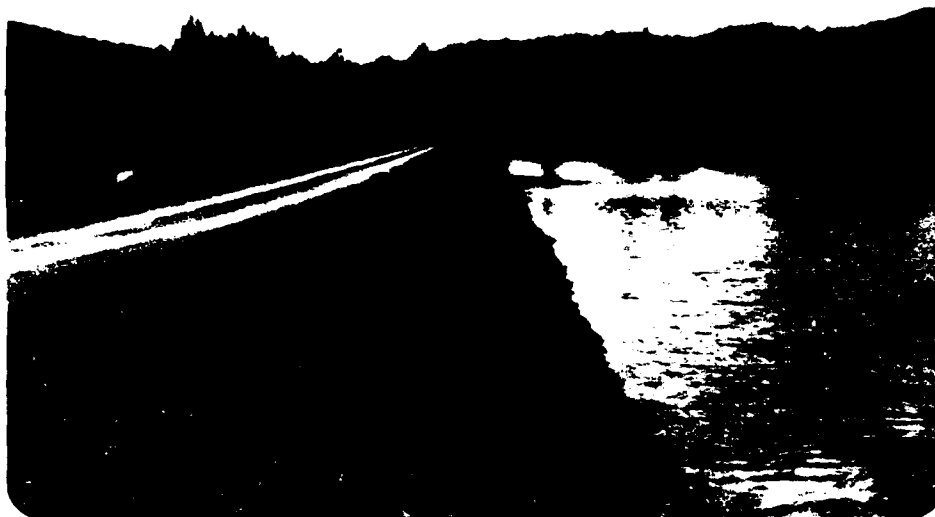
Photo No. 1

The upstream slope is covered with riprap, about 12 to 18 inches in size, from an elevation about 2 feet below the crest to some elevation below the water level in the reservoir at the time of the inspection. There is a slight irregularity in the riprap just below the high water mark, which is evidenced by dark staining of the riprap (Photo No. 1).

A slight irregularity in the riprap on the upstream slope in the normal range of reservoir indicates that some movement of the riprap has occurred, probably due to wave action and freezing action. However, the riprap appears to provide adequate erosion protection and no repairs appear to be needed at this time.

A slight irregularity in the riprap on the upstream slope in the normal range of reservoir levels indicates that some movement of the riprap has occurred, probably due to wave action and freezing action. However, the riprap appears to provide adequate erosion protection and no repairs appear to be needed at this time.

View of dam crest and upstream slope from left abutment.

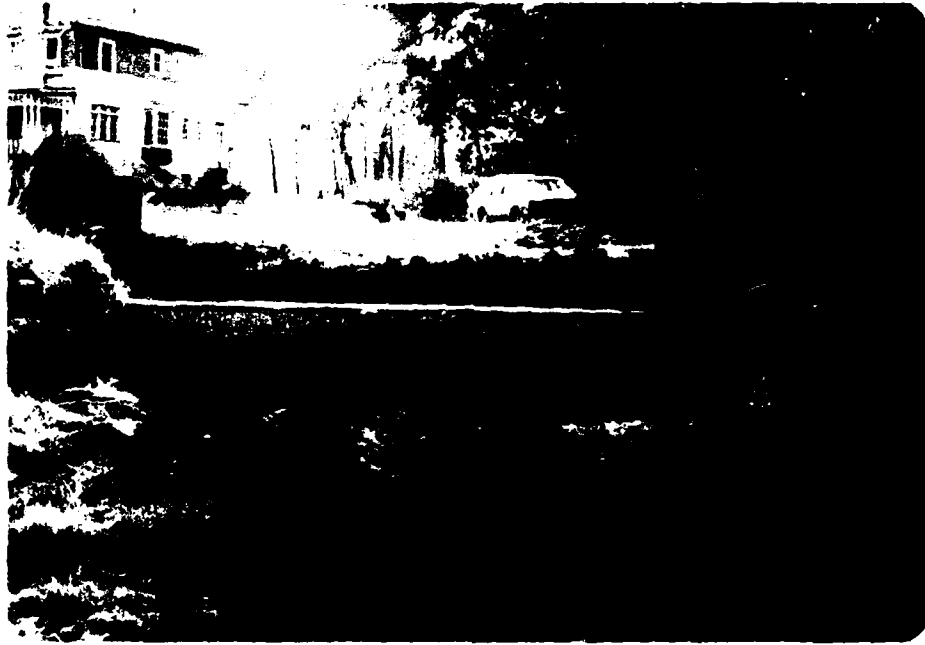
Photo No. 3

c. Appurtenant Structures. There is a side-channel spillway at the right abutment of the dam (Photo Nos. 3 and 4). The spillway consists of an earthen approach channel, a 23.4-foot long concrete weir, and a discharge channel. A concrete bridge crosses the discharge channel at the axis of the dam (Photo No. 4). Both the spillway approach channel and the concrete weir are in good condition. The discharge channel is in fair condition. Some rocks in the stone masonry lining are loose and might be washed away under large flows. The bridge across the spillway discharge channel is in satisfactory condition.

View of side channel spillway. Note earth approach channel, concrete overflow section and stone lined outlet channel.

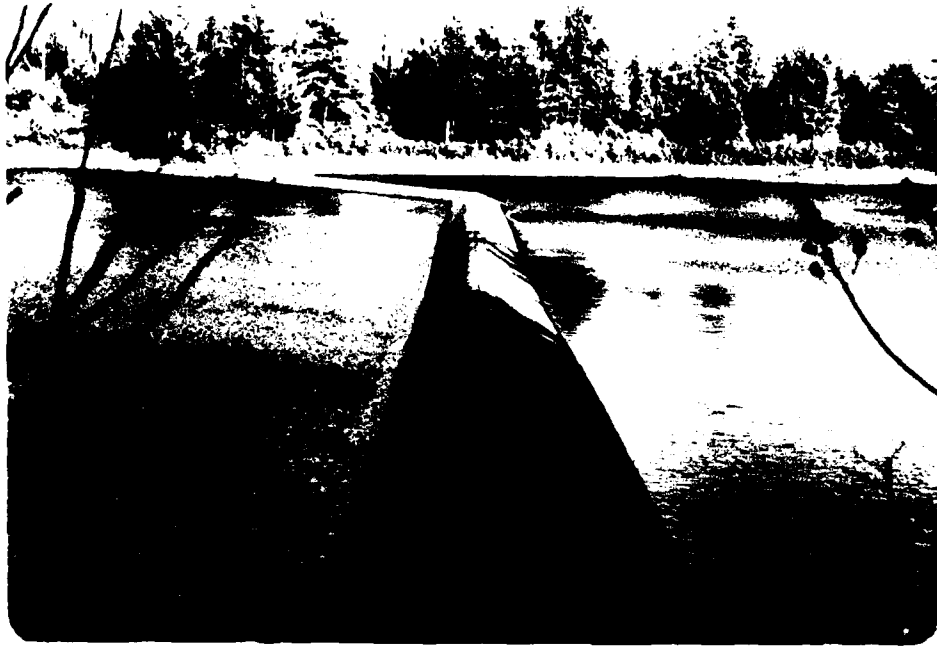
Photo No. 5

The timber crib structure in the reservoir was not judged to significantly affect the hydraulics. During a flood, small pool level differentials would exist, but there would be negligible effect. If the dam were to fail, there would be a very brief period when a significant pool level differential might exist. However, the timber structure has a thin cross-section, and failure of it would quickly ensue. As a result, failure conditions would only be modified slightly. The hydrologic and hydraulic computations performed for this report are included in Appendix D.

View of rock-filled timber crib structure which divides the reservoir into two sections.

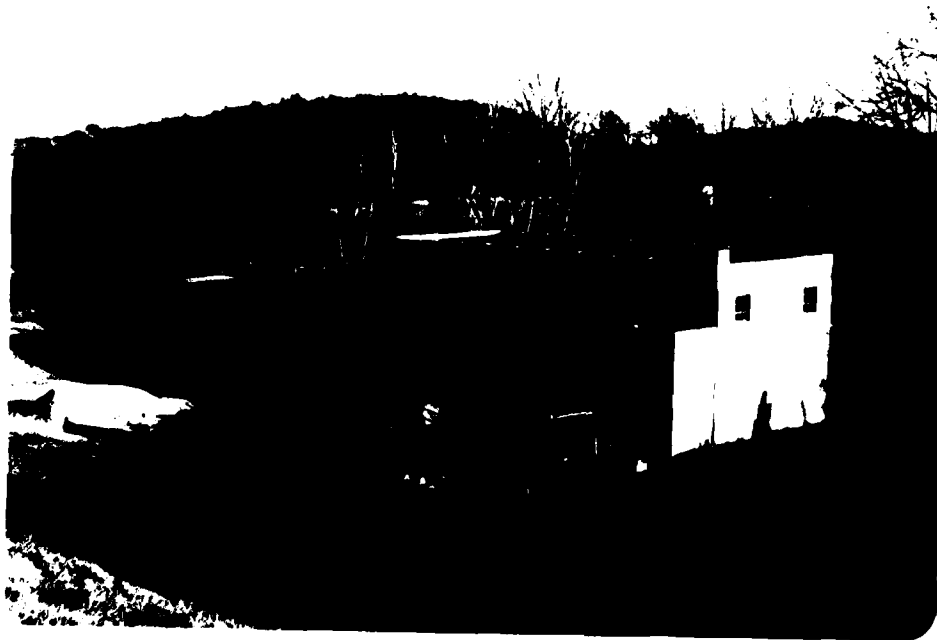
Photo No. 6

water treatment facilities, water works offices and maintenance shops (Photo No. 6). The buildings are located between 60 feet and 600 feet downstream from the toe of the dam. It is estimated that 35 persons work at the plant. Failure of the dam would cause significant property damage and probable loss of more than a few lives. Accordingly, the dam has been placed in the "high" hazard category.

View of water treatment plant building located near the toe of the dam.
