CAMBRIDGE RESERVOIR DAM
MA 00750

PHASE I INSPECTION REPORT
NATIONAL DAM INSPECTION PROGRAM

DEPARTMENT OF THE ARMY
NEW ENGLAND DIVISION, CORPS OF ENGINEERS
WALTHAM, MASS. 02154

JANUARY 1980

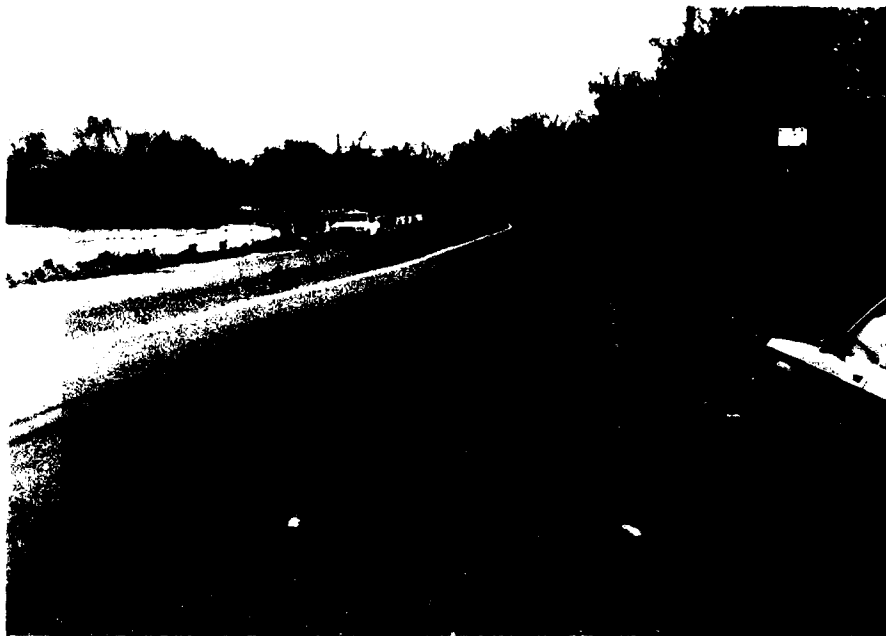
The crest, covered with an asphalt pavement, has an average width of about 50 ft., photograph 1. The pavement is in generally good condition but does have several longitudinal cracks near the centerline.

PHOTO NO. 1 - Crest of Dam as viewed from intake structure
looking toward left abutment.

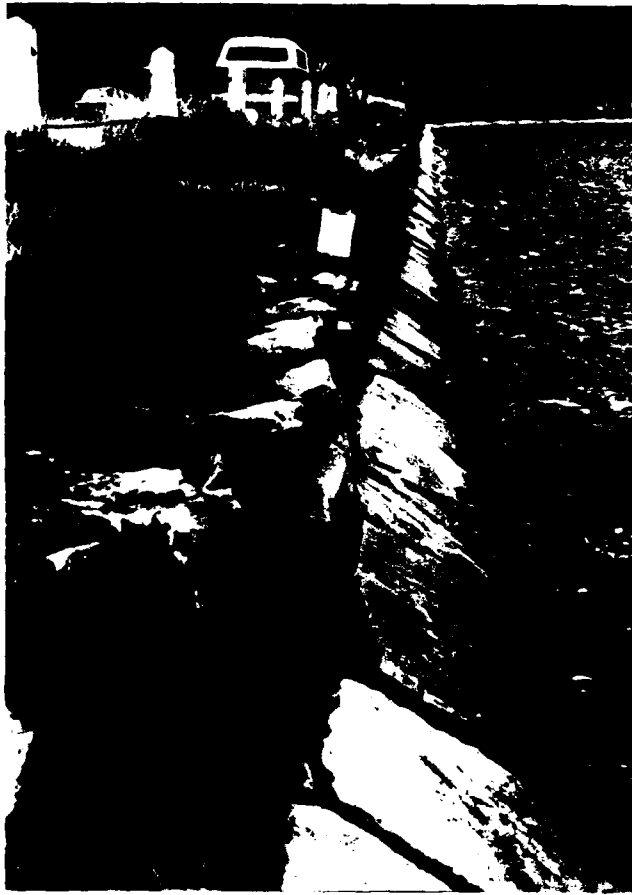
The upper riprap wall is displaced in several locations, the most deterioration being from the intake structure bridge to about 110 ft. right of the bridge, photograph 3. Photographs 2 and 4 shows undermining of the crest about 50 ft. and 90 ft. right of the bridge, respectively.

PHOTO NO. 3 - Displaced riprap on upstream slope locking toward right abutment. Clipboard in photo is about 110 ft. right of intake structure.

Furthermore, the Owner should institute remedial measures including the proposed renovations of the spillway discharge channel; the proposed repair of the riprap on the upstream slope; establishment of a system for locking stoplogs in place; testing of the gates and establishment of a formal downstream warning system.

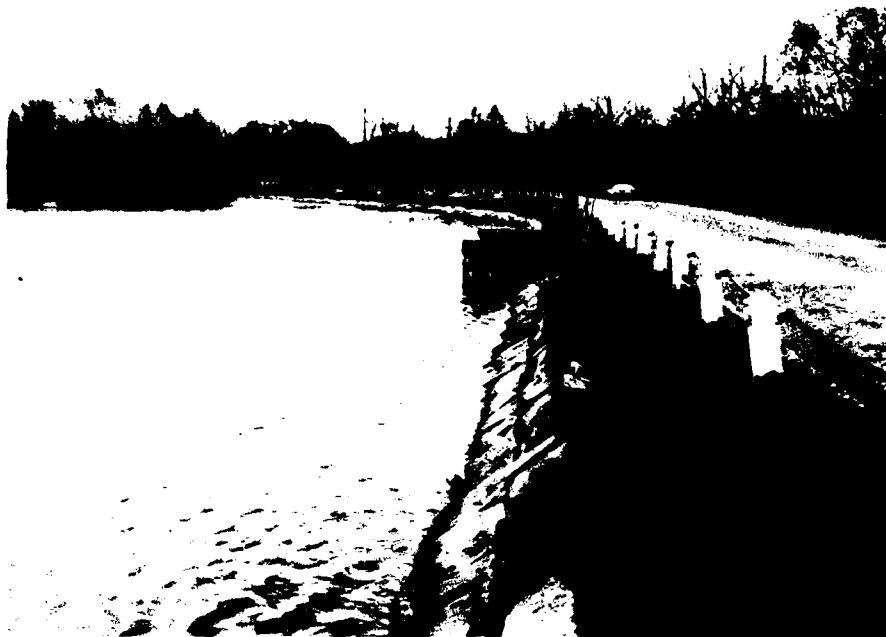
PHOTO NO. 5 - View along crest of Main Dam. Note the location of the sidewalls for overflow spillway. The spillway is located approximately 150 ft. to the left of the intake structure.

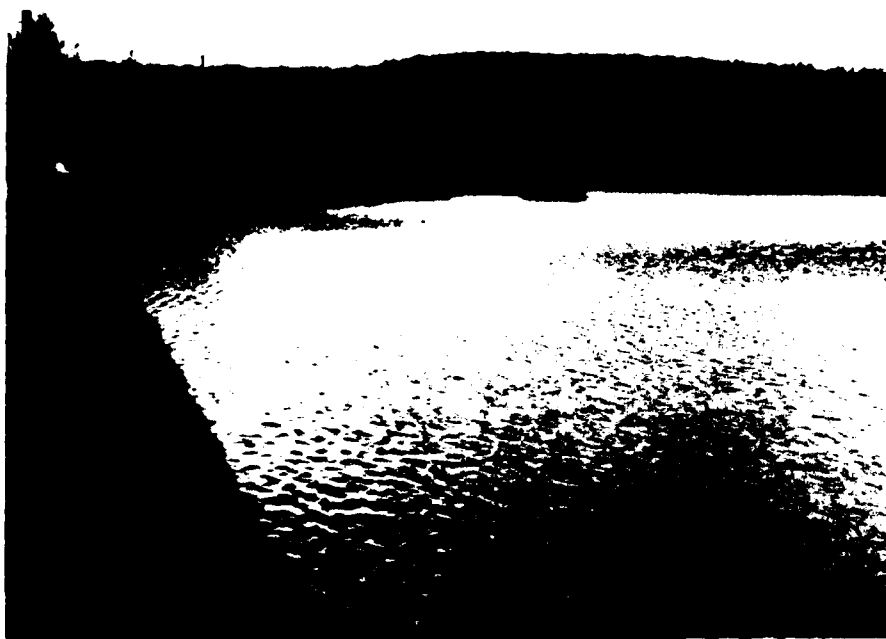
The upper 4 to 5 ft. of the upstream slope was above the reservoir level and available for inspection. A general view of the entire upstream slope is shown in photograph 8. Two types of riprap slope protection were observed, as shown in photograph 3. The upper 2.5 ft. \pm consists of a nearly vertical wall of hand placed angular boulders and cobbles; below this are hand placed cut stone pieces about 8 in. thick and ranging in size from about 1.5 ft. by 1.5 ft. to about 4 ft. by 4 ft. The cut stone pieces are sloped about 1.5 Hor.:1 Vert.

PHOTO NO. 8 - Upstream slope of Dam viewed from left
abutment area.

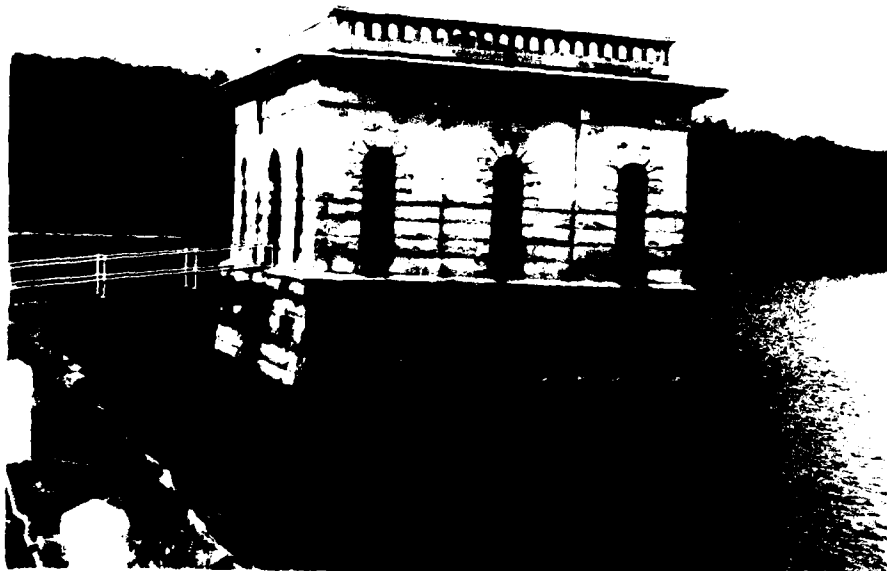
PHOTO NO. 9 - View of intake structure and service bridge. Note location of inlets to structure. Information pertaining to the location, size and inverts of the gates inside structure is not available.

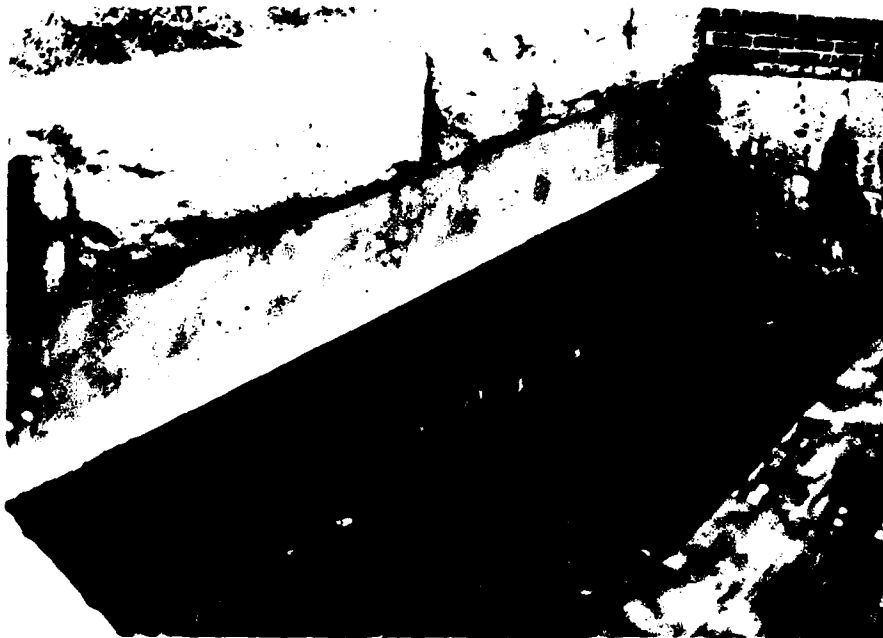
PHOTO NO. 10 - Spillway floor and opening below I beam of Winter Street Roadway Bridge. A comparison of the existing structure and plans dated 1895 indicate that the spillway has undergone some modifications during the lifetime of the Dam.

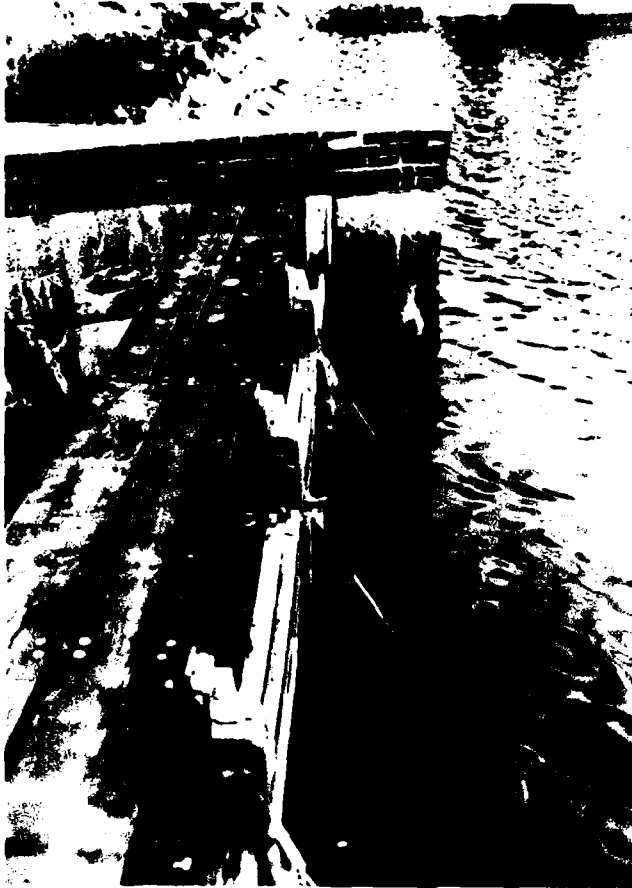
PHOTO NO. 11 - View of stop log facility for spillway. At time photo was taken there were approximately 1.9 ft. of stop logs in place. Note masonry side wall in upper portion of picture which is also visible in Photo No. 5.
