CONNECTICUT RIVER BASIN
SPRINGFIELD, MASSACHUSETTS

FOREST PARK UPPER DAM
MA 00568

PHASE I INSPECTION REPORT
NATIONAL DAM INSPECTION PROGRAM

SEPTEMBER 1979

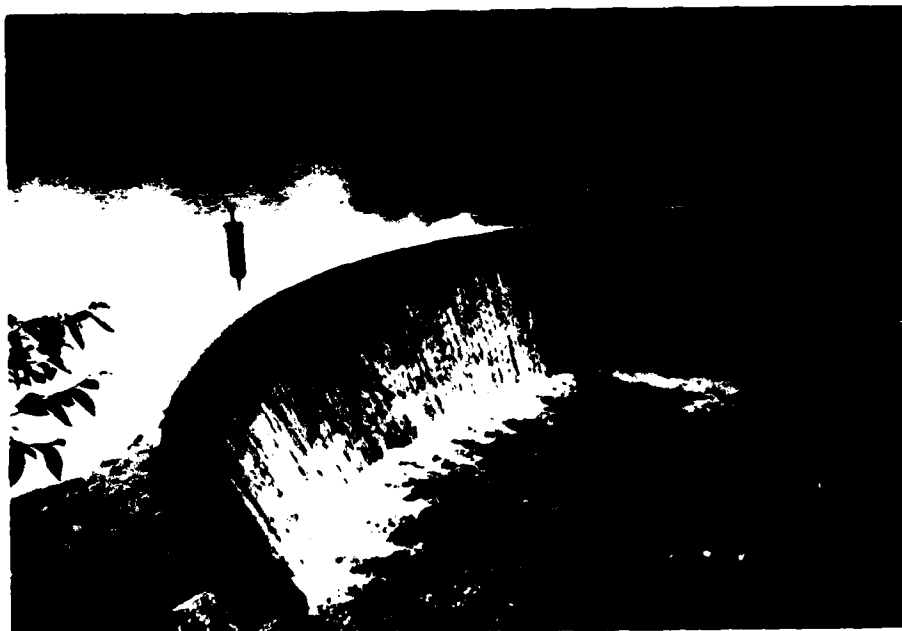
8. OVERVIEW OF SPILLWAY AT UPSTREAM FACE OF DAM.
