CONNECTICUT RIVER BASIN
WHATELY, MASSACHUSETTS

SOUTH DEERFIELD
MA 00522

PHASE I INSPECTION REPORT
NATIONAL DAM INSPECTION PROGRAM

JUNE 1979

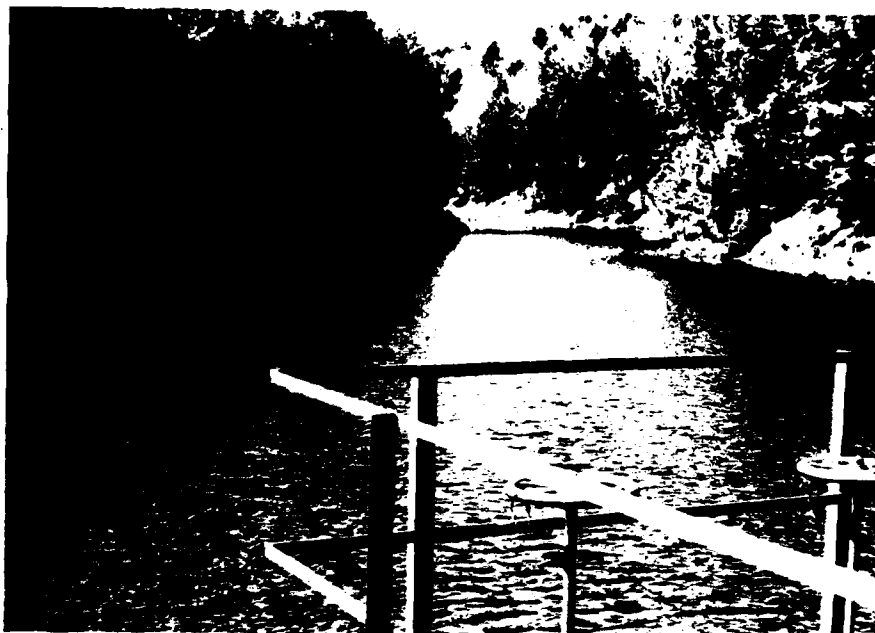
PHOTO NO. 10 - Upstream reservoir viewed from
intake structure.
