MERRIMACK RIVER BASIN  
FITCHBURG, MASSACHUSETTS

## LOVELL RESERVOIR DAM AND DIKE

## PHASE I INSPECTION REPORT NATIONAL DAM INSPECTION PROGRAM

AUGUST 1980

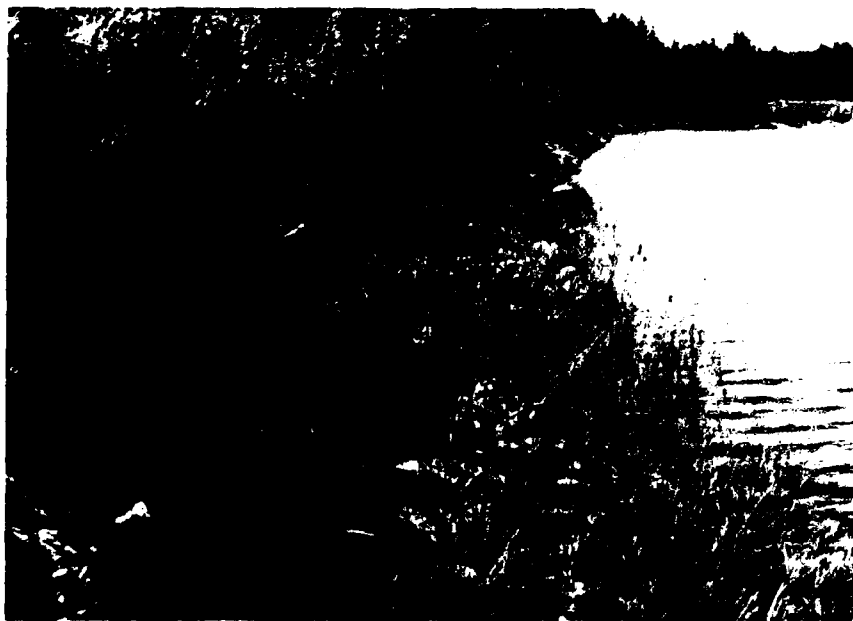
Photo No. 26 Slump in riprap.

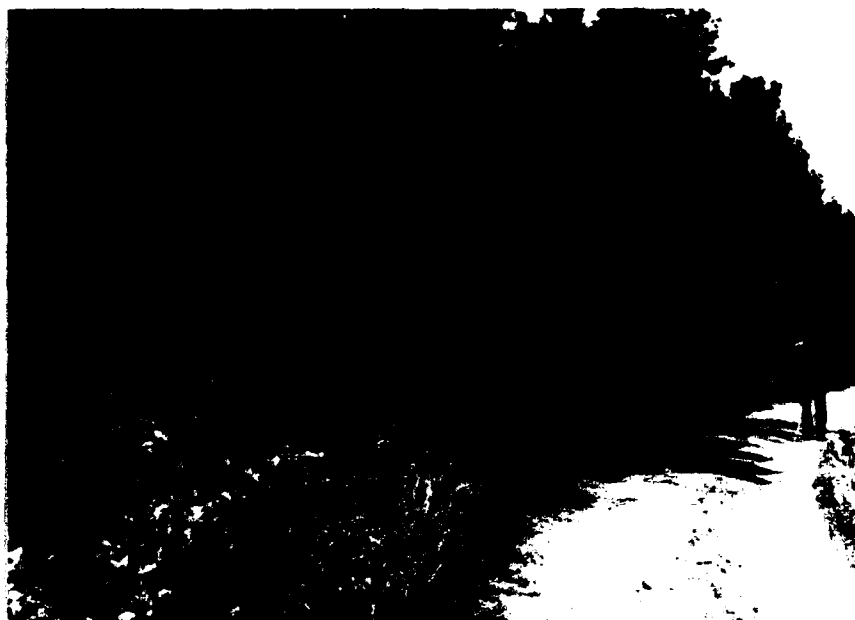
Photo No. 29 Downstream slope at a point 850 ft. right  
of left abutment.
