SUDBURY DAM

MA 00741

PHASE I INSPECTION REPORT
NATIONAL DAM INSPECTION PROGRAM

SEPTEMBER 1978

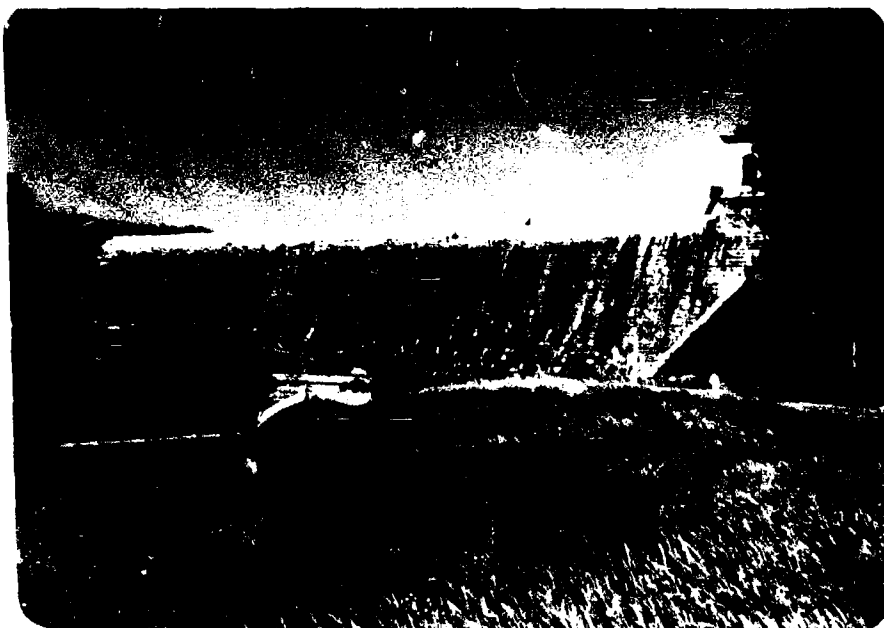
Overview Photo of Sudbury Dam (Roll C11, Frame 19A)

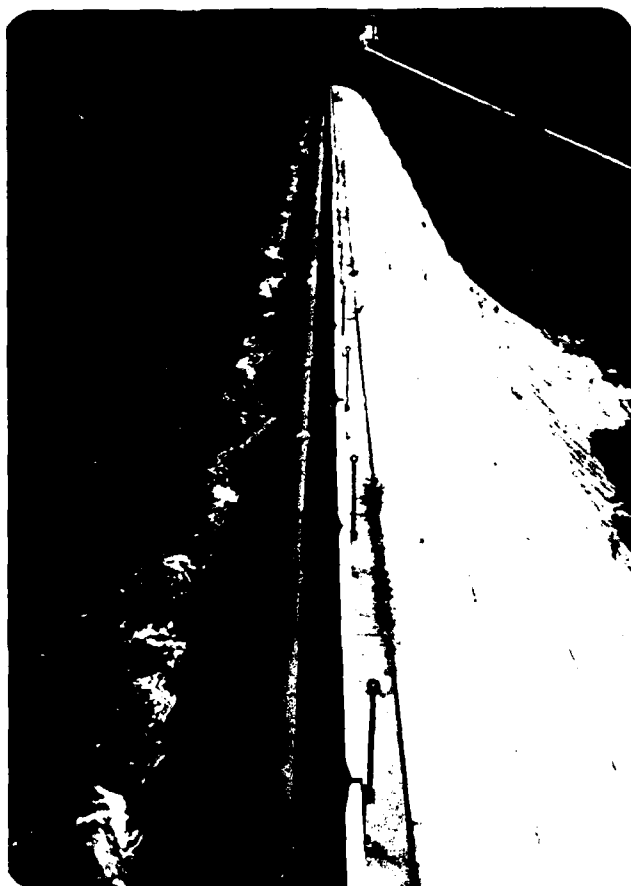
7. Crest of Spillway
Weir Showing
Flashboards

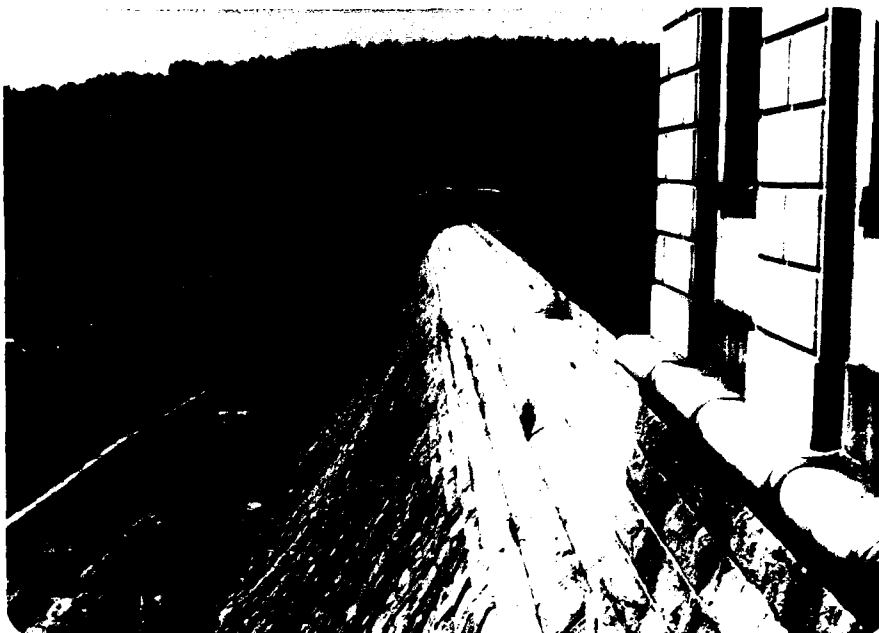
13. Spillway Weir From Gate House
