CONNECTICUT RIVER BASIN
NORTH BROOKFIELD, MASSACHUSETTS

HORSEPOND DAM MA 00950

PHASE I INSPECTION REPORT
NATIONAL DAM INSPECTION PROGRAM

JUNE, 1981

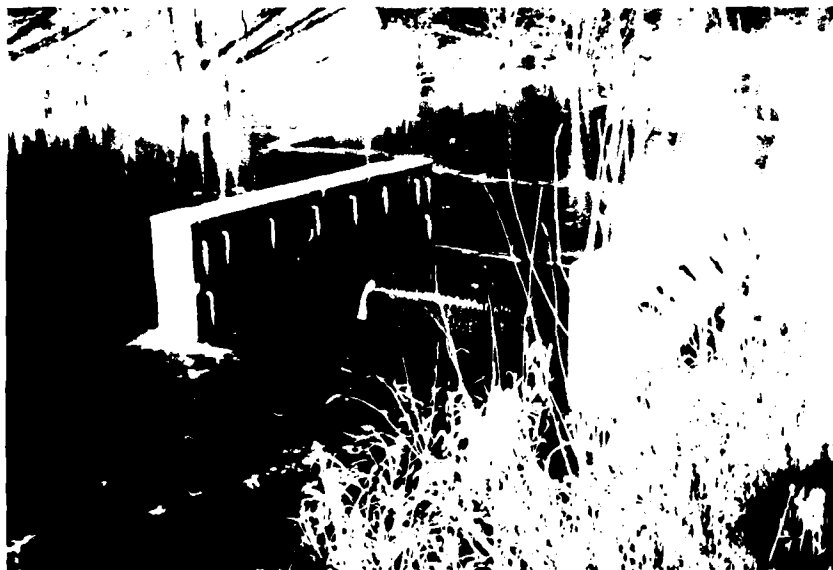
Other appurtenant structures consist of an inlet riser (Photo No. 10), 30-inch reinforced concrete pipe outlet and outlet impact basin (Photo No. 11). All are in good condition, although the inlet riser did not have a trash rack and grate at the time of inspection though there were provisions for one.

Photo No. 10 - Riser for principal spillway. Note supports for missing trash rack and grate.

- (1) Replace the trash rack and grate immediately. Prior to replacement, however, the owner *should inspect the pipe to insure* that no debris or brush have collected in it.
- (2) Remove vegetation from the inlet area.
- (3) Remove trees and brush between the downstream end of the spillway at the left abutment and the Fivemile River.
- (4) Limit dam access to authorized vehicles only.
- (5) Visually inspect the dam and appurtenant structures once a month.
- (6) Mow the grass on a regular basis.
- (7) Engage a registered professional engineer qualified in the design and construction of dams to make a comprehensive technical inspection of the dam once every year.
- (8) Establish a surveillance program for use during and immediately after heavy rainfall and also a downstream warning program to follow in case of emergency.
