MERRIMACK RIVER BASIN
FITCHBURG, MASSACHUSETTS

OVERLOOK RESERVOIR DAM AND DIKE

DAM _____ MA 00876
DIKE _____ MA 01335

PHASE I INSPECTION REPORT
NATIONAL DAM INSPECTION PROGRAM

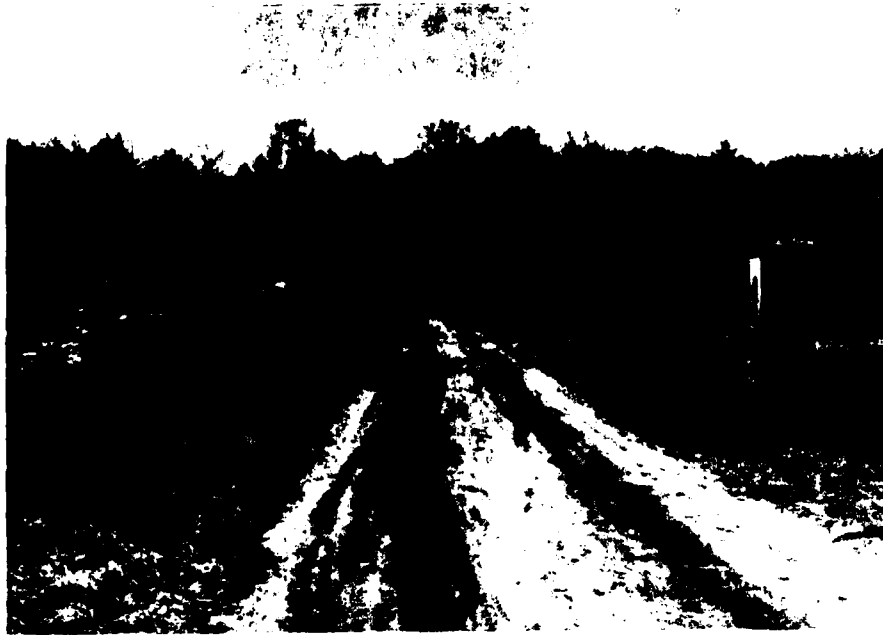
The crest of the dam is approximately 20 feet wide. As shown in photograph 5, a sand and gravel roadway crosses the crest of the dam. No cracking or misalignment is evident.

PHOTO NO. 5 View of crest and gatehouse from the left abutment.

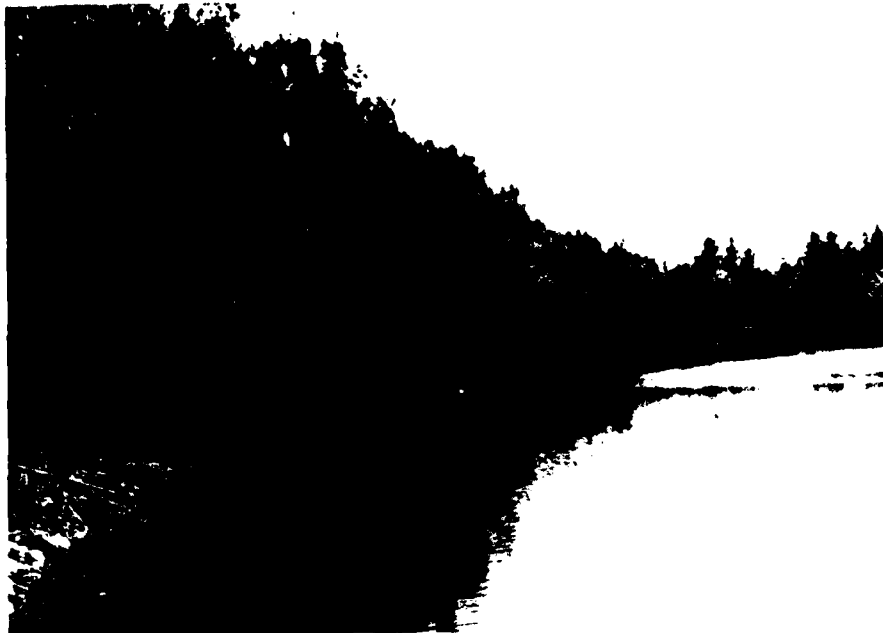
Photo 20 shows the upstream slope from the right abutment to the point of dike curvature and Photo 17 shows the slope from the spillway to the point of curvature. The upstream slope is inclined at 2.5H:1V. The riprap on the slope is in good condition. There is no riprap on the upper 4 feet (measured vertically) of the slope.

Photo No. 17 Upstream slope of dike viewed from spillway toward point of curvature.

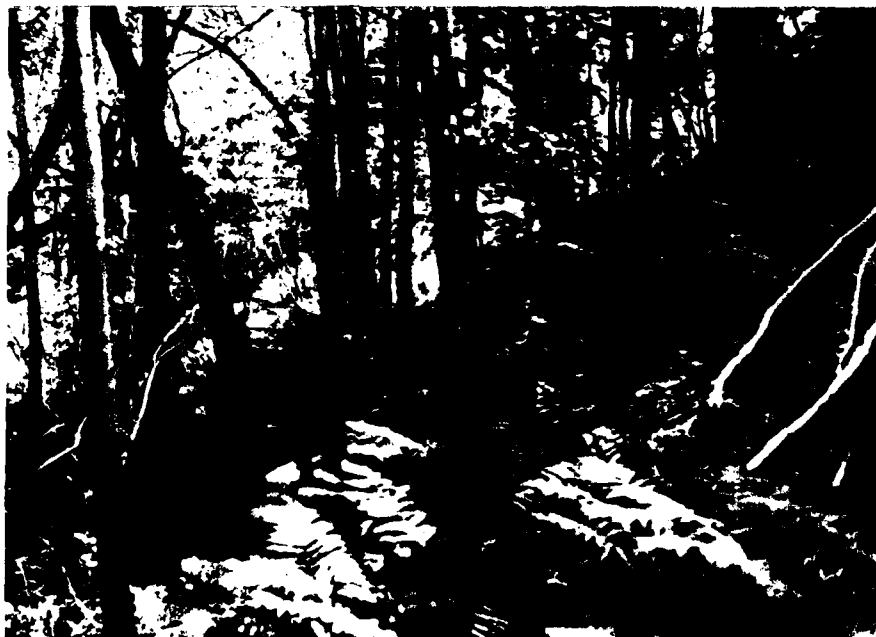
The downstream slope is inclined at about 1.5 to 1.75H:1V. The slope is covered with dense growth including many small trees with occasional larger trees. One tree, a few feet below the downstream toe has a trunk diameter of about 20 inches. Dead trees with trunk diameters greater than 12 inches were observed on the slope.

Photo No. 18 Downstream slope of dike at midheight viewed from the point of dike curvature toward the right abutment.

1. Removal of brush and briars on the slopes of the dam and dike.
2. Refill stump holes and animal burrows in the downstream slope of the dam.
3. Repair erosion and surficial sloughing damage on the downstream slope of the dam with compacted fill.
4. Repair spalled concrete on spillway walls.
5. Repair the approach channel riprap at the spillway inlet.
6. Place additional riprap around the spillway outlet.
7. Test and repair (as required) all valves on a regular basis.
8. Repair and maintain the outlet channel at the 12 inch outlet drain.
9. Install a floor deck for the service bridge.
10. Develop a formal downstream warning system.
11. Institute a program of annual technical inspection.
