CHARLES RIVER BASIN
BOSTON, MASSACHUSETTS

CHESTNUT HILL RESERVOIR DAM
MA 01113

PHASE I INSPECTION REPORT
NATIONAL DAM INSPECTION PROGRAM

JANUARY 1980

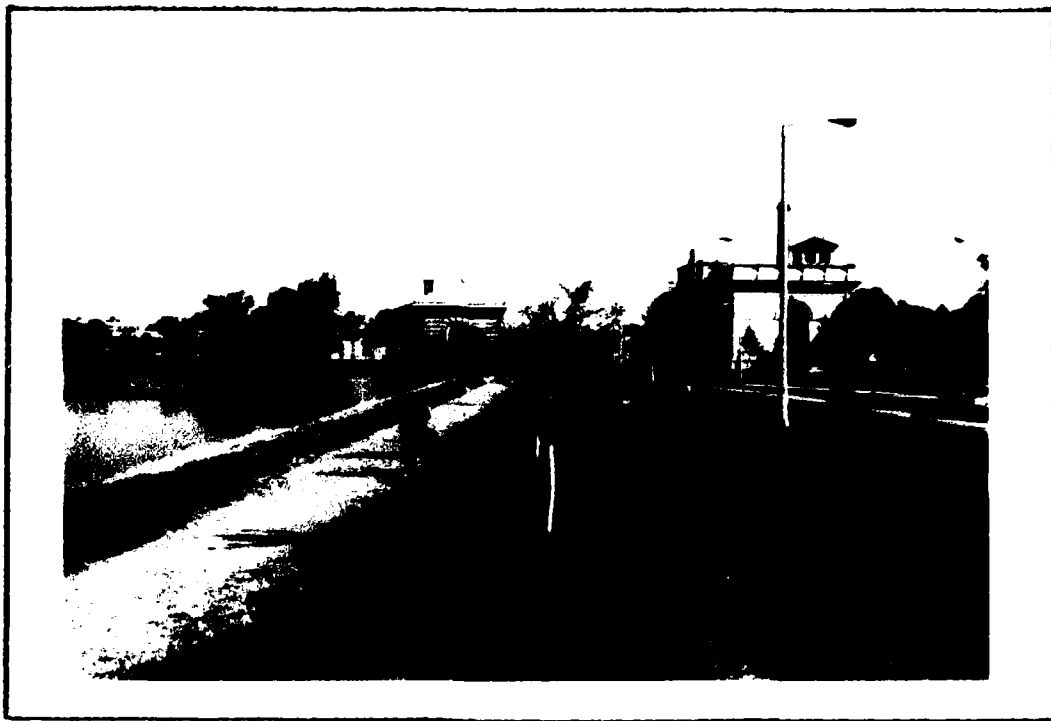
OVERVIEW OF THE CHESTNUT HILL RESERVOIR DAM FROM THE WESTERN
ABUTMENT WITH THE EFFLUENT GATEHOUSE NO. 2 IN THE BACKGROUND.
(10/23/79)

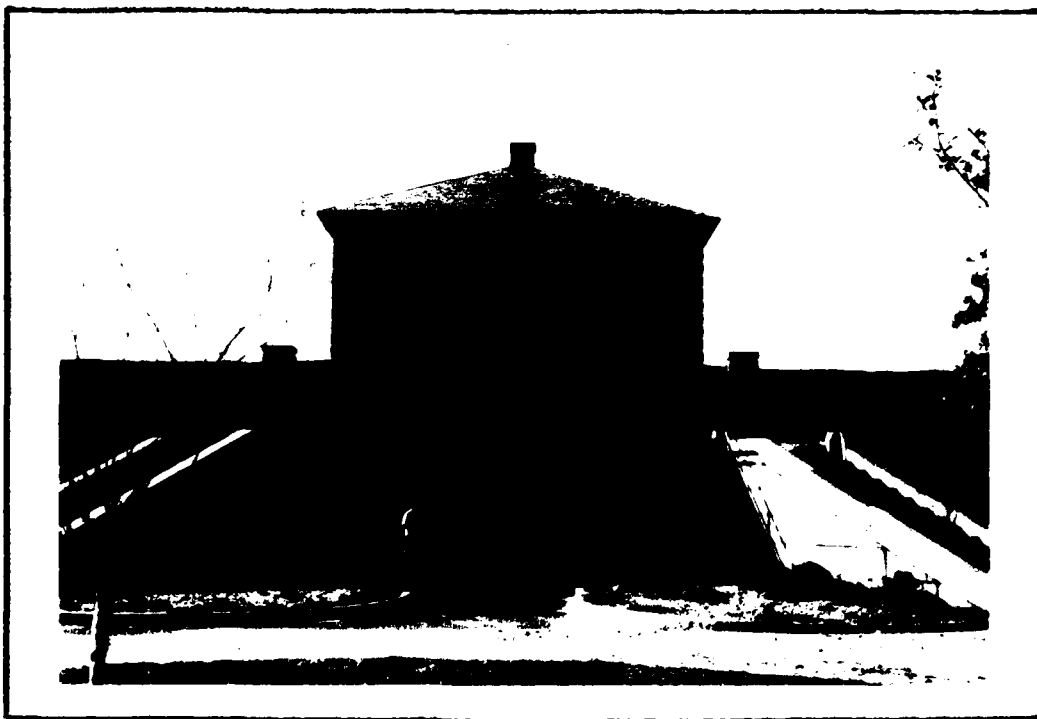
2. EFFLUENT GATEHOUSE NO. 1 AS VIEWED FROM DOWNSTREAM. (10/23/79)

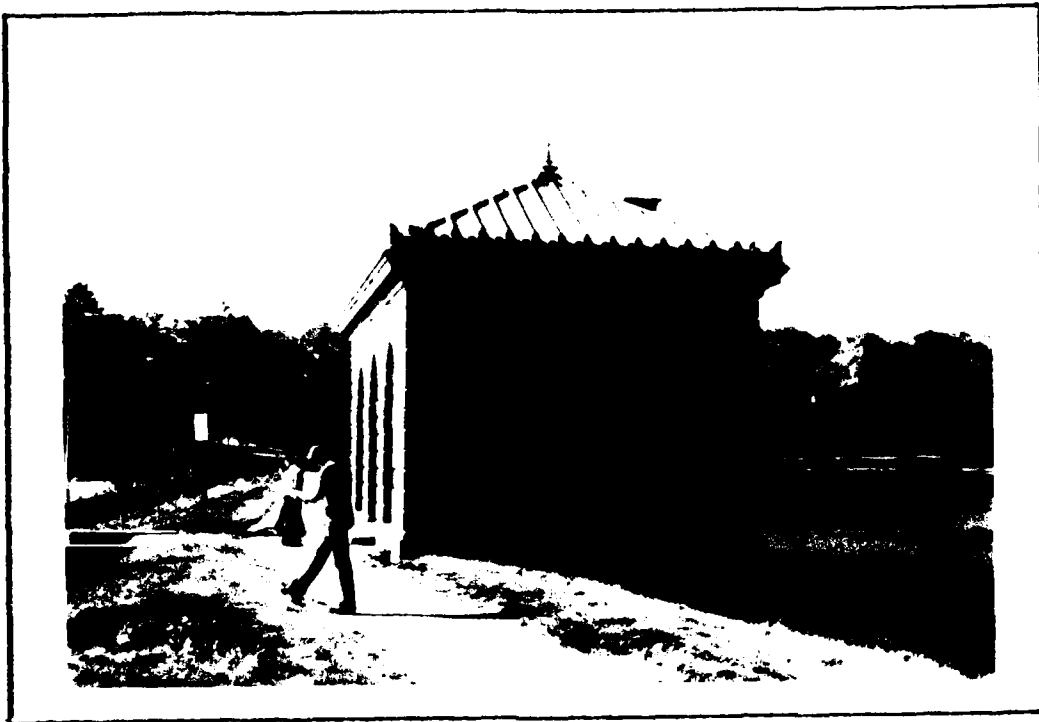
5. EFFLUENT GATEHOUSE NO. 2 LOOKING TOWARDS THE WESTERN ABUTMENT.
(10/23/79)
