CONNECTICUT RIVER BASIN
NORTHAMPTON, MASSACHUSETTS

ROBERTS MEADOW RESERVOIR
(MIDDLE DAM)
MA 00761

PHASE I INSPECTION REPORT
NATIONAL DAM INSPECTION PROGRAM

AUGUST 1978

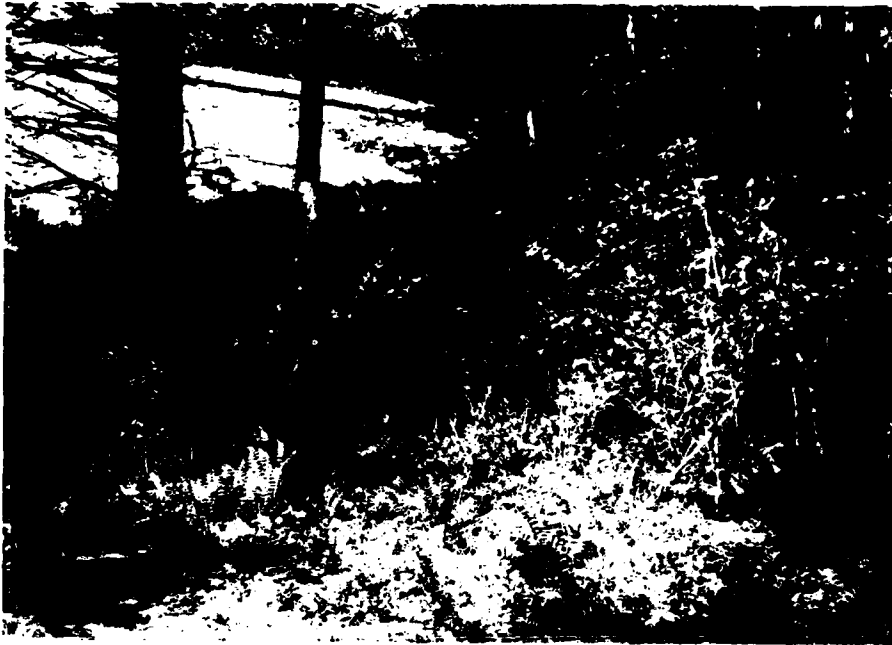
The left abutment was traversed from the dam face to the end of the spillway channel and two additional wet areas were noted at approximately the same elevation as the seep mentioned above. The second area, about 15 ft downstream of the first area, was damp but no surface water was visible. The third area was about 65 ft downstream of the dam face. This third area was very small with no surface water visible.

PHOTO NO. 3 - General view of seep area #2 on left abutment.

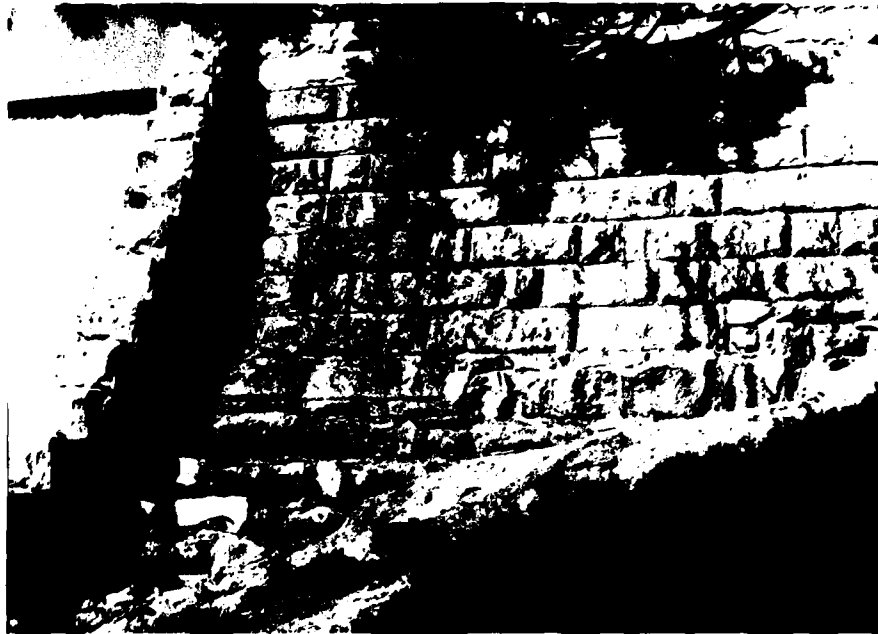
This dam was showing some leakage thru the mortar joints at the time of inspection. The dam has experienced heavy leakage in recent years and currently the City is attempting to have this leakage stopped. Section 4 of this report addresses in more detail the remedial action the city is undertaking.

PHOTO NO. 8 - General view of water seeping through left face of dam.

It is assumed that the grouting program referred to in Section 4.2 will continue forthwith until all leaking has been stopped.

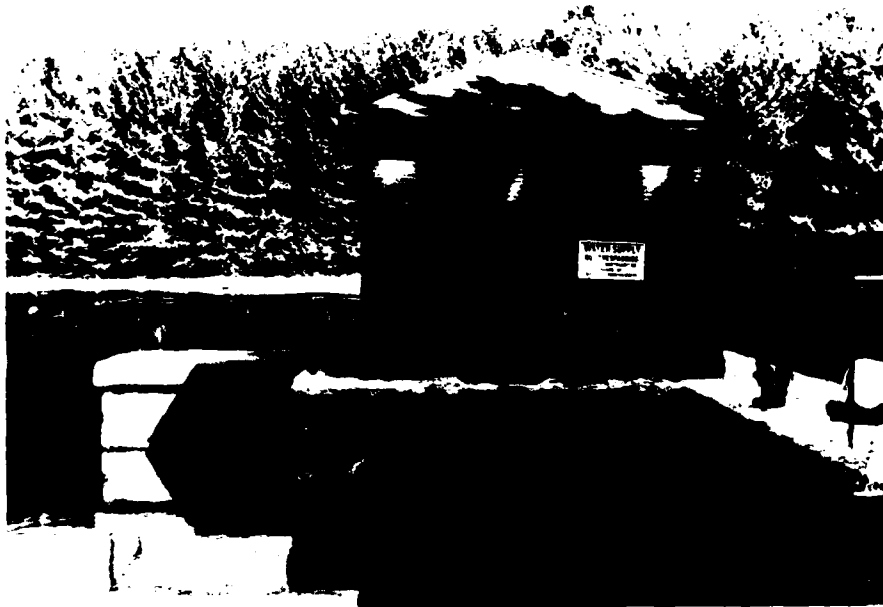
The gate house was inspected to the water surface. The house has a granite masonry substructure with a brick wall and wood roof superstructure. A concrete waste well attached to the rear of the gate house was added in 1933. A crack exists in the left rear corner of this waste well approximately 1/4 inch wide and extends down into the water. Some Spalling exist on the slab of this waste well. The east wall of the brick superstructure shows some cracking of the brick.

PHOTO NO. 12 - General view of Gate House.
