CONNECTICUT RIVER BASIN
RUSSELL, MASSACHUSETTS

WORONOCO MILLS (60 FEET) DAM MA 00738
WORONOCO MILLS (29 FEET) DAM MA 00737

PHASE I INSPECTION REPORT
NATIONAL DAM INSPECTION PROGRAM

FEBRUARY 1979

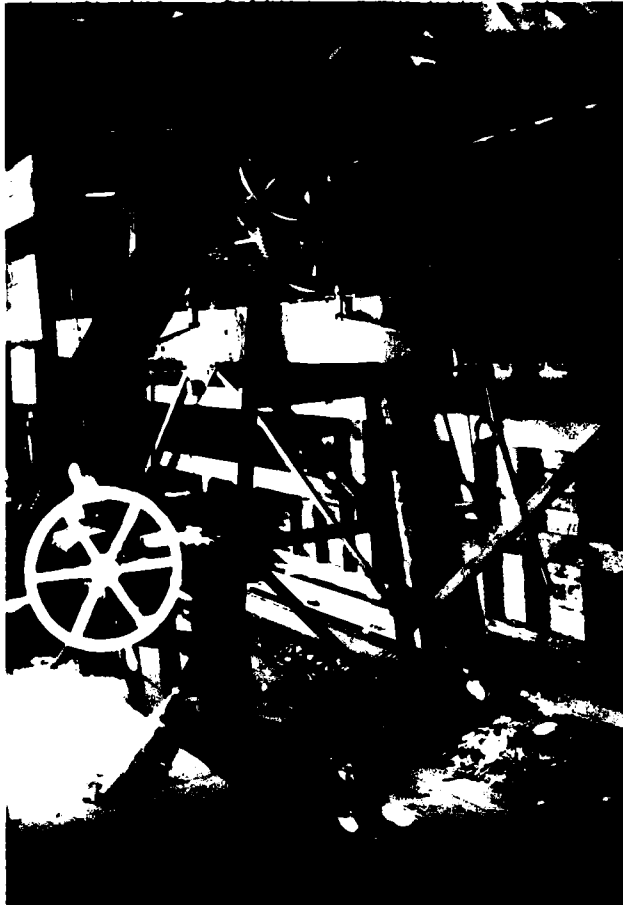
5. GATE & SCREEN OPERATORS WITHIN SCREEN HOUSE.

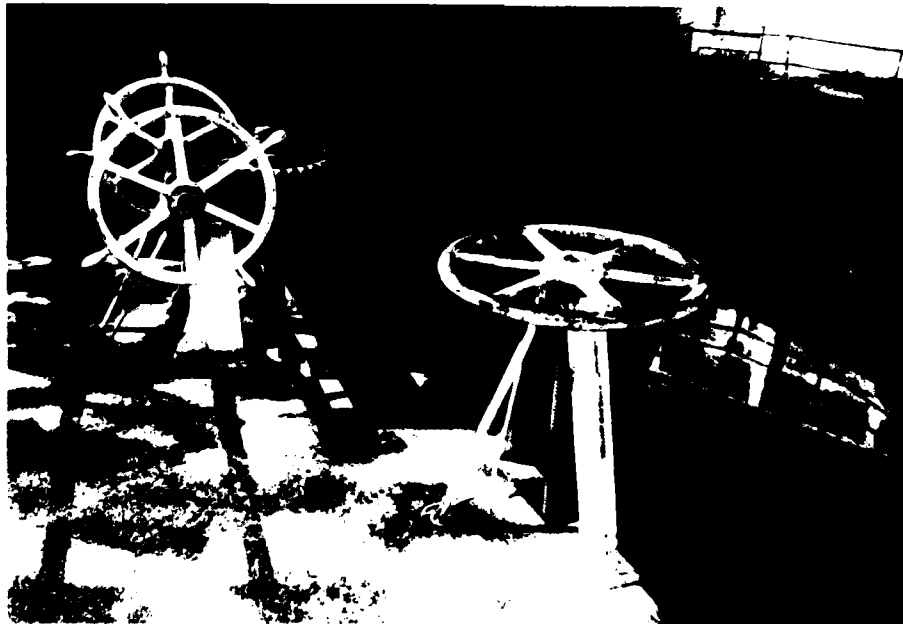
6. GATE OPERATORS ON LEFT ENTRANCE TRAINING WALL OF SCREEN HOUSE.

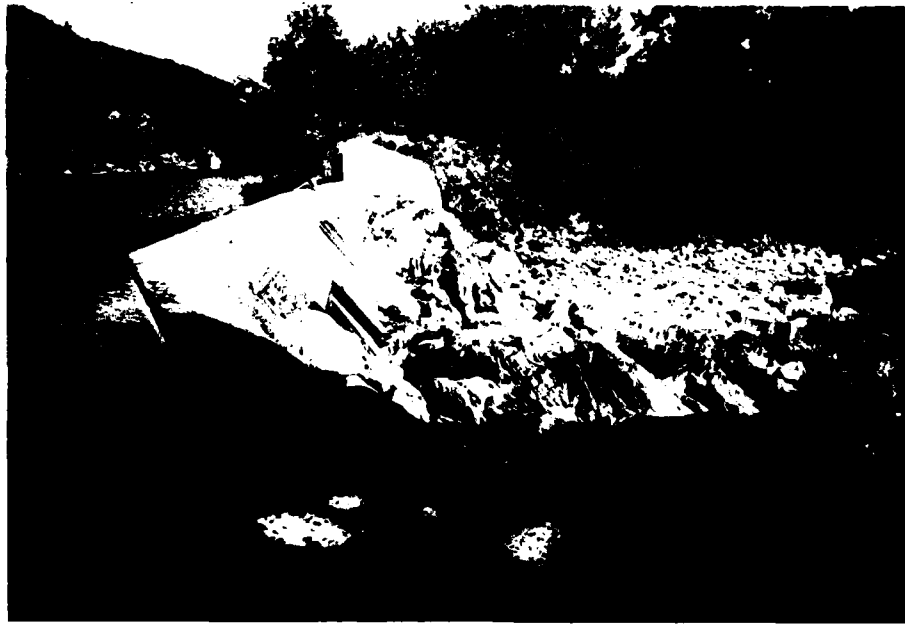
20. OVERVIEW OF WORONOCO (29 FOOT) DAM FROM RIGHT ABUTMENT (ISLAND). NOTE SURFACE EROSION OF RIGHT CONCRETE ABUTMENT IN FOREGROUND.

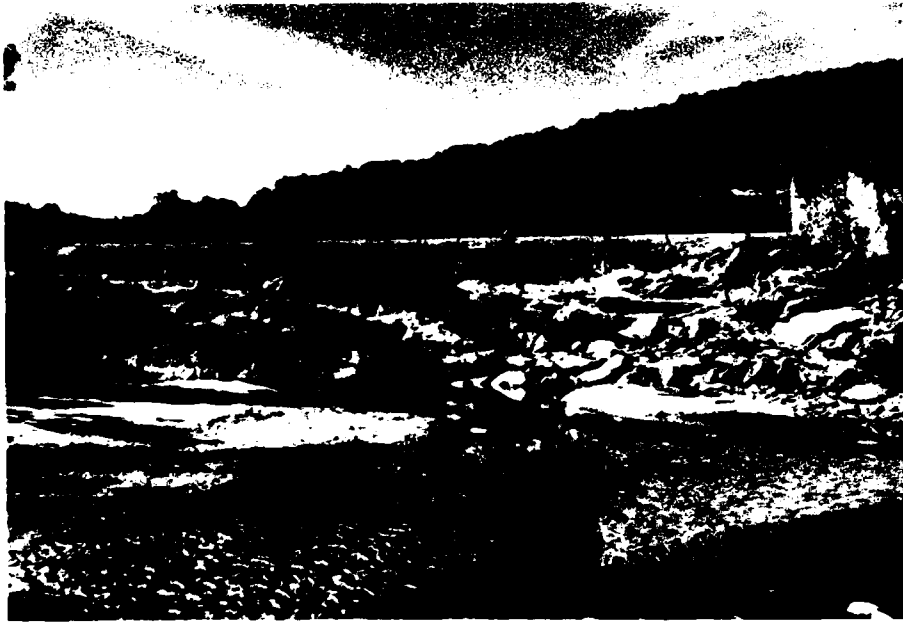
In addition to the seepage that appears from the riprap, there is an unstable area of channel-bottom sand deposits about 200 feet downstream from the 29-foot dam. A 10 to 20 foot wide area of wet sand, shown in Photos 21 and 22, apparently has a slight upward seepage flow and will not readily support foot traffic. No actual soil movement with the flow was observed. Whether the seepage has its origin close upstream in the channel, or further away in the rock foundation of the concrete dam or the soils on either side of the channel is not known.

22. DOWNSTREAM FACE OF WORONOCO (29 FOOT) DAM. SAND IN FOREGROUND IS SATURATED AND VERY LOOSE.

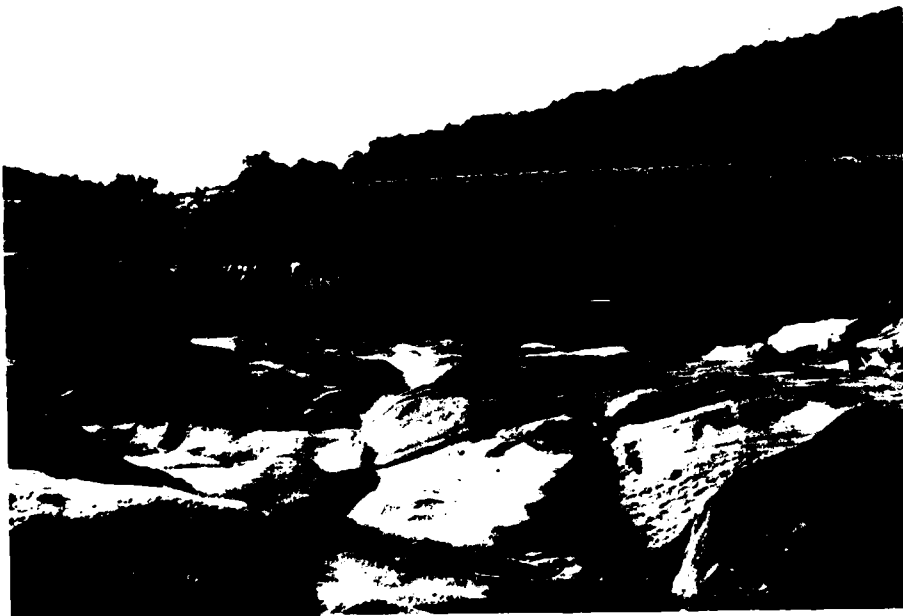
23. SURFACE AND JOINT EROSION IN DOWNSTREAM FACE OF WORONOCO (29 FOOT) DAM.

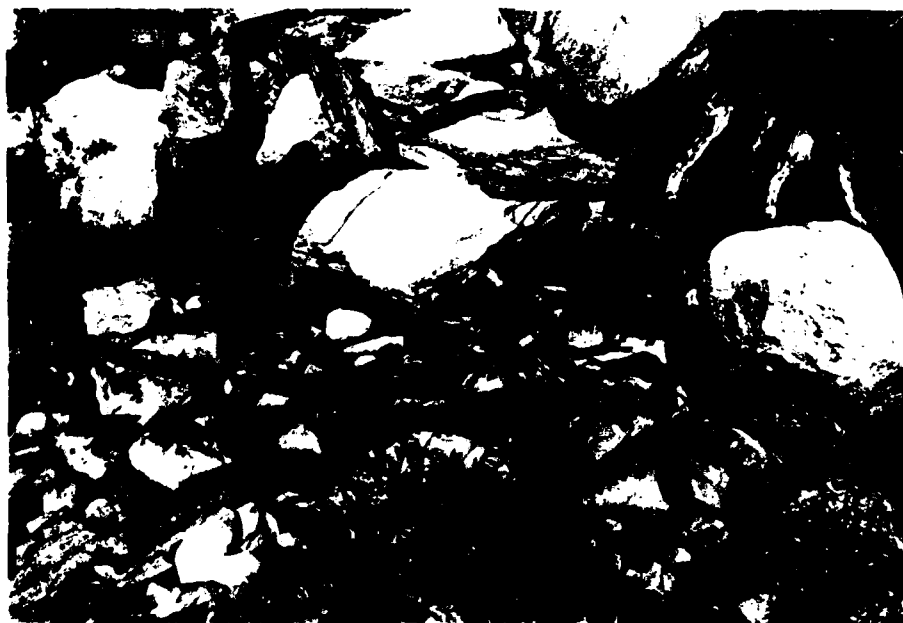
26. SEEPAGE AND RUST STAIN FROM LEFT CHANNEL BANK APPROXIMATELY 300 FEET DOWNSTREAM OF WORONOCO (29 FOOT) DAM LEFT ABUTMENT.
