WEYMOUTH RIVER BASIN
BRAINTREE & RANDOLPH, MASSACHUSETTS

GREAT POND UPPER RESERVOIR DAM

MA 00823

PHASE I INSPECTION REPORT
NATIONAL DAM INSPECTION PROGRAM

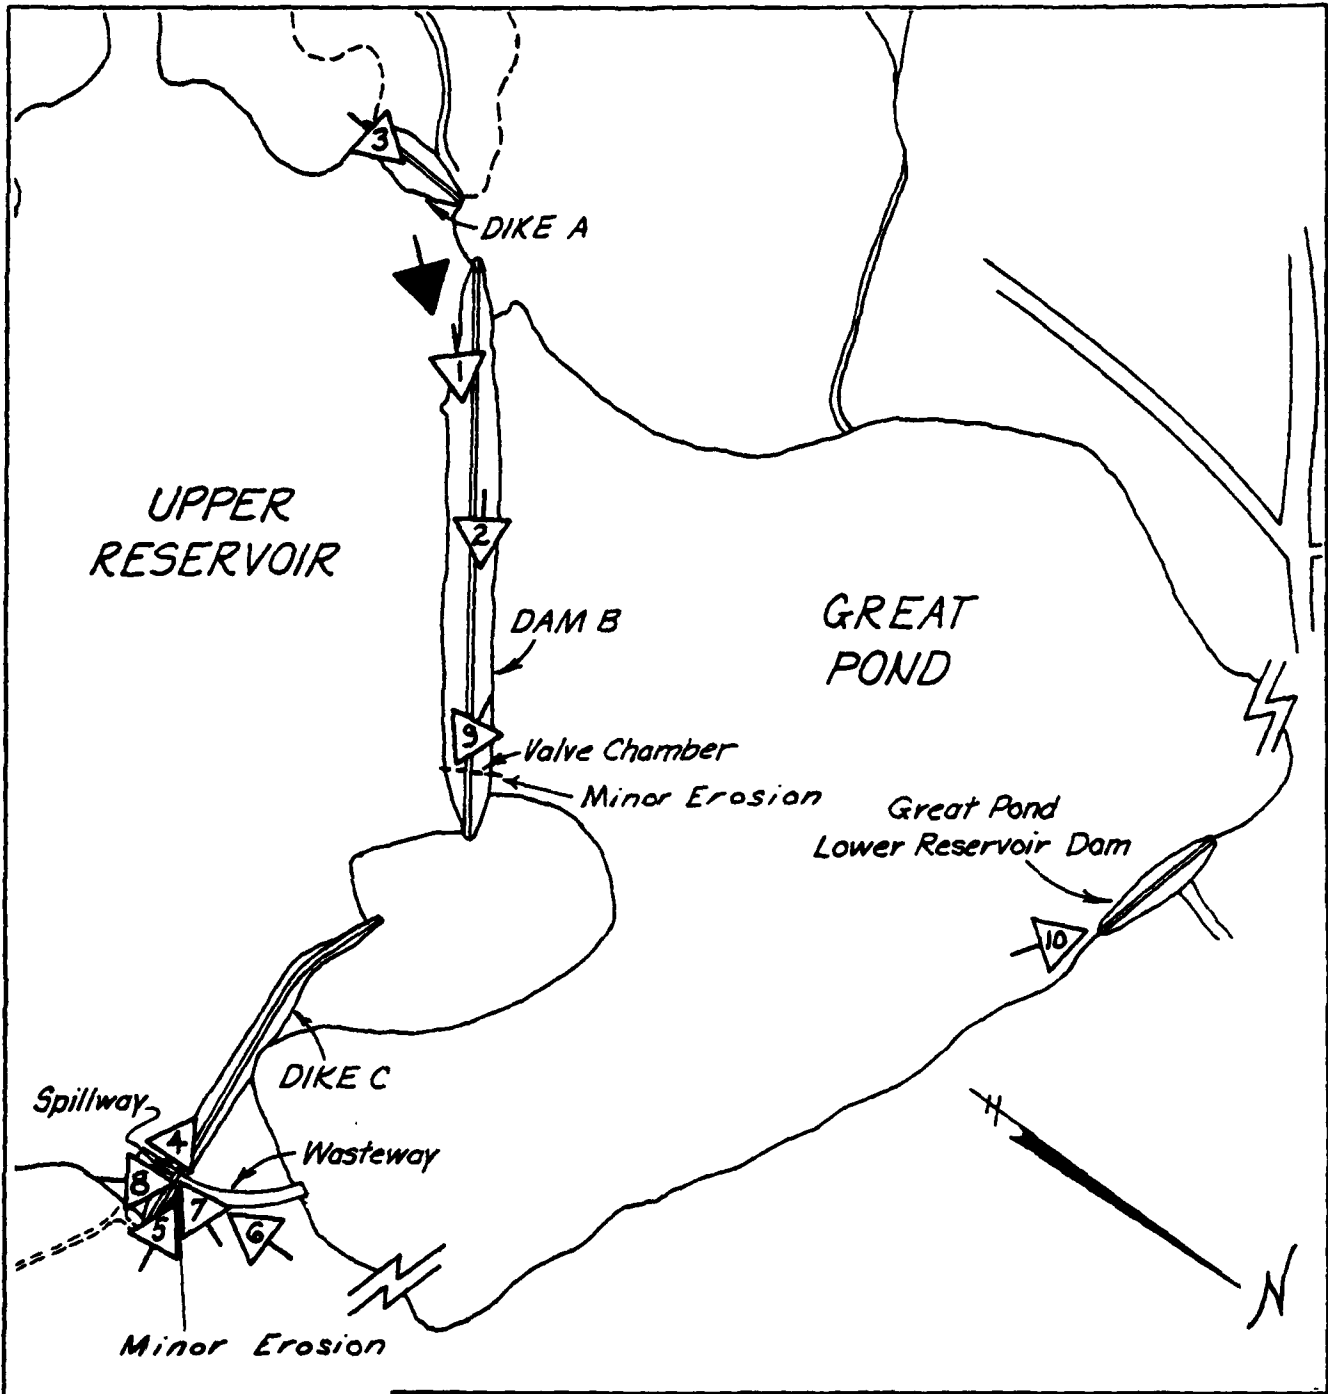
OVERVIEW
PHOTO

Photo No. 3 is a view of the crest and downstream slope of Dike A, and, as may be noted, there is considerable brush growth on the slope. The overview photo shows the upstream slope of Dike A, taken from the far left end looking in the direction of Dam B. A slight amount of growth can be noted along the entire length of the upstream slopes of the embankments. Photo No. 1 is a view of the upstream slope of Dam B showing the hand placed stone slope protection. Photo No. 2 is a view of the downstream slope of Dam B taken from the left end looking toward the right end. As may be noted, there is considerable brush and light tree growth, and a relatively large pine on the downstream slope. Photo Nos. 4 and 5 show the growth on the upstream and downstream slope of Dike C in the vicinity of the spillway.
