MERRIMACK RIVER BASIN
CLINTON, MASSACHUSETTS

LANCASTER MILLPOND DAM
MA 00887

PHASE I INSPECTION REPORT
NATIONAL DAM INSPECTION PROGRAM

JUNE, 1981

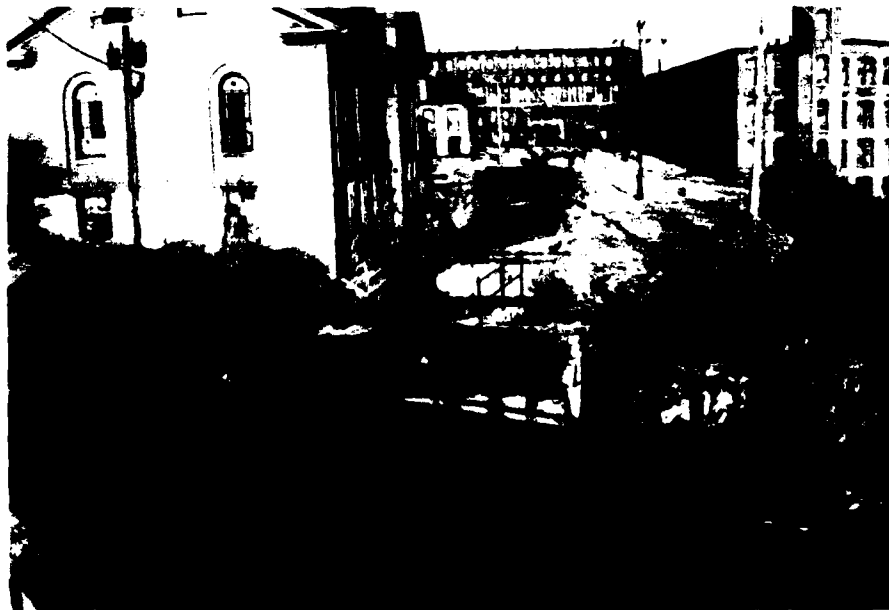
Photo No. 7 - Entrance to mill channel on left side of dam.
