WILSON POND DAM
ME 00121

PHASE I INSPECTION REPORT
NATIONAL DAM INSPECTION PROGRAM

DEPARTMENT OF THE ARMY
NEW ENGLAND DIVISION, CORPS OF ENGINEERS
WALTHAM, MASS. 02154

MARCH 1980

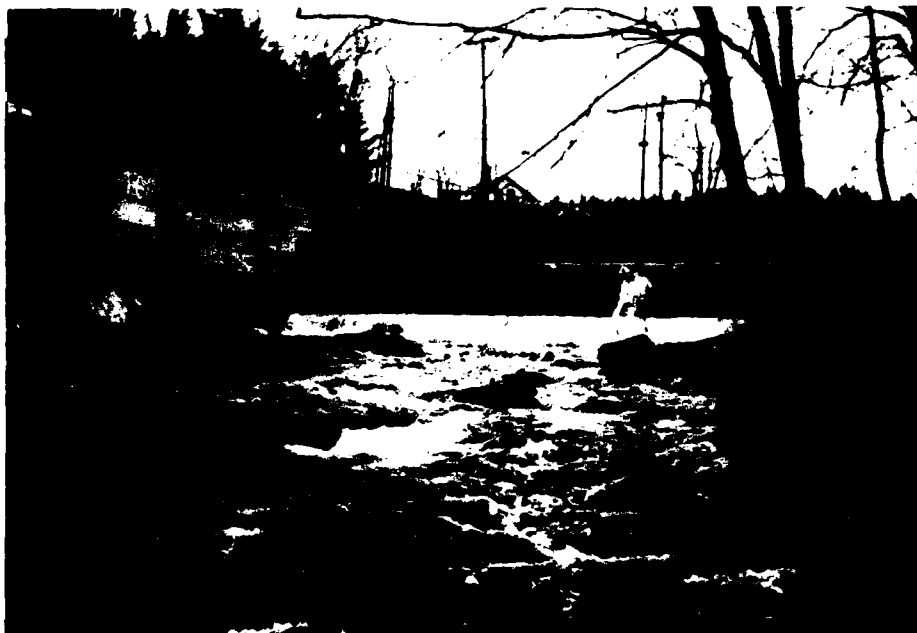
b. Dam. Wilson Pond Dam, the spillway and adjacent intake structure, appears to be in good to fair condition. The spillway was obscured from view by flowing water during the site visit, Photo No. 4. However, based upon those portions of the spillway that could be viewed, the abutments, and observations made during an initial site reconnaissance in September 1979, Photo No. 5, when no water was flowing over the weir, the structure appears to be in good condition. The only significant conditions noted near the spillway were an apparent depression of the stream bed downstream from the weir, erosion of the concrete/ledge interface downstream of the right abutment, Photo No. 6, and the loss of stone at the masonry retaining wall about 50 ft. downstream of the right abutment, Photo No. 7.

4. Spillway and right abutment, downstream

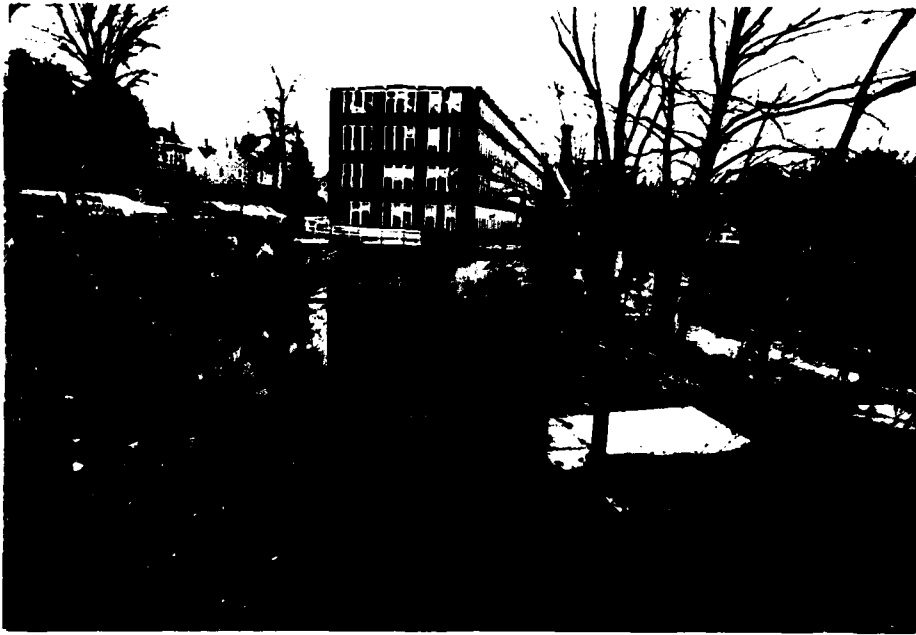
c. Appurtenant Structures. The power canal, Photo No. 10, is in fair condition with several local failures of the stone walls along the canal. Minor brush is present along

10. Power canal downstream from intake structure

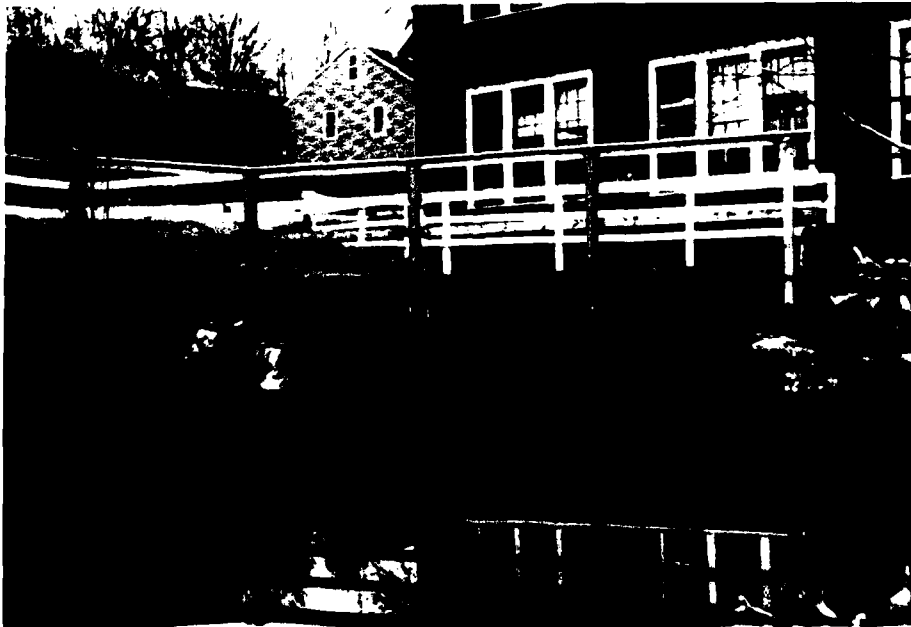
The wooden access bridge and area adjacent to the forebay are in good condition, Photo No. 11. The debris rack over the intake of the shoe factory power tunnel, though rusted, is considered to be in good condition and was free of debris.

11. Power tunnel forebay with access bridge
