BLACKSTONE RIVER BASIN  
NORTHBRIDGE, MASSACHUSETTS

LINWOOD POND DAM

MA 00896

PHASE I INSPECTION REPORT  
NATIONAL DAM INSPECTION PROGRAM

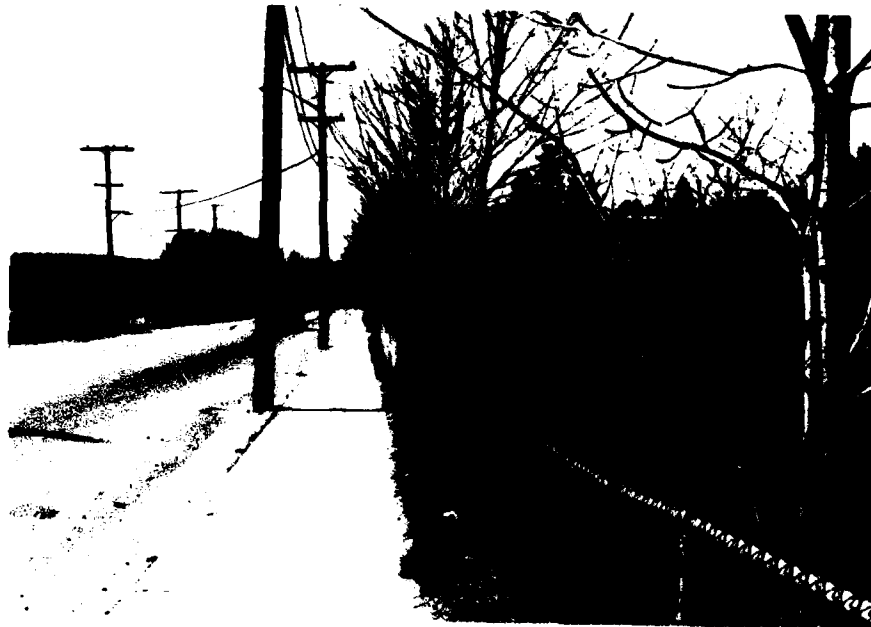
5. Crest and upstream slope of Linwood Avenue Dike.

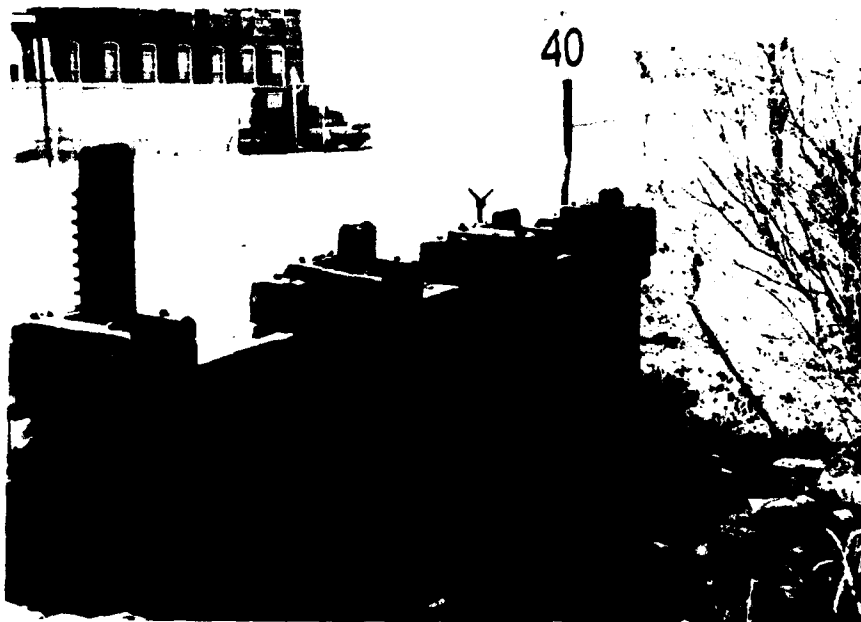
Linwood Avenue Dike. A portion of Linwood Avenue and the mill complex's parking lot acts as a dike retaining part of Linwood Pond in a catchment which lies to the left of Linwood Avenue. The dike is about 276 ft. long and has a wide crest with a minimum width of about 100 ft. A culvert located just upstream of the dike and under Linwood Avenue connects the two parts of the pond. The Linwood Avenue Dike is covered with heavy brush and tree growth on the upstream slope. Because of the heavy growth, the condition of the upstream slope could not be determined. The dike runs parallel to the Mumford River. On its downstream end there is an abandoned gate structure which leads to a conduit which passes through the mill and connects back to the Mumford River. The intake to the conduit has been blocked off completely by a concrete plug and no longer serves any useful purpose (see Appendix C, Photo Nos. 5 & 10).

10. Abandoned outlet gate structure at Linwood Avenue Dike

(4) Institute procedures for an annual periodic technical inspection of the dam and appurtenant structures including operation of the low level outlet and the condition of the concrete plug in the abandoned outlet conduit.

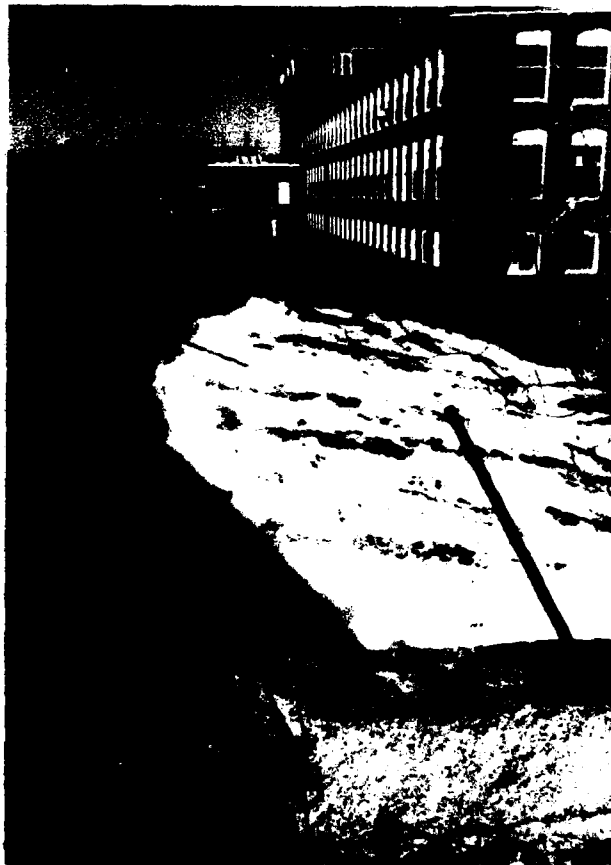
11. View along spillway crest.
