CLAM LAKE DAM
MA 01052

PHASE I INSPECTION REPORT
NATIONAL DAM INSPECTION PROGRAM

DEPARTMENT OF THE ARMY
NEW ENGLAND DIVISION, CORPS OF ENGINEERS
WALTHAM, MASS. 02154

FEBRUARY 1980

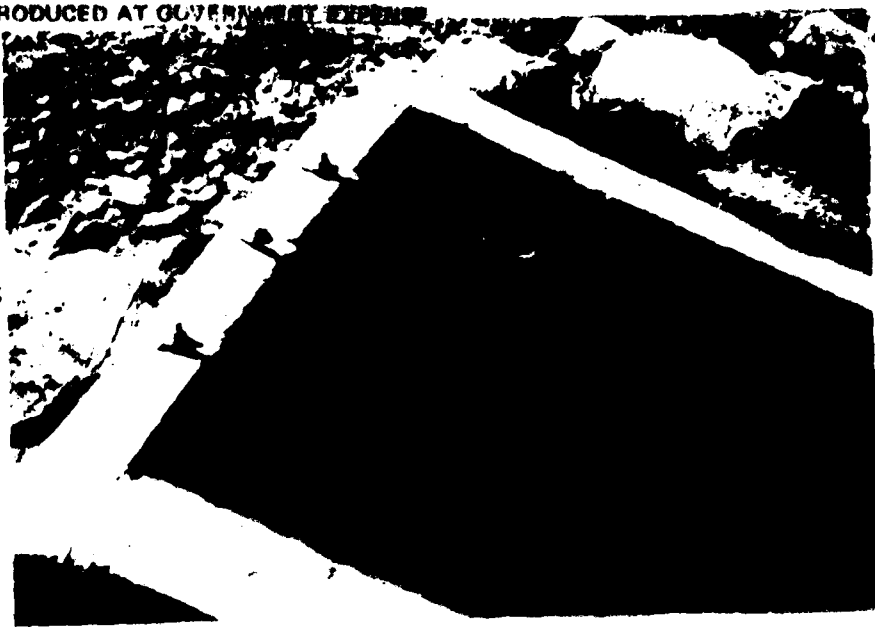
Photo 11

Gate well of principal spillway structure. Note the lower two stem guides are damaged.

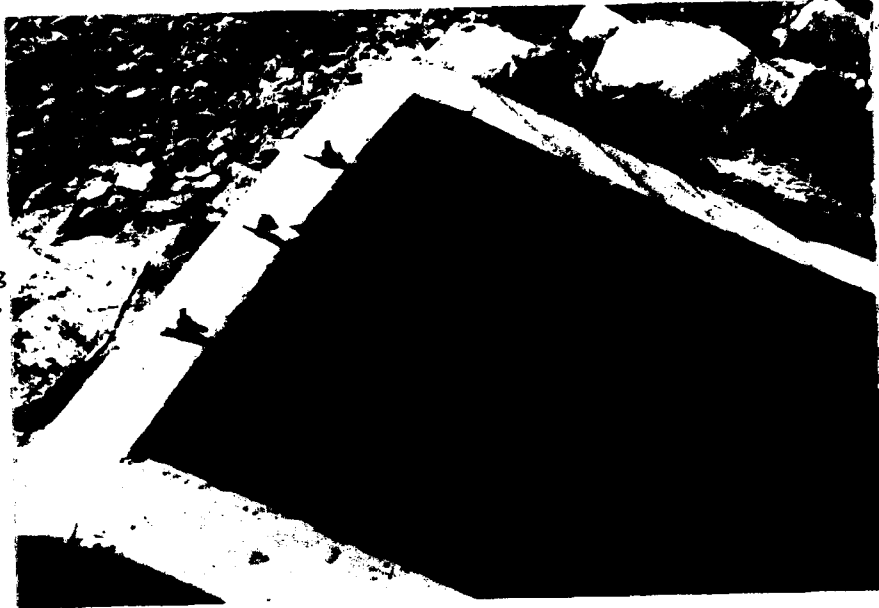
Photo 11

Gate well of principal spillway structure. Note the lower two stem guides are damaged.
