MOUSAM RIVER BASIN
SANFORD, MAINE

GOODALL-SANFORD DAM
ME-00185

PHASE I INSPECTION REPORT
NATIONAL DAM INSPECTION PROGRAM

JUNE 1979

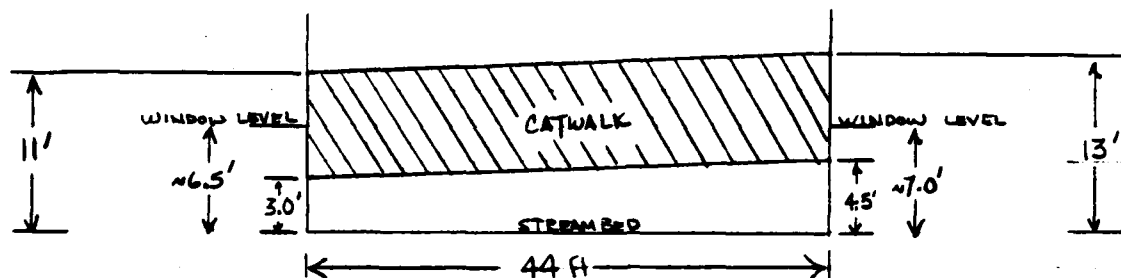
CROSS - SECTION #2
(AT CATWALK LOCATED ~ 250 FT BELOW DAM)

NOTE: CATWALK SIDES AND ROOF ARE CONSTRUCTED OF THIN SHEET METAL AND IS SUPPORTED BY 12" AND 8" STEEL "I" BEAMS. FLOOD WATERS IMPACTING THE CATWALK WOULD PROBABLY SEVERELY DAMAGE AND WASH OUT THE SHEET METAL PORTIONS OF THE STRUCTURE.
