MERRIMACK RIVER BASIN
WESTMINSTER, MASSACHUSETTS

MEETINGHOUSE POND DAM
MA 01018

PHASE I INSPECTION REPORT
NATIONAL DAM INSPECTION PROGRAM

NOVEMBER 1978

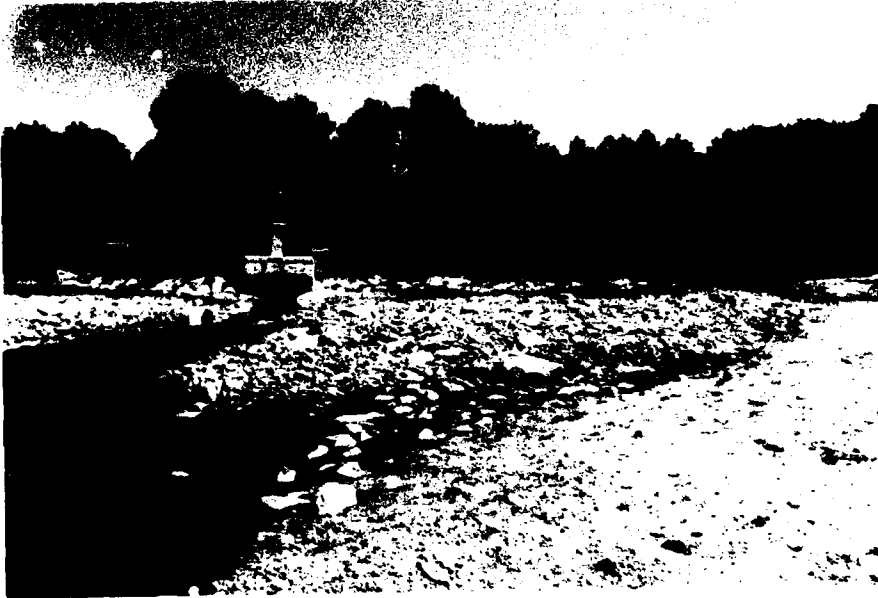
1. OVERVIEW OF MAIN DAM AND GATE HOUSE.

- c. Appurtenant Structures - The gate house shown in Photo Nos. 1 and 2 is in good condition. The wood trim on the structure requires maintenance and repainting. The parge coat at the base of the structure has some cracking present. The equipment shown in Photo Nos. 6 and 7 within the gate house, is operational with the exception of an abandoned 10-inch reservoir drain. All other valves within the structure are kept in the open position and the flow is controlled by valves at the downstream end of the pipeline. The blow-off valve and pipe shown in Photo Nos. 8 and 9, which are currently used as the reservoir drain, are operational. The field stone intake channel shown in Photo Nos. 1 and 3 was partially obscured by water but appeared to be in good condition.

- (1) Clear brush and trees from the dam and dike embankments, including stump removal and backfilling; establish vegetative cover; and cut grass and weeds on the embankments at least once a year. It would be reasonable to exclude the area downstream from West Princeton Road from the clearing requirement.
- (2) Provide additional riprap erosion protection where it is lacking or deficient on the upstream faces of the dam and dike.
- (3) Evict any occupants and fill the animal burrows in the downstream slope of the dike.
- (4) Re-shape the dam crest and limit vehicle traffic to avoid possible slope erosion by concentrated storm water runoff from ruts.
- (5) Remove and replace all loose shotcrete on the spillway structure.
- (6) Perform maintenance work on the gate house wood trim and the foundation parge coat.

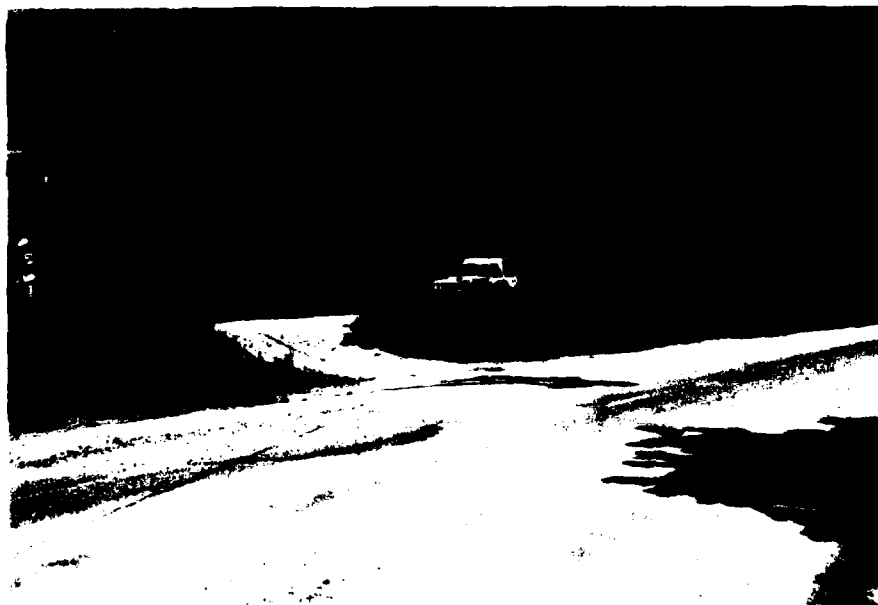
5. VIEW OF LEFT DAM EMBANKMENT FROM ROAD DOWNSTREAM
AND PARALLEL TO DAM.
