KENNEBEC RIVER BASIN  
PITTSFIELD, MAINE

WAVERLY DAM  
ME 00111

PHASE I INSPECTION REPORT  
NATIONAL DAM INSPECTION PROGRAM

MAY 1981

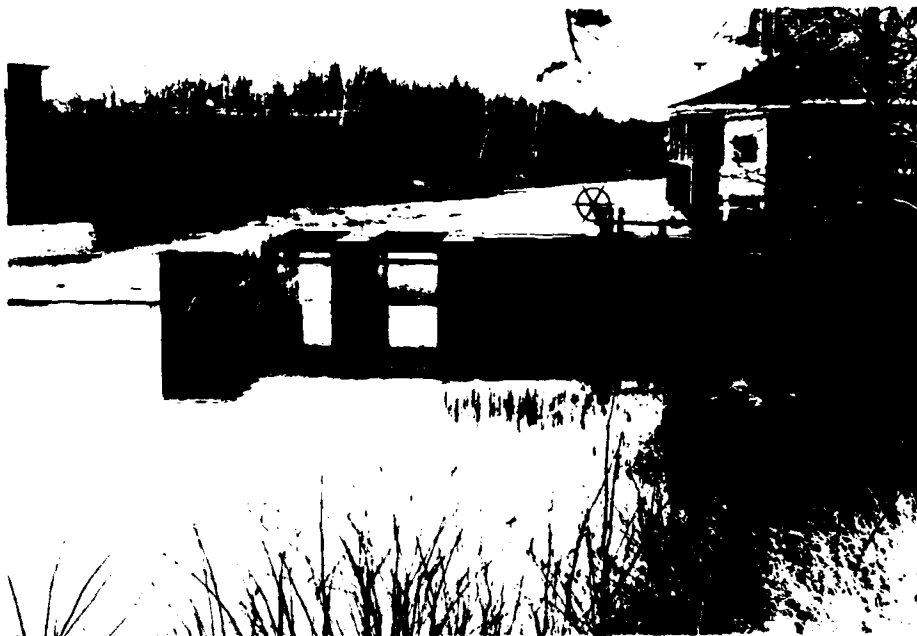
The two stoplog bays and two penstocks, located at the right side of the dam, were in good condition, Photo No. 12. The gate lift mechanisms were partially dismantled and not operable. Flow through one of the penstocks, Photo No. 13, indicated leakage through the corresponding slide gate. The gate chamber training walls were cracked at the top, Photo No. 14, where steel members were embedded in the concrete. These steel members supported walkway gratings at some previous time.

12. Alignment at right end of dam
