SOUTHERN MAINE COASTAL BASIN
YORK, MAINE

CHASES POND DAM
ME 00188

PHASE I INSPECTION REPORT
NATIONAL DAM INSPECTION PROGRAM

APRIL 1980

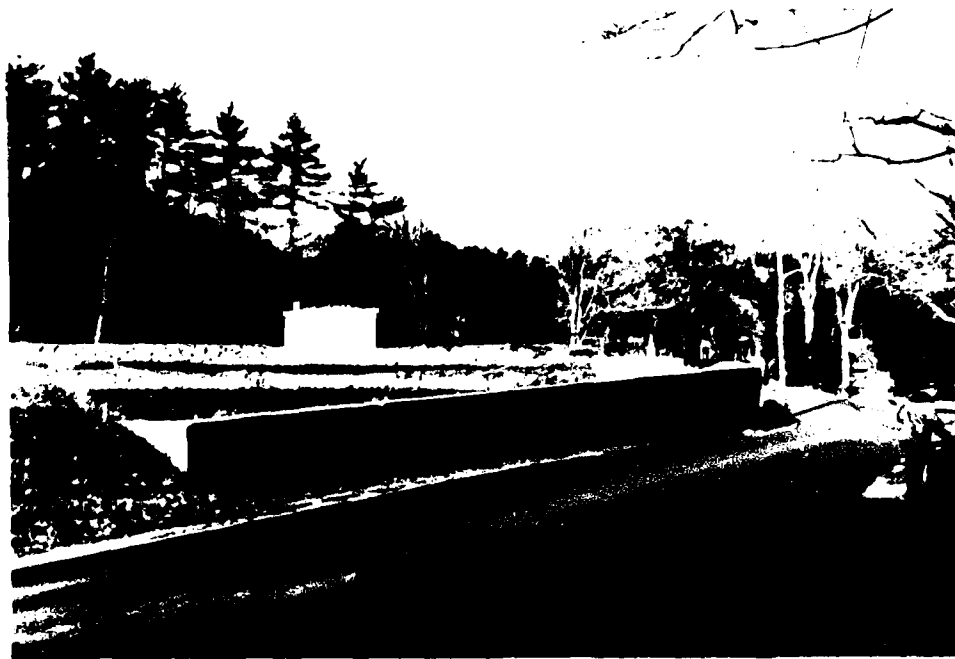
The right cantilever wall, Photo No. 10, evidences early signs of major deterioration of the concrete (see Appendix page A-5). Many of the wall panels have edge and joint deterioration, a longitudinal crack along the top surface of the wall, surface crazing of the concrete and/or efflorescence on the downstream face. The second panel from the spillway, Photo No. 11, appears to have shifted or tilted outward from the alignment of the adjacent wall panels. Other than the second panel, the alignment of the wall is good, Photo No. 6.

10. Cantilever wall, downstream

2. Determine the depth of surface deterioration of concrete elements and the necessity and means of repair.

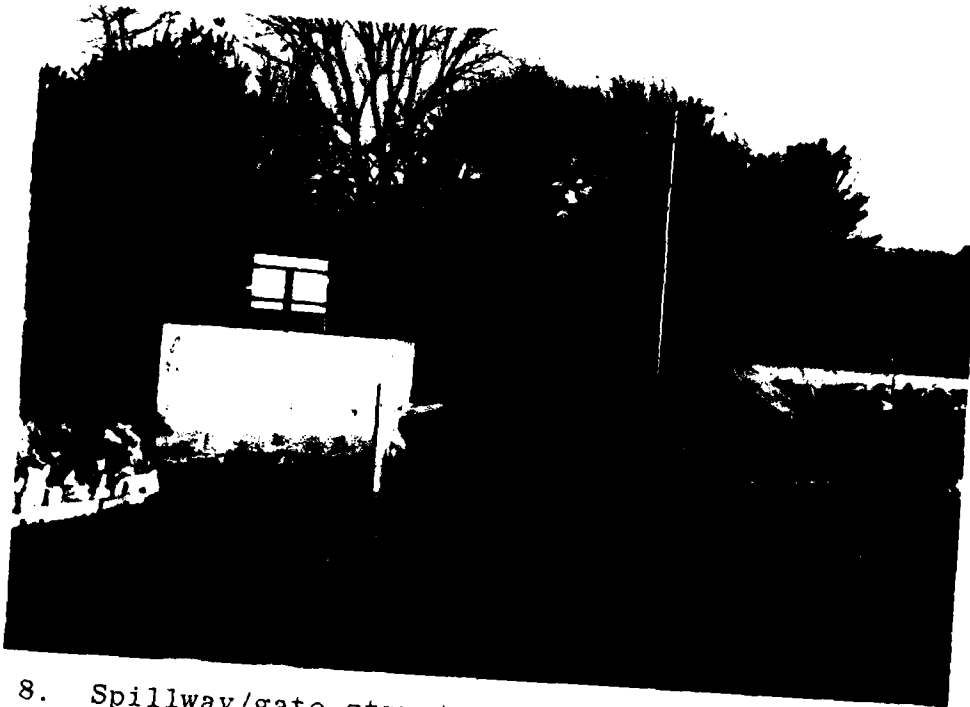
The spillway/gate structure, Photo No. 8, has a lightly eroded surface, but it does not appear to be of significance. There is a crack or opening near the spillway crest apparently where concrete placed for the 1950 reconstruction of the dam abuts the original concrete. Minor spalling, Photo No. 7, and areas of moisture were on the spillway surface but the conditions are not extensive. The upstream side of the intake or gate portion of the structure appeared to be a more recent placement of concrete and was in good condition. The downstream side of the structure, especially the lower regions, showed efflorescence, spalling, some cracking and general surface deterioration.

8. Spillway/gate structure, upstream

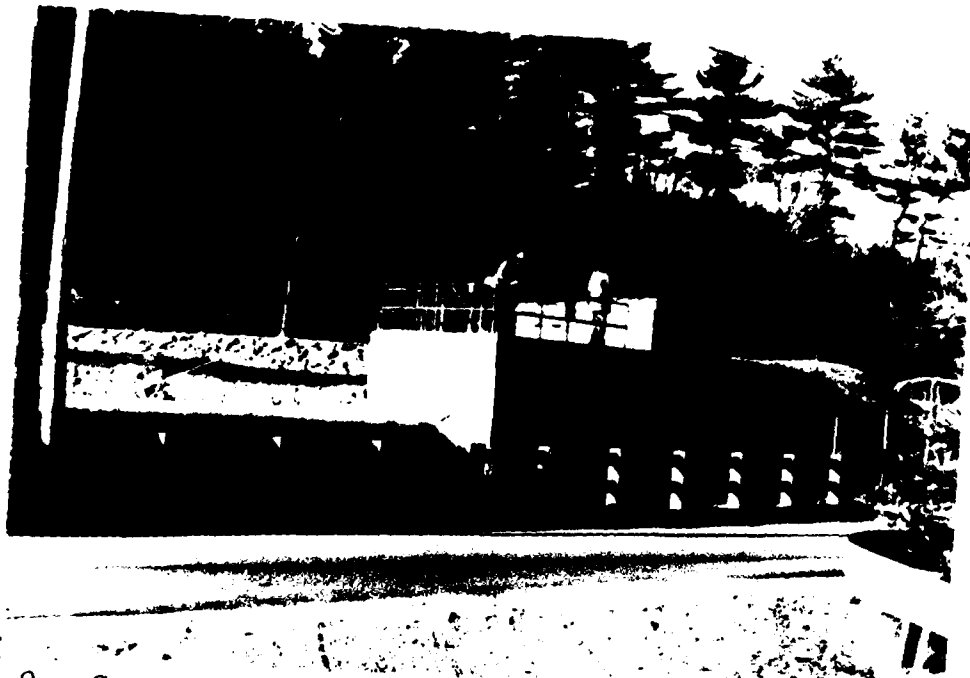
The visible portion of the gravity wall to the left of the spillway, Photo No. 9, has very pronounced surface deterioration in the lower region of the downstream face. Other portions of this wall have surface crazing, efflorescence and shrinkage cracks. The major portion of the wall's downstream side is covered by an earth fill shell with a well vegetated surface of mowed grass.

9. Spillway/gate structure and Chases Pond Road, downstream

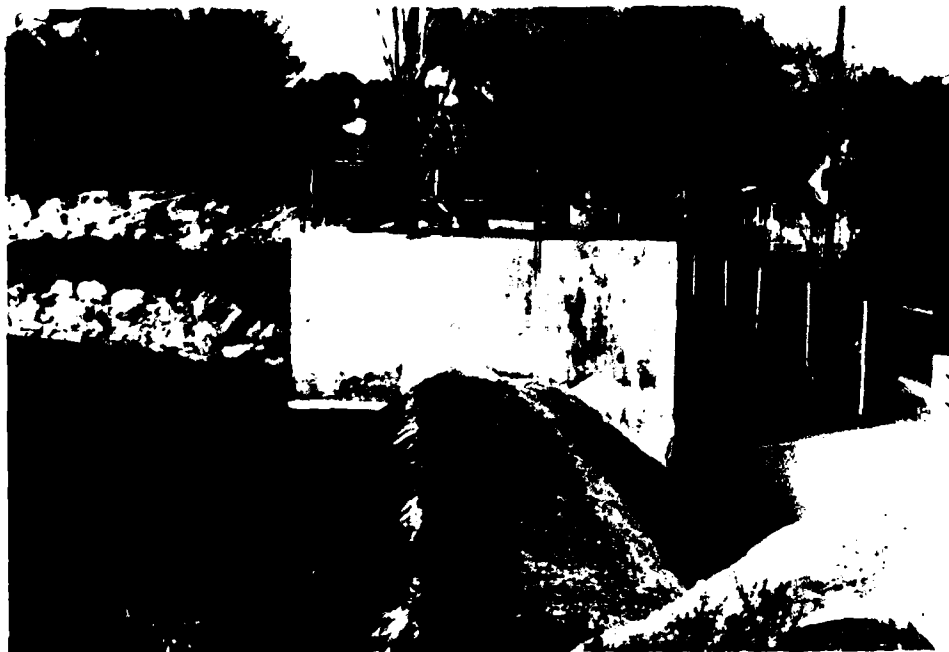
The top surface of the wall where it abuts the upstream side of the spillway is deteriorated, Photo No. 7. This low deteriorated area exposes the adjacent cantilever wall backfill to potential scouring during higher than normal discharges over the spillway.

7. Alignment of spillway/gate structure, from right side

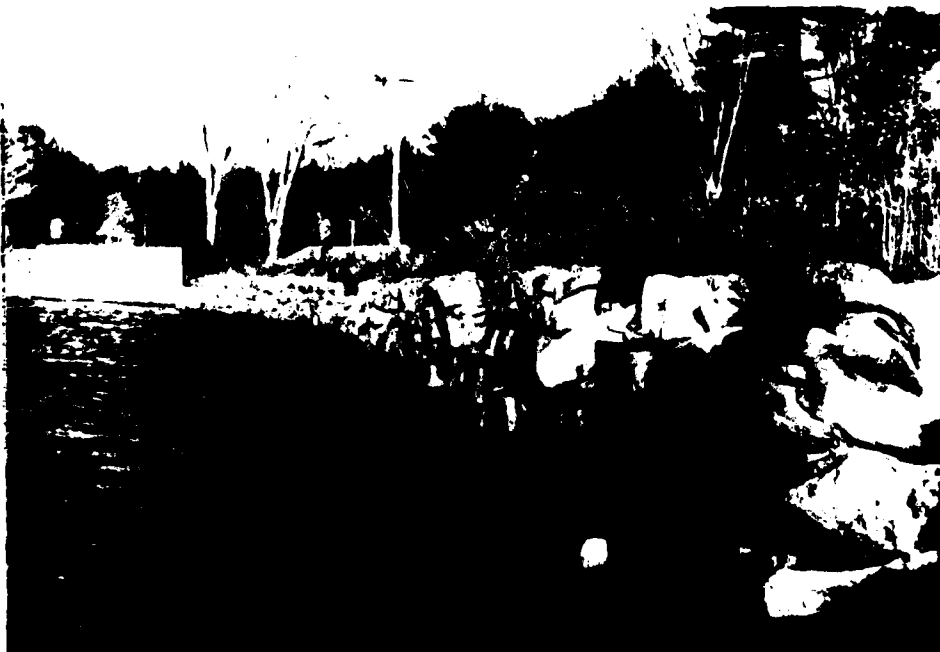
The upstream vertical stone wall at this section of the dam, Photo No. 5, is also in generally fair to poor condition. In several places, the stones have collapsed and in many areas they are out of alignment. Generally, the stone wall is in better condition within 50 ft. of the spillway.

5. Dry laid stone masonry along reservoir at right side

4. Rebuild the failed portions of the dry laid stone wall. A regular maintenance program to correct future localized failures of the stone wall should be developed.

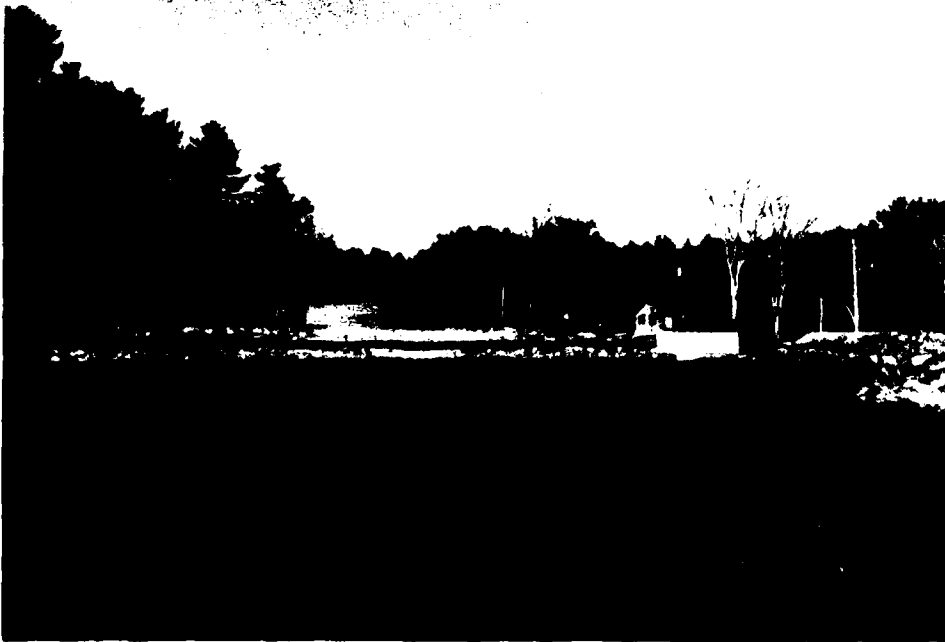
Reconstruction of the left embankment, Photo No. 2, following installation of the new (1979) intake pipe was not yet complete. The top surface had not been brought to the required grade, Photo No. 3, nor had the downstream slope been finally shaped, loamed and seeded. The condition of the earth material placed at this section was soft (following recent rains) and irregular.

2. Overview of left embankment, upstream

2. Monitor the condition of the left embankment in the area of the 1979 excavation with attention to the development of any transverse cracks or irregular settlement. Observation of the conditions in this area should be maintained for the next two to three years, particularly during high reservoir levels.
