BLACKSTONE RIVER BASIN
SUTTON, MASSACHUSETTS

MANCHAUG POND DAM

MA. 00955

PHASE I INSPECTION REPORT
NATIONAL DAM INSPECTION PROGRAM

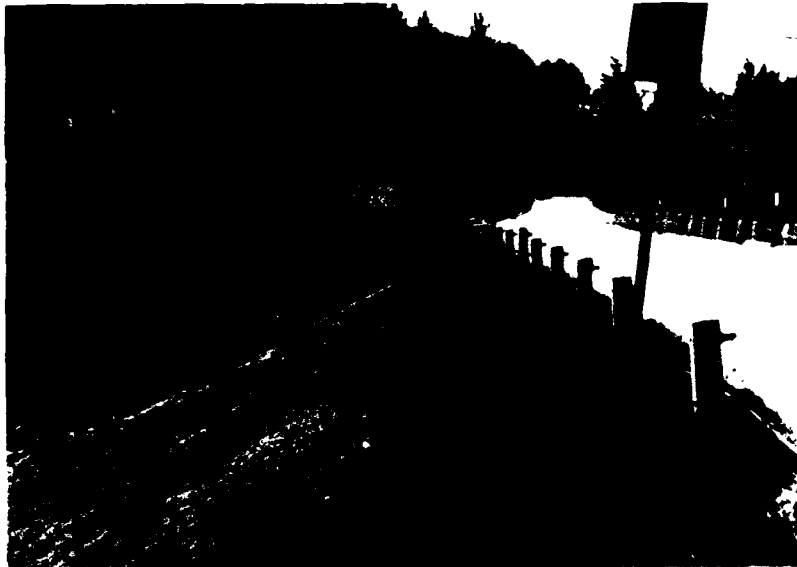
3. Downstream slope from left abutment
