HOLDEN RESERVOIR NO 1 DAM

MA 00960

PHASE I INSPECTION REPORT NATIONAL DAM INSPECTION PROGRAM

JUNE, 1981

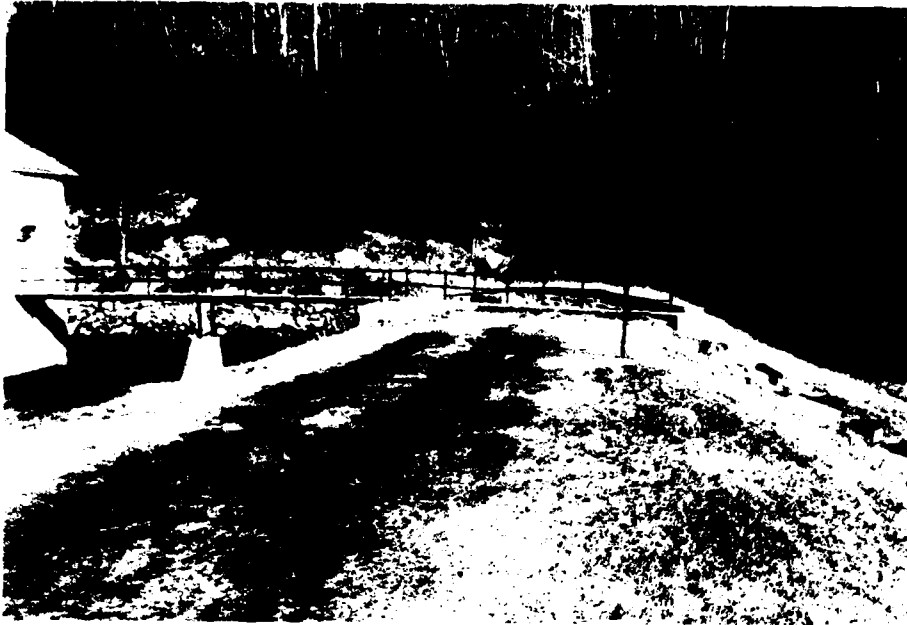
Both abutments of the dam appear to consist of soil at the ground surface (Photo No. 5). No evidence of seepage from the abutments was observed.

Photo No. 5 - Left abutment.

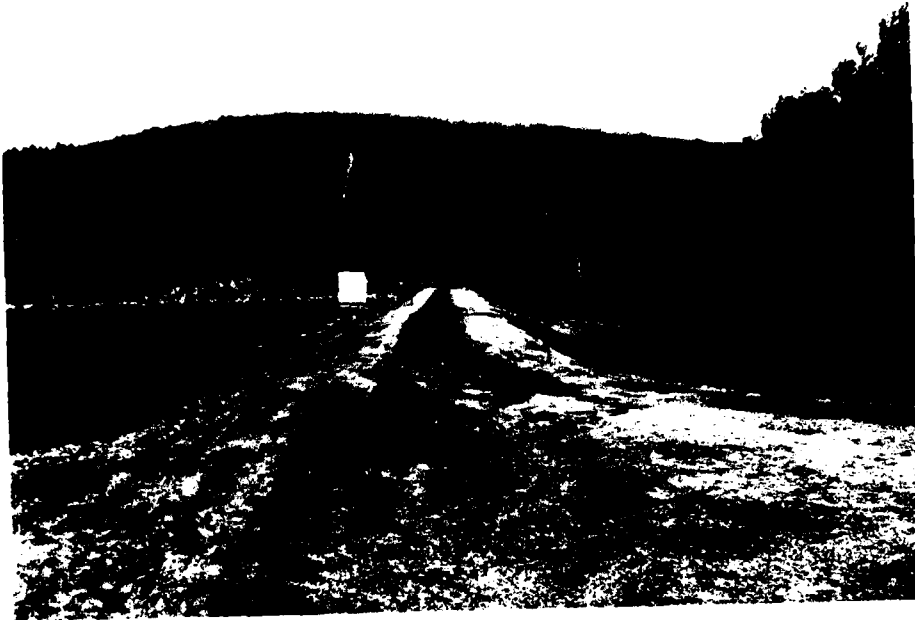
Photo No. 1 - Crest of dam viewed from right abutment. Mowed grass on crest but relatively bare of vegetation in wheel tracks.

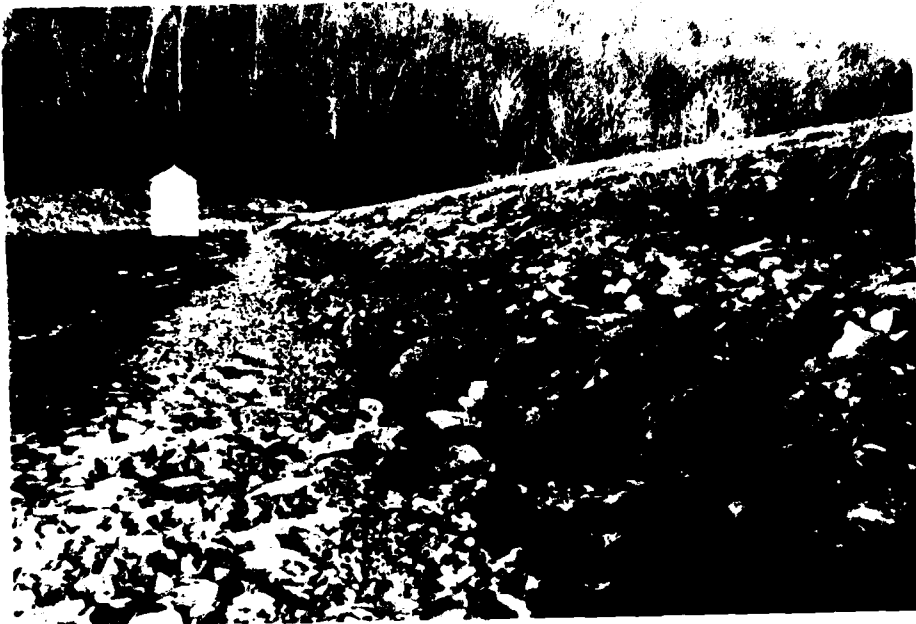
- (1) Some irregularity of the riprap on the upstream face of the dam and some cracking and deterioration of the slush grout between the riprap stones in the upper part of the riprap is evidence of deterioration of the riprap, which should be controlled so as to prevent erosion of the embankment fill.
- (2) The lack of grass cover in the wheel tracks on the crest of the dam increases the susceptibility of the crest to erosion in case the dam should be overtopped.
- (3) Minor softness on some of the lower parts of the downstream slope may be indicative of a seepage problem which could become worse and might possibly lead to a piping problem.
- (4) The spillway is adequate to carry only 28 percent of test flood discharge.

Photo No. 2 - Detail of riprap on upstream slope. Riprap is slush-grouted down to approximately normal water level. Grout is cracked around most riprap stones. Apparent wave-cut terrace just above present water level. Riprap shows signs of irregular subsidence or sloughing.

- (1) Specify and oversee repairs for the riprap on the upstream slope.
- (2) Specify and oversee construction of adequate erosion protection for the crest of the dam.
