KENNEBEC RIVER BASIN
PITTSFIELD, MAINE

PIONEER DAM
ME 00110

PHASE I INSPECTION REPORT
NATIONAL DAM INSPECTION PROGRAM

APRIL 1981

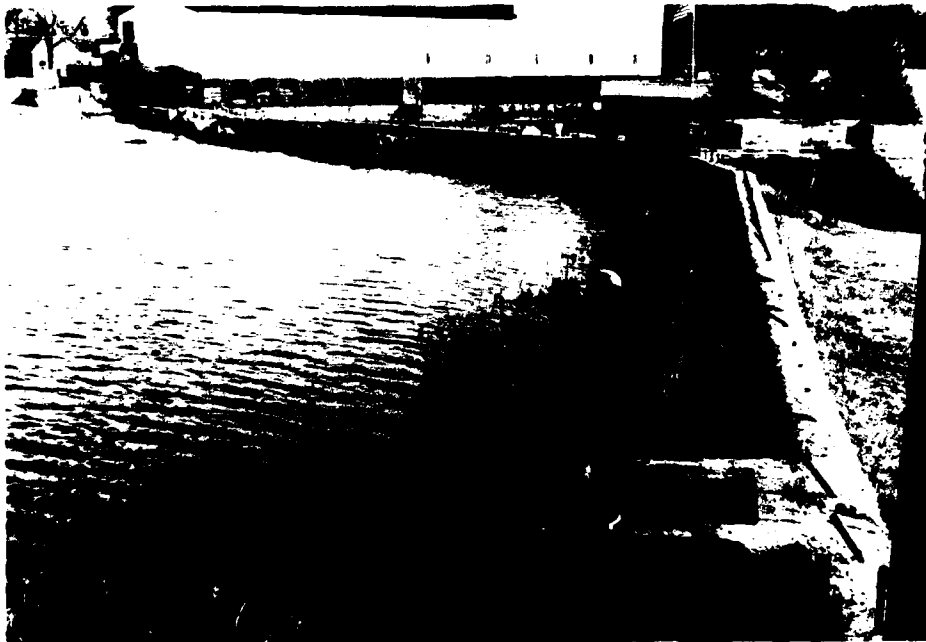
The right end of the composite dam was in fair condition overall, Photo No. 2. The earthfill on the downstream side showed no signs of sloughing or major erosion, Photo No. 3. Alignment of the masonry crest was good, but, spalling and deterioration of the concrete was evident. Thick brush and weeds were growing over the fill on the upstream side.

2. Alignment of right side of dam from right abutment, upstream

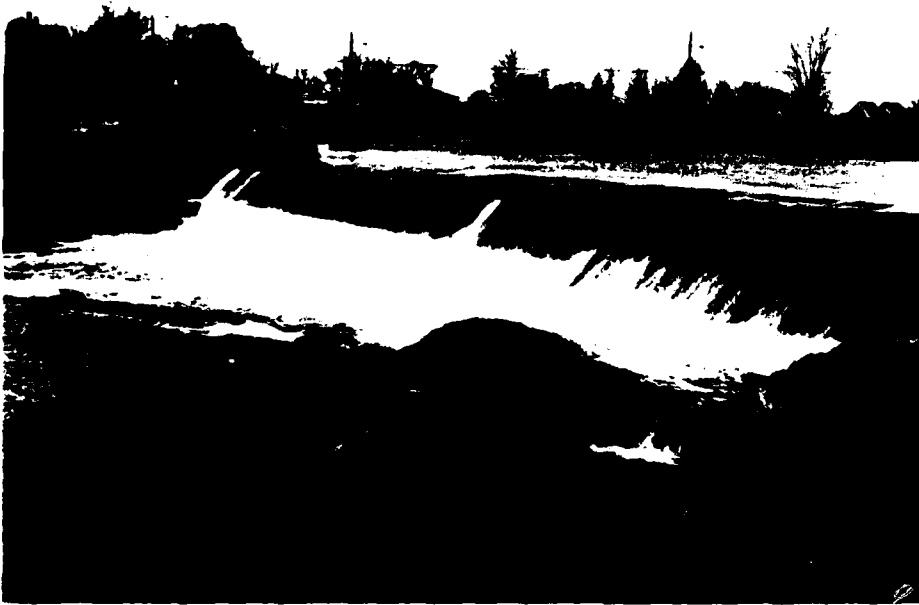
12. Right side of spillway, downstream
