KENNEBEC RIVER BASIN  
NEWPORT, MAINE

MAIN STREET DAM  
ME 00114

PHASE I INSPECTION REPORT  
NATIONAL DAM INSPECTION PROGRAM

MAY 1981

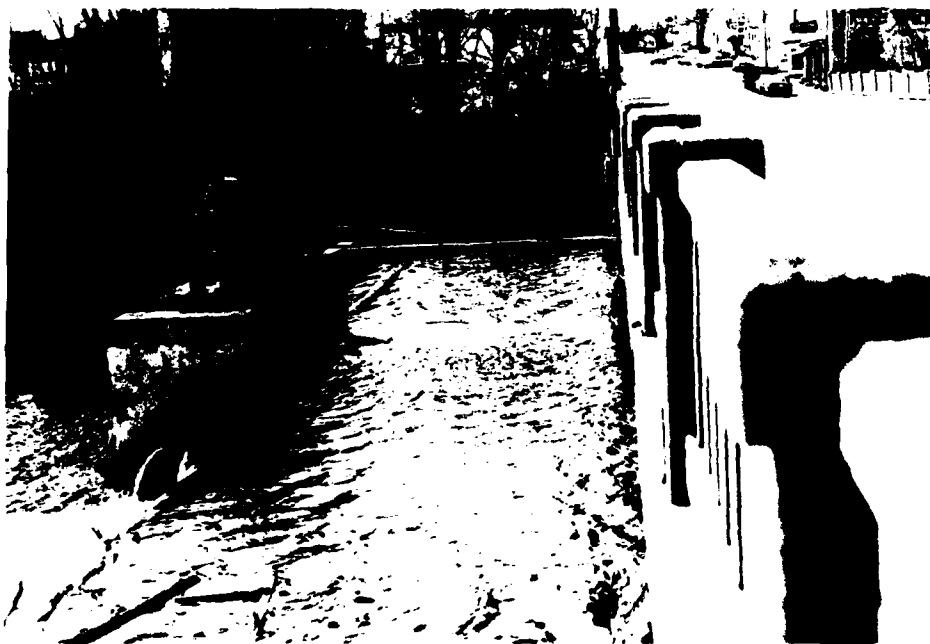
c. Appurtenant Structures. The outlet works located at the right center of the spillway was in fair condition, Photo No. 7. The concrete abutments were generally deteriorated and eroded with some cracking present. Only the center of the three slide gates appeared to be in operable condition. This gate was partially open during the site visit, but, no attempt was made to operate it. The outlet works was accessible from the Main Street Bridge via three loosely placed planks across a steel post truss bridge. The steel portions of this footbridge were moderately rusted. Bolts anchoring the footbridge to the outlet works and the Main Street Bridge appeared in good condition.

The outlet works of Main Street Dam warrants attention to prevent further deterioration. The cracking and erosion of the concrete should be repaired. However, the structural stability of the outlet works appears to be satisfactory at the present time.

7. Alignment of dam and outlet works

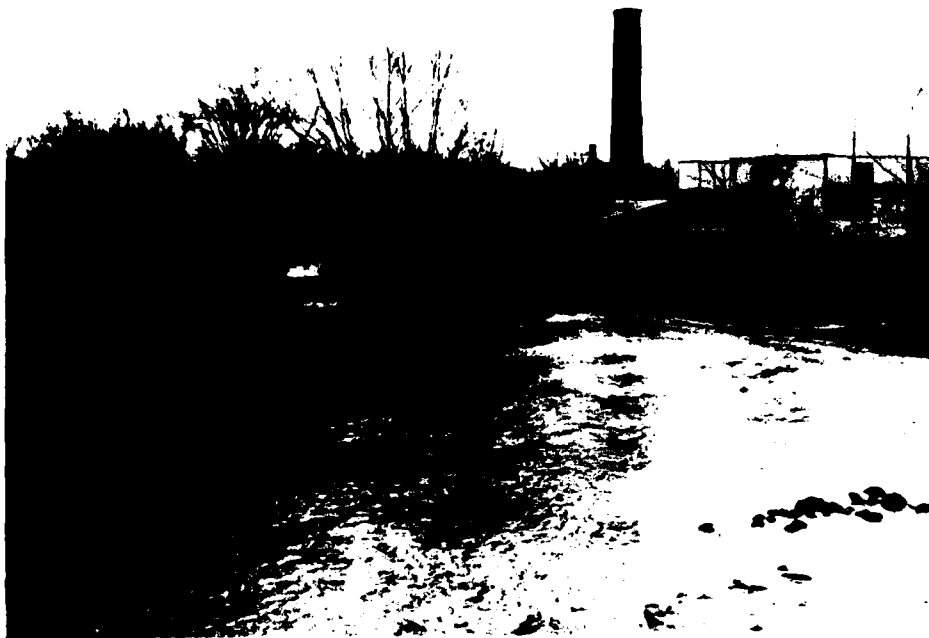
15. River channel immediately downstream of spillway from left abutment
