ANNISQUAM RIVER BASIN
GLOUCESTER, MASSACHUSETTS

STRANGMAN POND DAM
MA 01097

**PHASE I INSPECTION REPORT
NATIONAL DAM INSPECTION PROGRAM**

AUGUST 1981

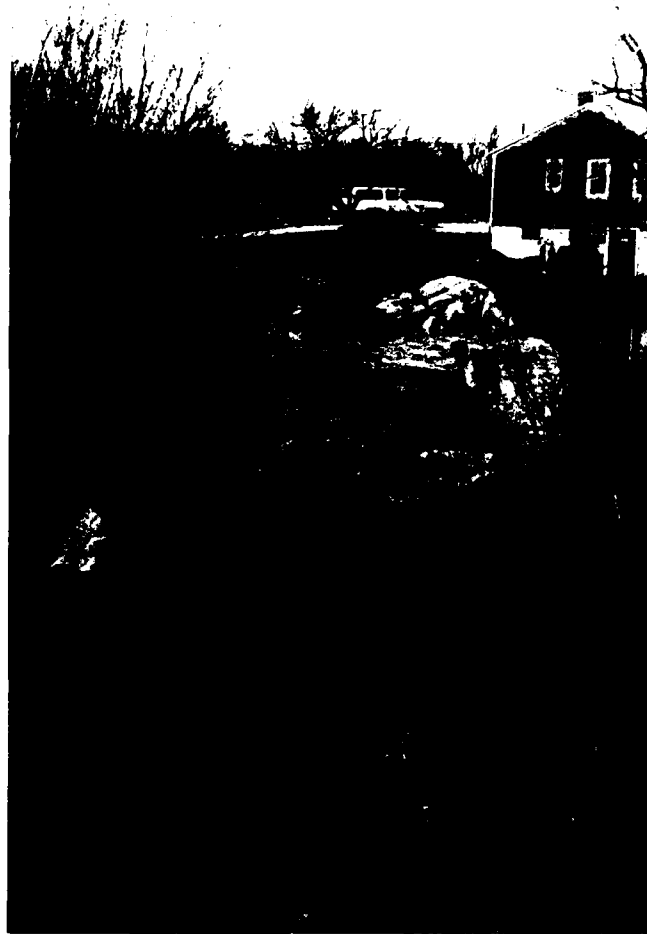
NO. 2 TOP OF DAM
