MERRIMACK RIVER BASIN  
BERLIN, MASSACHUSETTS

LESTER G. ROSS DAM  
MA 01229

# PHASE I INSPECTION REPORT NATIONAL DAM INSPECTION PROGRAM

JUNE 1981

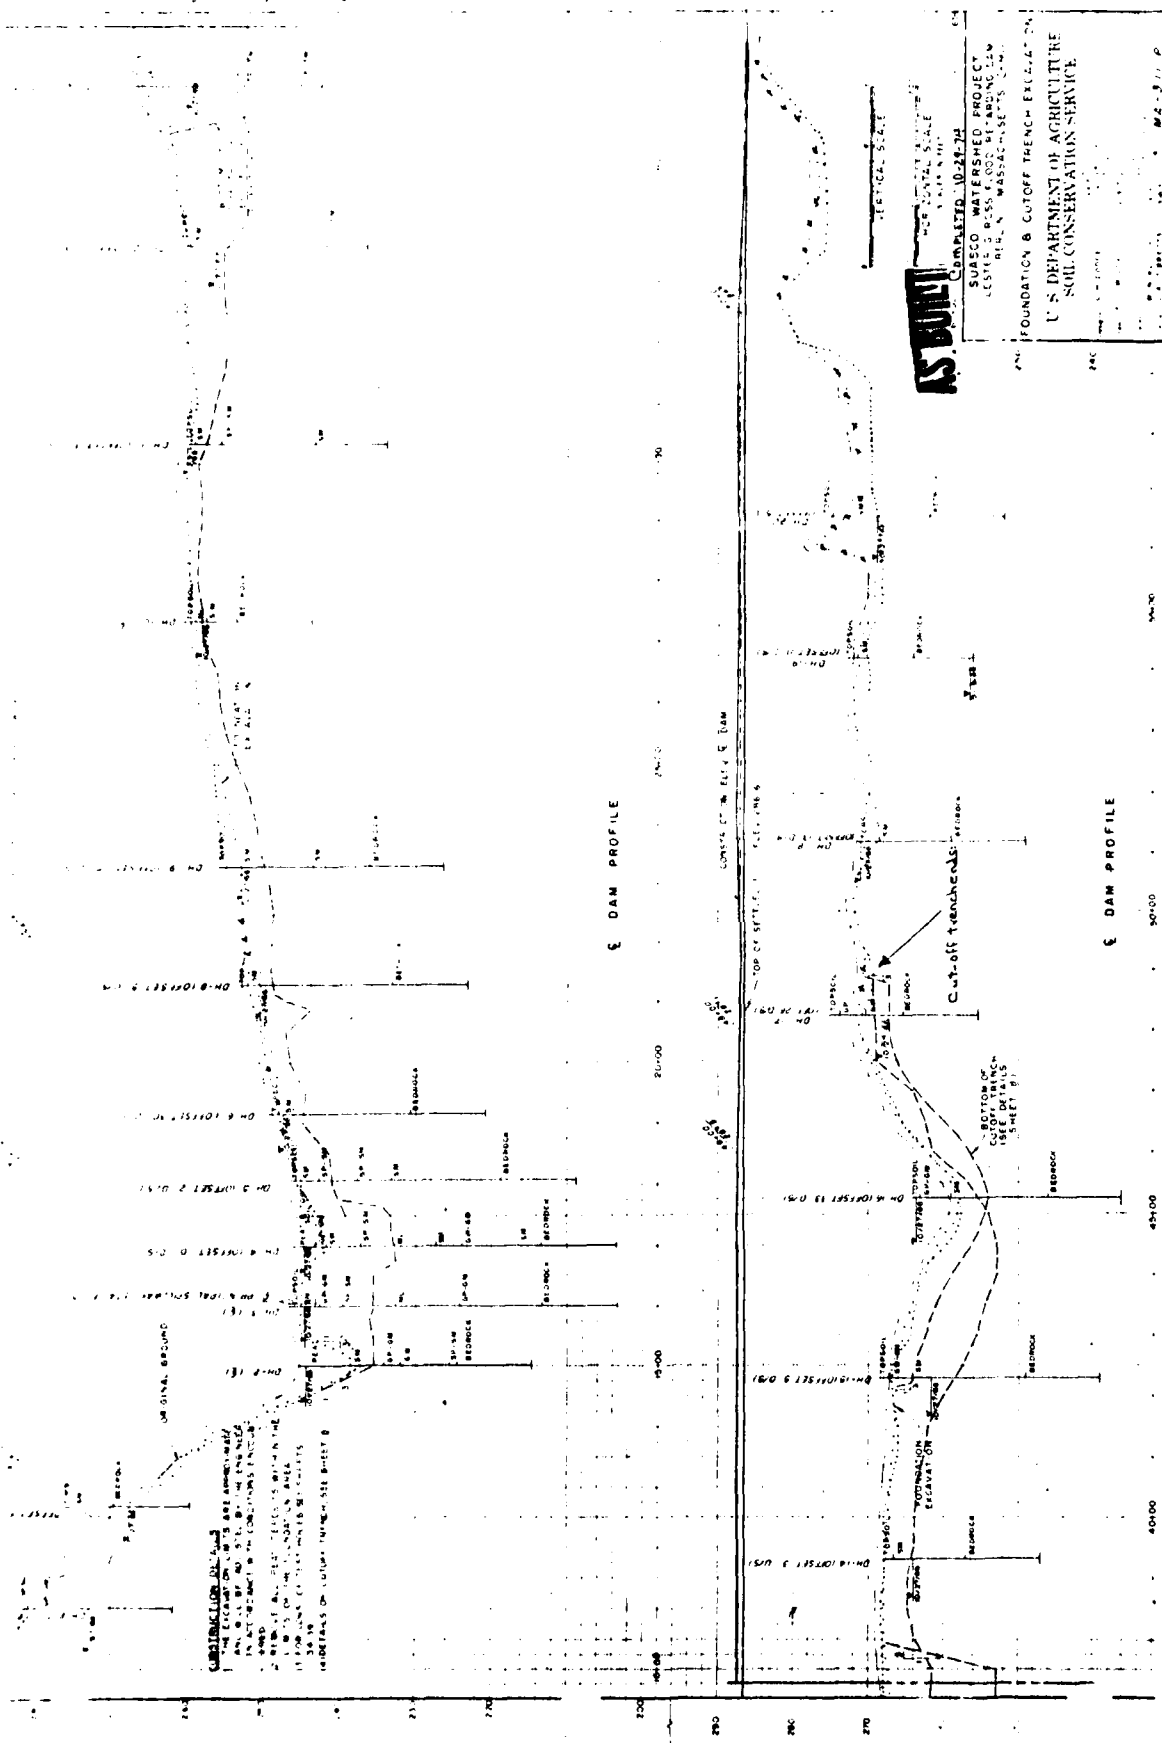
FIGURE B-9

The dike was constructed to protect the parallel railroad embankment. A foundation drain (Figure B-9) was designed to collect and discharge seepage into a ditch between the railroad embankment and the toe of the dike. The ditch joins the North Brook downstream of the dam, at Linden Street.

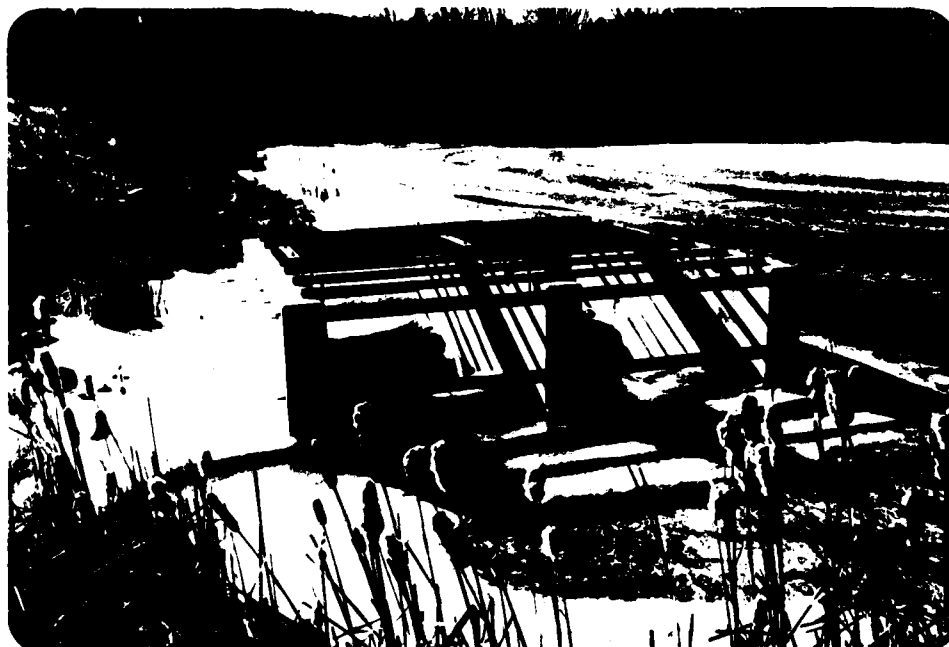
The concrete on the inlet and riser is in good condition. There are some minor chips which are generally due to vandalism. Two large pieces of riprap had been dropped into the structure. One was caught in a slot in the left wall of the riser. The other was lodged in the entrance to the discharge conduit. The conduit was also chipped. There was no other debris visible in the main spillway structure.

NO. 6    DROP INLET STRUCTURE

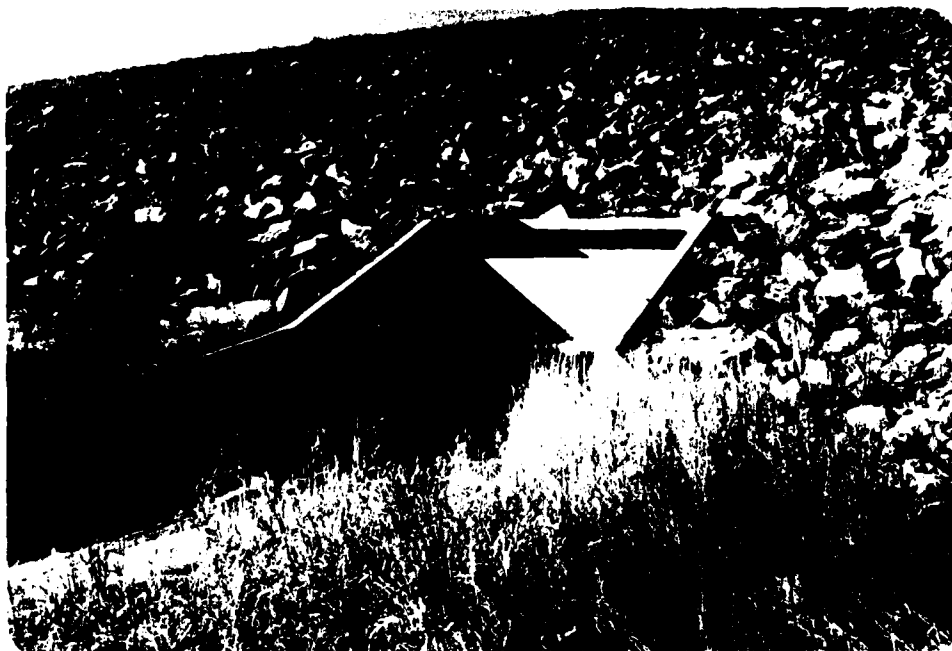
The concrete impact basin at the downstream end of the dam is in good condition, with only minor chips in the concrete, most of which had already been patched. A moderate amount of flow was discharging into the basin at the time of the inspection. The outlets to the foundation drains were submerged. The basin was clear of brush and debris, however, a small obstruction consisting of riprap blocks had been built by vandals just downstream of the basin, obstructing flow in the channel.

NO. 7    IMPACT BASIN AT OUTLET DISCHARGE
