CONNECTICUT RIVER BASIN
ATHOL MASSACHUSETTS

ATHOL MANUFACTURING
DAM
MA 00932

PHASE I INSPECTION REPORT
NATIONAL DAM INSPECTION PROGRAM

MARCH 1979

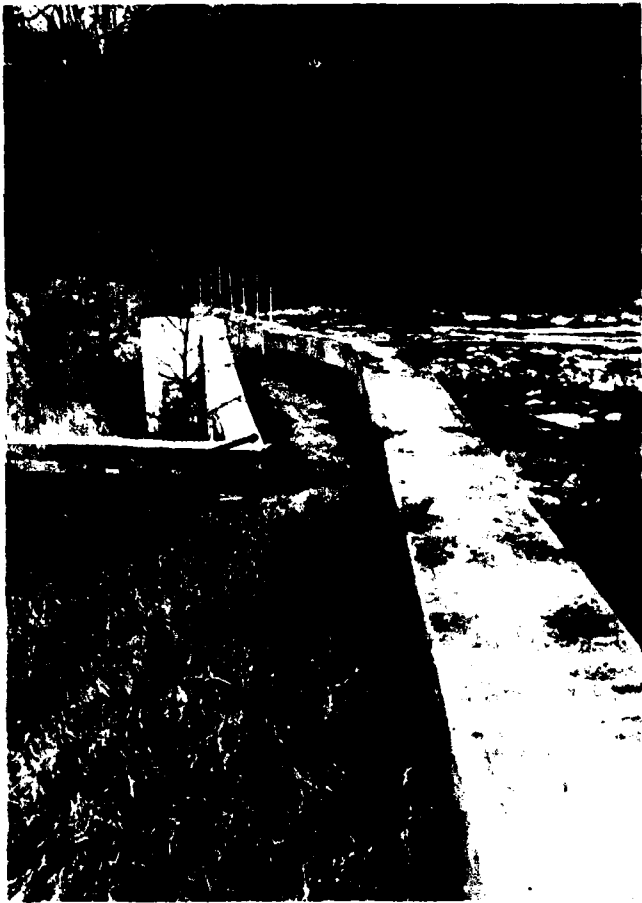
PHOTO NO. 3 - View of concrete retaining wall extending downstream from the dam-overflow spillway junction.

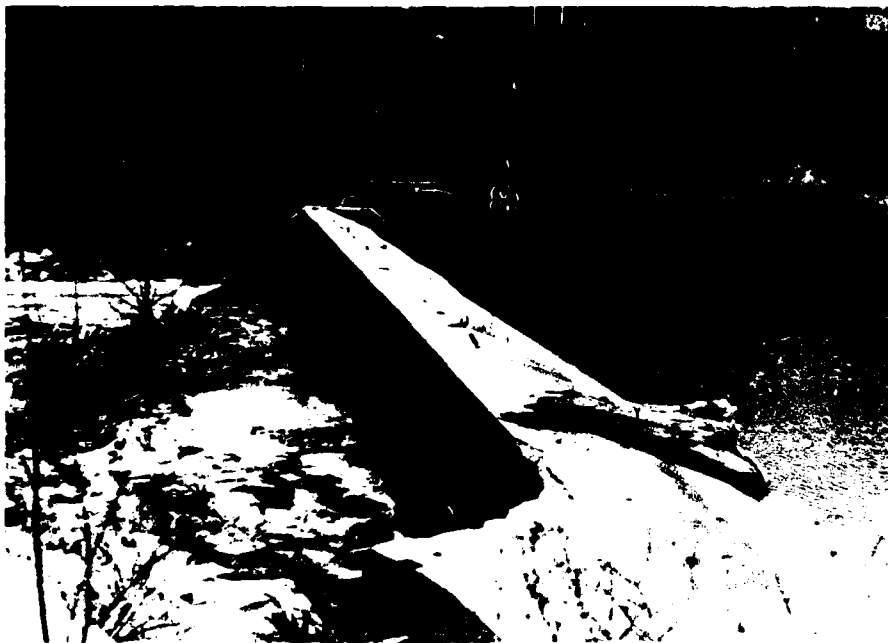
could not be observed. The crest of the overflow spillway had cracks which appeared limited to construction joint locations. Cracks and misalignment of the crest are minor and not considered attributed to movements of the structure. The downstream face of the structure is mortared stone, photo (6). Weep holes present in the downstream face, and several feet below the upstream water surface, did not discharge any water. The downstream toe and channel of the overflow spillway consisted of cobbles grouted in place. The grouted cobble area is generally in good condition with some erosion, small trees and vegetation, photo(4). Seeps were not observed along the toe of the downstream face.

PHOTO NO. 4 - Overflow spillway viewed from junction with the dam. Note spalling of concrete at the bend in the structure and cobbles grouted in place along the toe.

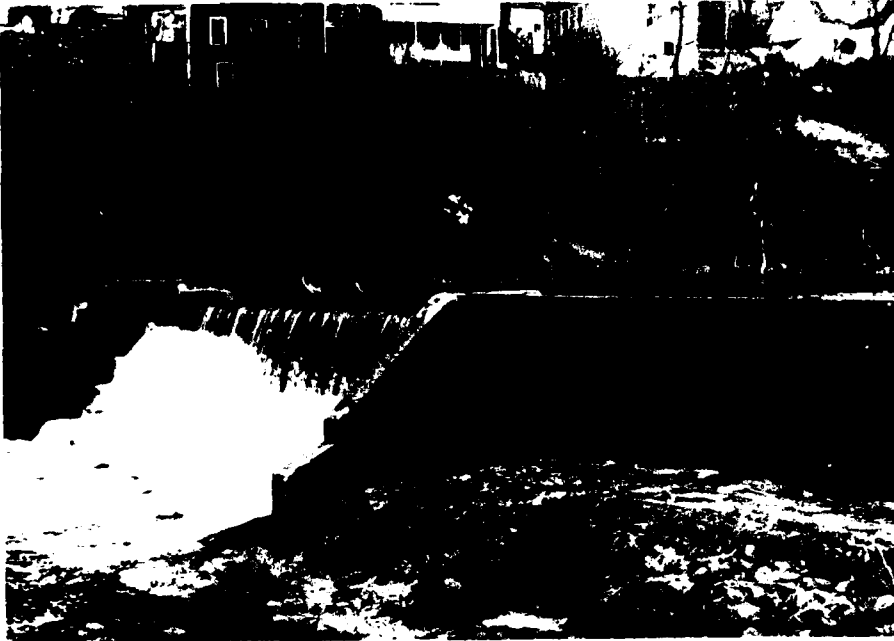
The primary spillway abuts the right side of the river. The structure is bounded on the right by bedrock capped with a concrete block which serves as a training wall and on the left by a concrete training wall, photo(5). The upstream face, crest, downstream face, and apron of the spillway were under water and could not be observed. Flashboards were not present at the time of inspection.

PHOTO NO. 5 - Primary spillway. Note right abutment on bedrock and position of flash board pins.

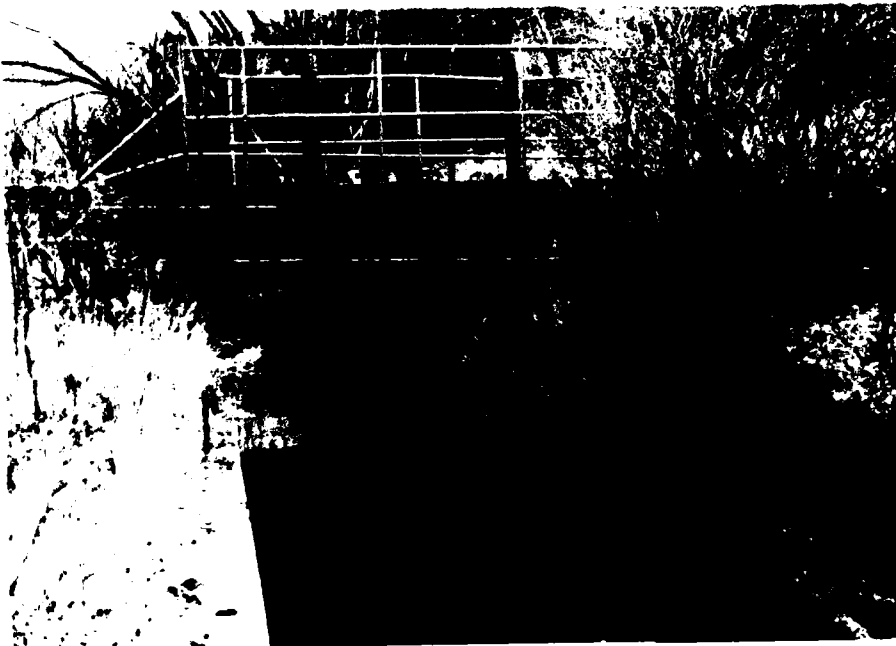
This facility consists of concrete training walls, steel framed, hand operated wooden sluice gate and a service walkway. The training walls were in fair to poor condition with some spalling. The sluice gate and walkway appeared to be in good condition and were last used during the spring of 1978.

PHOTO NO. 10 - Downstream view of outlet sluice gate and service walkway. Facility is used in power generation.

3. Spalling of the powerhouse canal training walls should be corrected and overhanging trees should be removed.
