PENOBSCOT RIVER BASIN
BUCKSPORT, MAINE
SILVER LAKE DAM
ME 00147

PHASE I INSPECTION REPORT
NATIONAL DAM INSPECTION PROGRAM

OCTOBER 1978

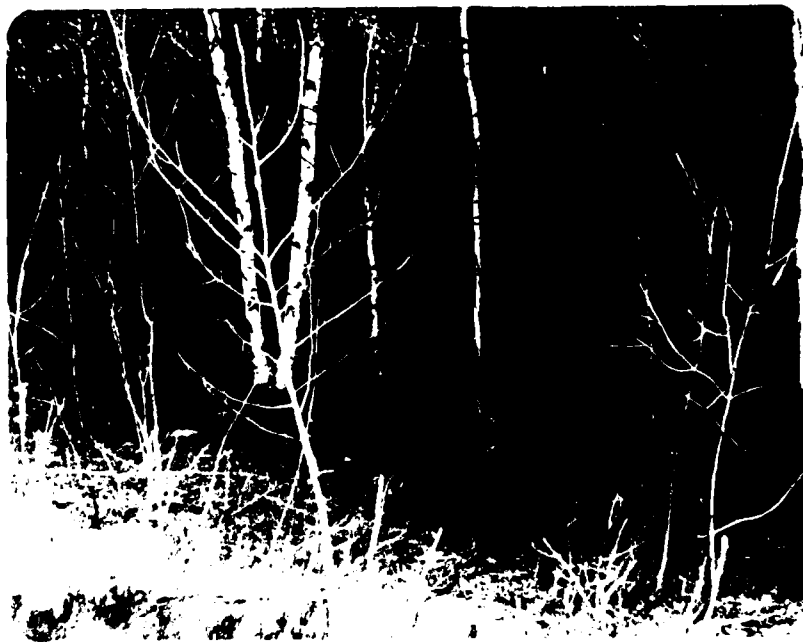
No. 8

seepage water was very cold and was rust colored. The discoloration of the water in the pool and on the ground surface is caused by precipitation of iron minerals, (upon contact with air) from the seepage flows. The seepage emergence area overlaps the buried cast iron pipes. Some seepage could be following along these pipes. A lesser quantity of seepage was observed flowing from the left embankment toe at the intersection of the embankment and left discharge channel wall. This seepage was also flowing clear. No seepage was observed flowing from the embankments.

(1) The dam, approximately 50 years old, showed no signs of sloughing or erosion of the embankment or the abutment slopes. The vertical as well as horizontal alignment of the crest showed no signs of distress and no cracks or unusual movement, including rip-rap failure and/or dislocations were visible. Some vehicle caused rutting (about 6" deep) was observed on the crest of the right side embankment. Shrubs were noted growing on the upstream and downstream slopes of both embankments while several large trees (up to 12" dia.) were noted on the downstream slopes. (See photo nos. 2 and 8).

(4) Seepage emergence was noted near the downstream toe of the right embankment. The seepage was ponding in a shallow pool over a length of about 70 feet (see plate B-1 and photo no. 8). The seepage was flowing clear indicating that material piping was not occurring. The

FOUNDATION SEEPAGE (ORANGE COLORED) AT DOWNSTREAM
TOE OF RIGHT SIDE EMBANKMENT

(3) The two cases of seepage observed are not considered to have an adverse effect on the structural integrity of the dam at this time, but should be closely monitored for cloudiness or any increase or decrease in quantity relating to reservoir stage which could require prompt corrective action.

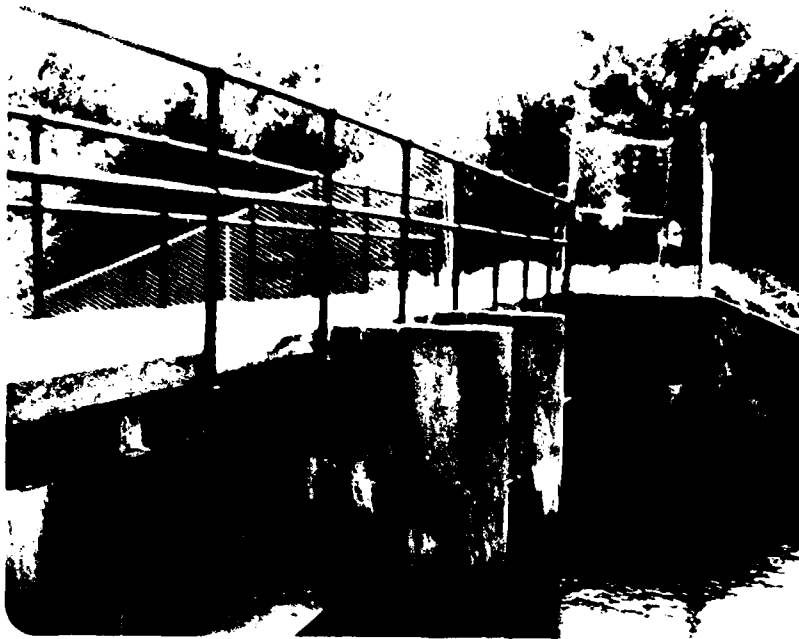
No. 5

VIEW LOOKING WEST AT UPSTREAM SIDE OF SPILLWAY &
SERVICE BRIDGE

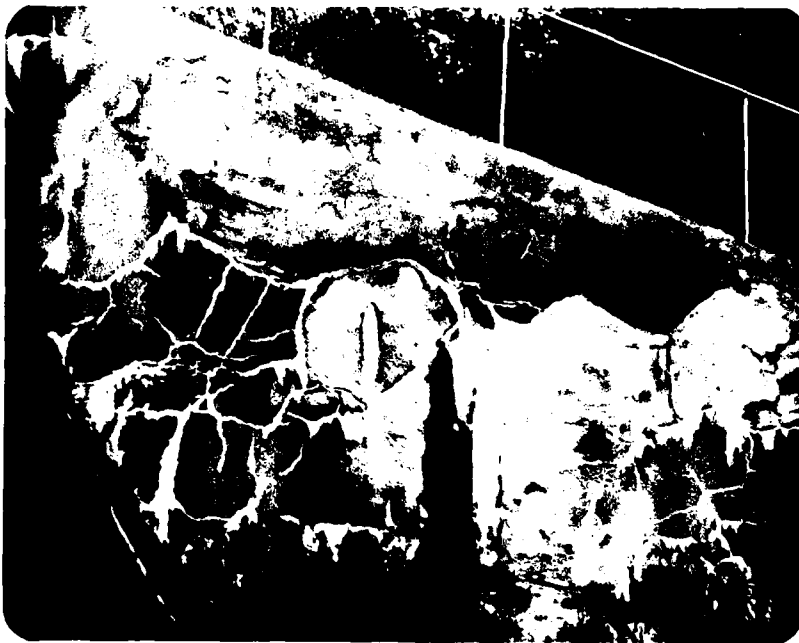
No. 6

(2) The gravity type walls of both the approach and discharge channels exhibited numerous surficial cracks. The depths and lengths of the original cracks were difficult to determine since most of the wall surfaces had been gunited in 1972. Most of the cracks showed signs of seepage emergence as indicated by lime deposits that covered and filled these cracks. The only visible open structural crack was at the upstream corner of the west abutment wall. This structural crack was about 1/4 inch wide and was located above about elev. 129. Seven weep holes, consisting of about 1" pipe, were observed protruding from the east side discharge channel wall. According to Mr. Robinson, they were installed (about 6 inches into the wall) during the guniting to control seepage flowing thru cracks in the wall. Only two weep holes were bleeding at the time of inspection. The downstream concrete apron at the downstream toe of weir could not be observed because of the presence of 3 to 4 feet of soil, vegetation and rubble.

VIEW OF DISCHARGE CHANNEL WALL (LEFT SIDE) - NOTE
CRACKING EFFLORESCENCE AND SEEPAGE ON WALL

(4) The surficial cracking of the discharge channel walls should be monitored for any further deterioration. This can be accomplished by periodic comparative photographs and/or physical measurements.
