ANDROSCOGGIN RIVER BASIN  
RUMFORD, MAINE

MOUNT ZIRCON RESERVOIR DAM  
ME-00244

PHASE I INSPECTION REPORT  
NATIONAL DAM INSPECTION PROGRAM

OCTOBER 1978

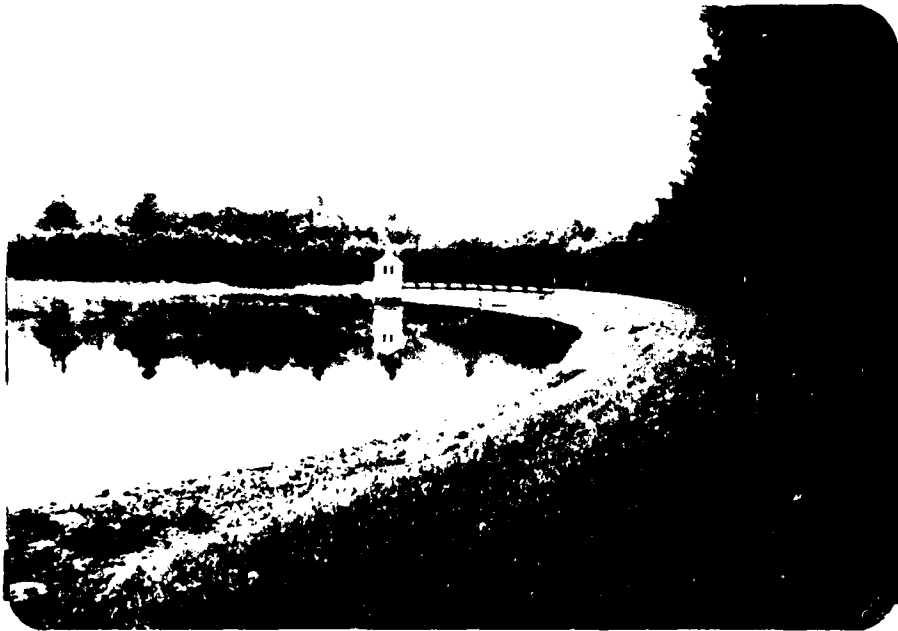
- (1) Structural - The dam is an earth embankment structure with a stone masonry spillway. The visual inspection of the dam resulted in the following major findings:
  - (a) No evidence of general settlement of the embankment was found. Wheel traffic on the dam crest has, however, caused local depressions. Some settlement has occurred behind the walls of the spillway.
  - (b) The embankment slopes appear true to design line and grade. No evidence of major slope instability was found. Some minor surficial sloughing has occurred along the toe of the dam near Station 5+50.
  - (c) Some moderate downslope creep of the riprap slope protection has occurred east of the service bridge below normal pool level.
  - (d) Very minor seepage (total estimated accumulative volume of 5 gpm) is occurring along the toe of the dam from Station 3+50 to 6+00. No piping, boils or erosion was found, however.

- b. Slope Stability. The upstream slope of the dam is true to line and grade and no evidence of instability was found. The downstream slope of the dam is tree covered (6 to 14 inch diameter pine) with no grass growth. The slope is generally in good shape and shows no signs of instability. There is evidence of some minor surficial sloughing at the toe of the dam at approximately Station 5+50.

1  
VIEW OF DAM FROM EAST END

7. The service bridge planking should be repaired.
8. Seepage at the downstream toe of the dam should be monitored and any excess seepage should be noted and corrective measures should be taken as necessary.

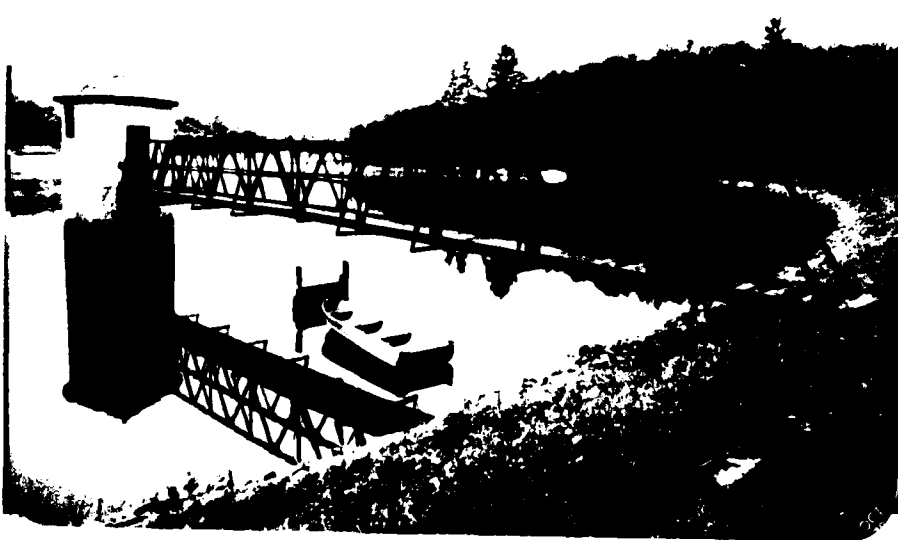
c. Appurtenant Structures. The gate house is an appurtenant structure to the dam. It is constructed of reinforced concrete. Some spalling of the concrete has occurred near the water level. Generally the structure is in good condition. The service bridge to the gate house appears to be in good condition structurally but the deck planking is rotted.

a. Concrete Surfaces. Except for the zone from about elevation 835 to 840 the concrete surface of the gate house is good. Within the zone from elevation 835 to 840, the exterior surface is spalled to a depth of 1 to 3 inches. The area has been previously repaired and since spalled again.

2  
CONTROL GATE HOUSE

5. The spalled concrete on the sidewalls of the gate works should be repaired.
6. The condition of the riprap slope protection should be examined at least once each year and whenever the reservoir level is low enough to permit direct observation. Repairs should be scheduled if conditions warrant.
