SHELBURNE FALLS FIRE DISTRICT
RESERVOIR DAM
MA 00462

PHASE I INSPECTION REPORT
NATIONAL DAM INSPECTION PROGRAM

DEPARTMENT OF THE ARMY
NEW ENGLAND DIVISION, CORPS OF ENGINEERS
WALTHAM, MASS. 02154

APRIL 1981

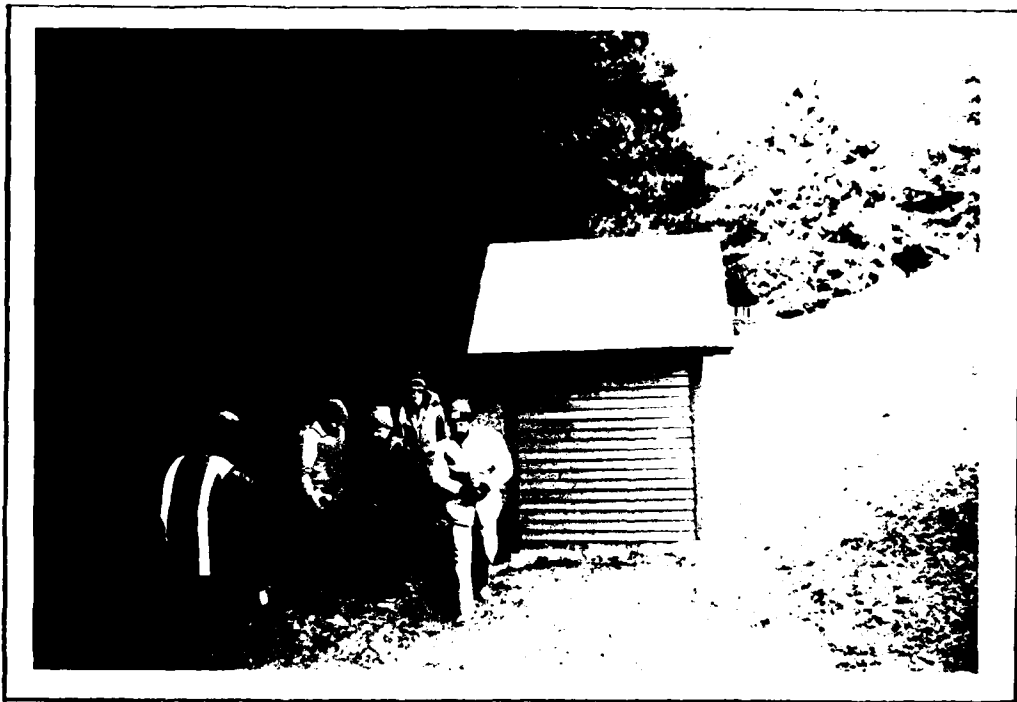
The dam appears to be in fair overall condition. The entire embankment has a well maintained grass cover. The closest trees to the downstream toe of the dam (photo no. 3, Appendix C) are 20 feet away from the toe of the embankment. Clear seepage (about 2 gpm) was noticed around the outlet of the two 8-inch diameter cast iron low level outlet pipes. The concrete spillway appears to be in good condition except for some minor spalling on the two, four foot high buttresses.

3. GATEHOUSE AT THE DOWNSTREAM TOE OF THE DAM. (12/3/80)

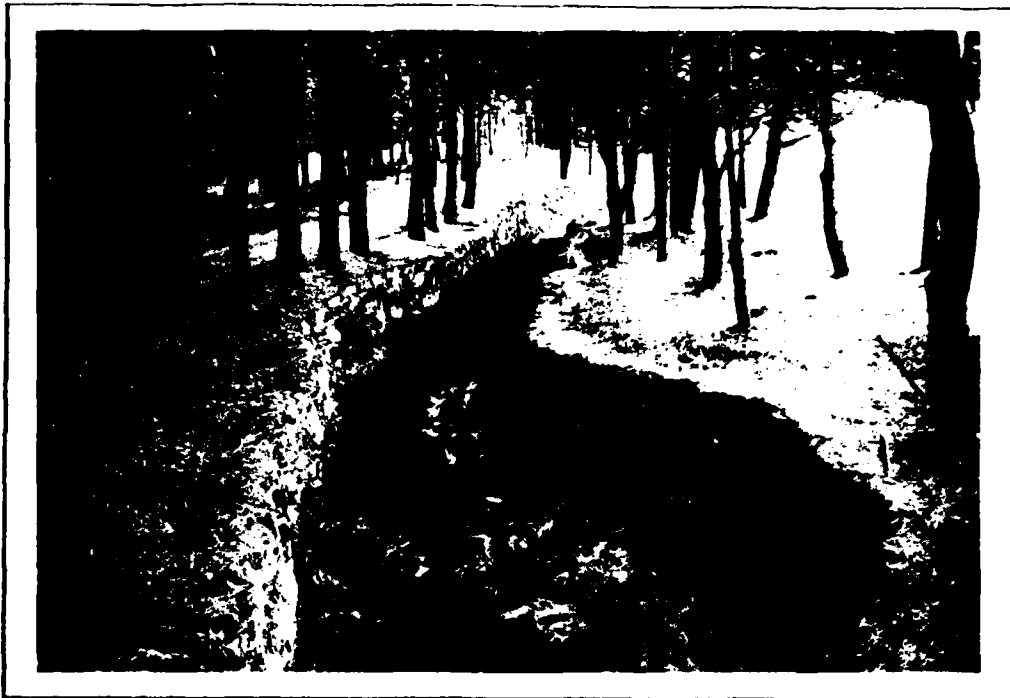
5. TYPICAL LINED CHANNEL DOWNSTREAM OF THE SPILLWAY OUTLET CHANNEL. (12/3/80)
