COLTON POND DAM

VT 00114

PHASE I INSPECTION REPORT NATIONAL DAM INSPECTION PROGRAM

OCTOBER 1979

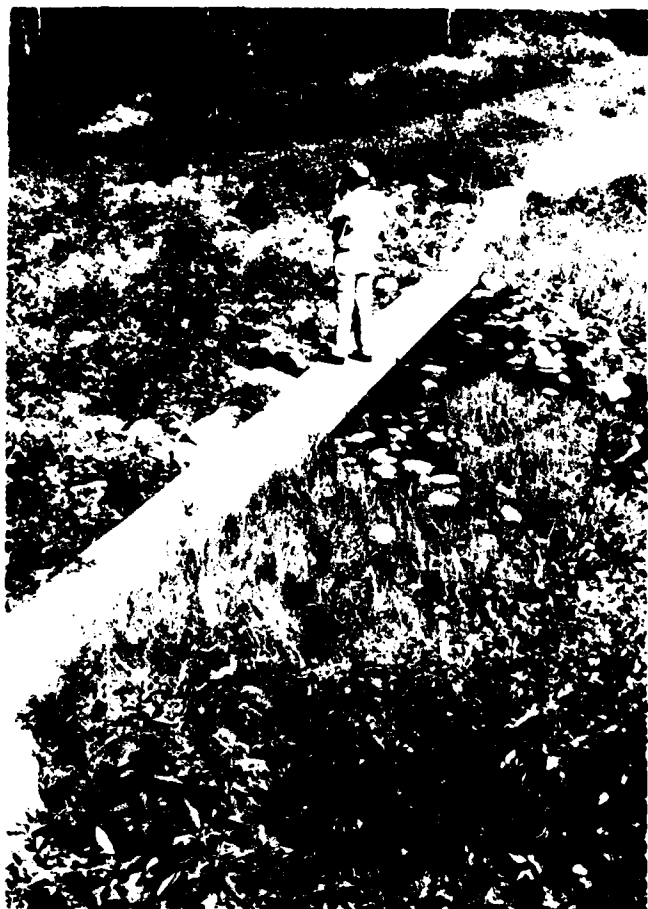
PHOTO NO. 10 - Emergency
spillway crest is viewed
from left end of spillway.

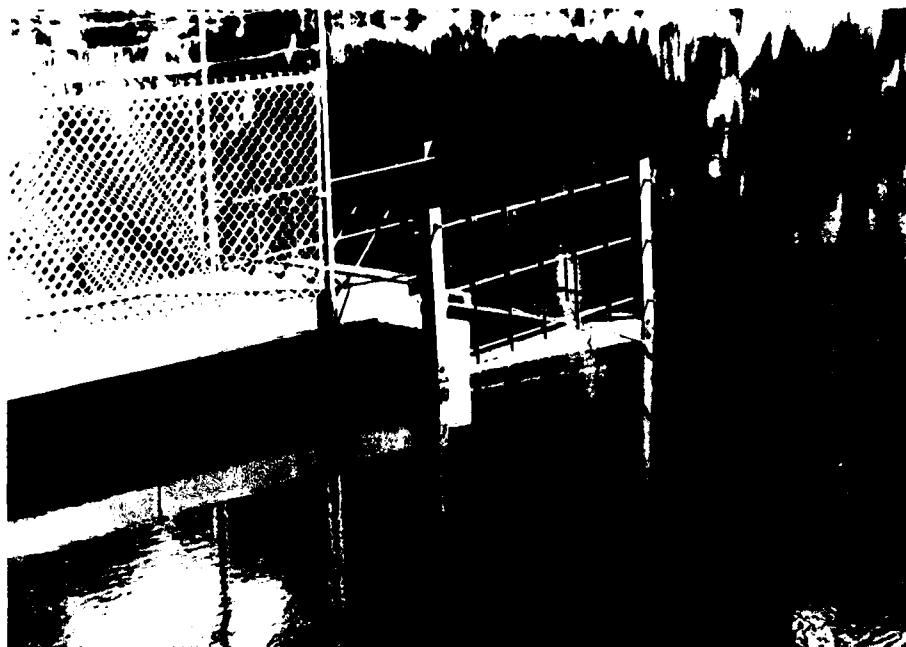
The principal box spillway structure, as seen in Photo No. 12, consists of three elements: a box inlet overflow control, a vertical transition (box structure) and closed discharge conduit. Removal of the stoplogs would permit use of the 18 inch closed discharge conduit as a pond drain. The spillway structure is located at the toe of the embankment near the center of the dam. Visual inspection revealed that the concrete box spillway structure appeared to be in sound condition except for the surface deterioration as seen in Photo No. 13. Up to 1/2 inch of fine concrete particles appear to be missing from the concrete surface.

PHOTO NO. 12 - Principal spillway from crest of dam.
