NATIONAL PROGRAM FOR INSPECTION OF NON-FEDERAL DAMS  
DOLLOFF DAM NH 00134 (U) CORPS OF ENGINEERS WALTHAM MA  
NEW ENGLAND DIV JUN 78

DOLLOFF DAM  
NH 00134

PHASE I INSPECTION REPORT  
NATIONAL DAM INSPECTION PROGRAM

JULY 1978

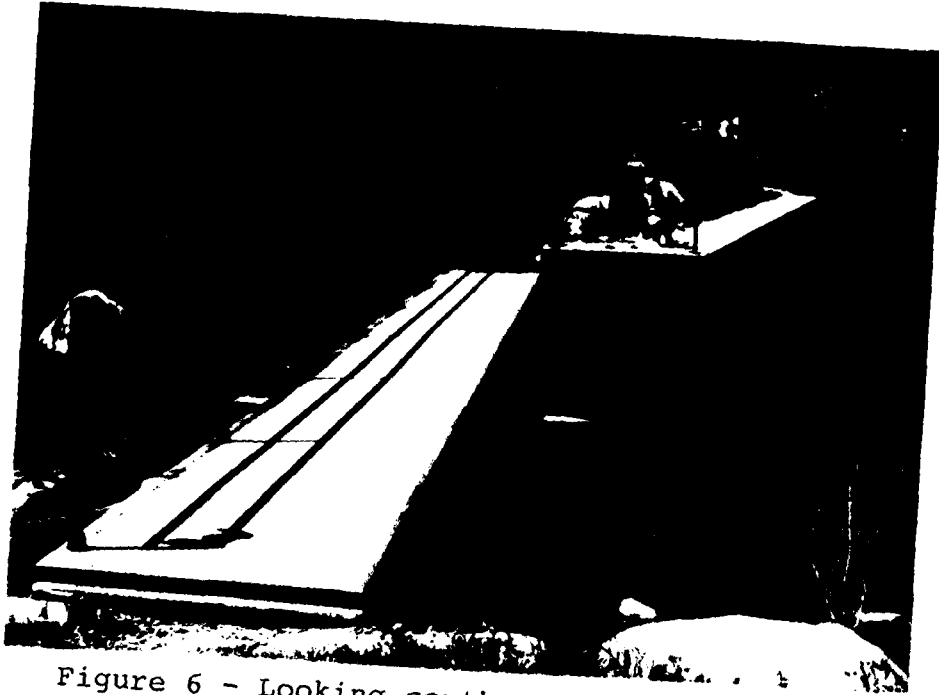
c. Appurtenant Structures. Access to the top of the dam is across a concrete service bridge over the overflow spillway. (See Appendix C - Figure 6.) The bridge consists of two simple spans. The concrete deck is supported in the center with a steel wide-flange beam spaced between the top of a concrete pier and the underside of the deck. (See Appendix C - Figure 7.) The wide-flange beam has not been painted and is rusting. There is a hairline crack through the left deck section at the left abutment. (See Appendix C - Figure 8.) The service bridge railing is painted steel with little evidence of corrosion. The expansion joint in the deck at the center pier is in fair condition and has some evidence of deterioration.

Figure 6 - Looking southwest across the overflow spillway from the northeast abutment.

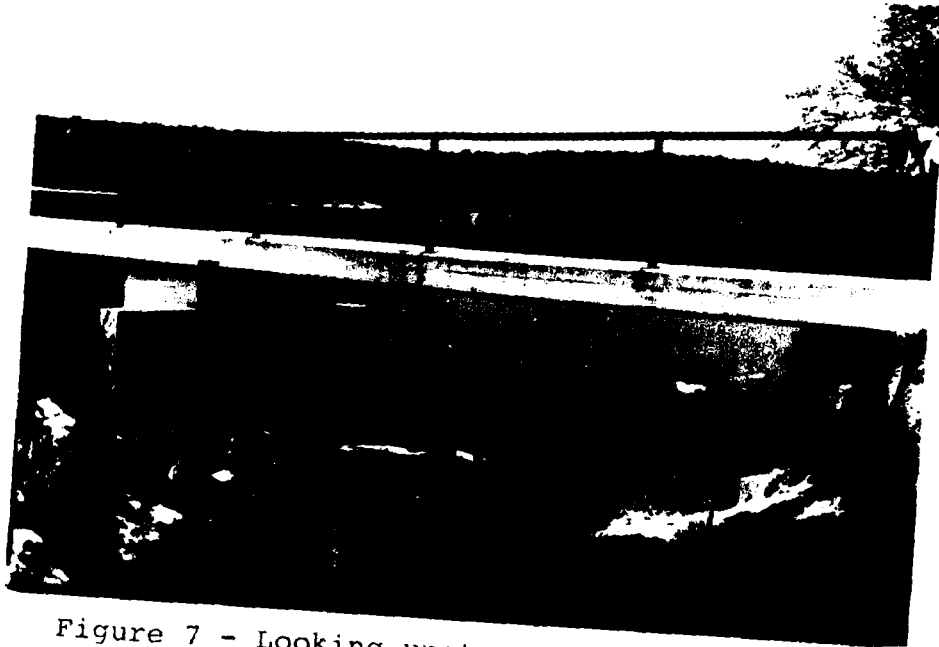
Figure 7 - Looking upstream at the overflow spillway and service bridge.

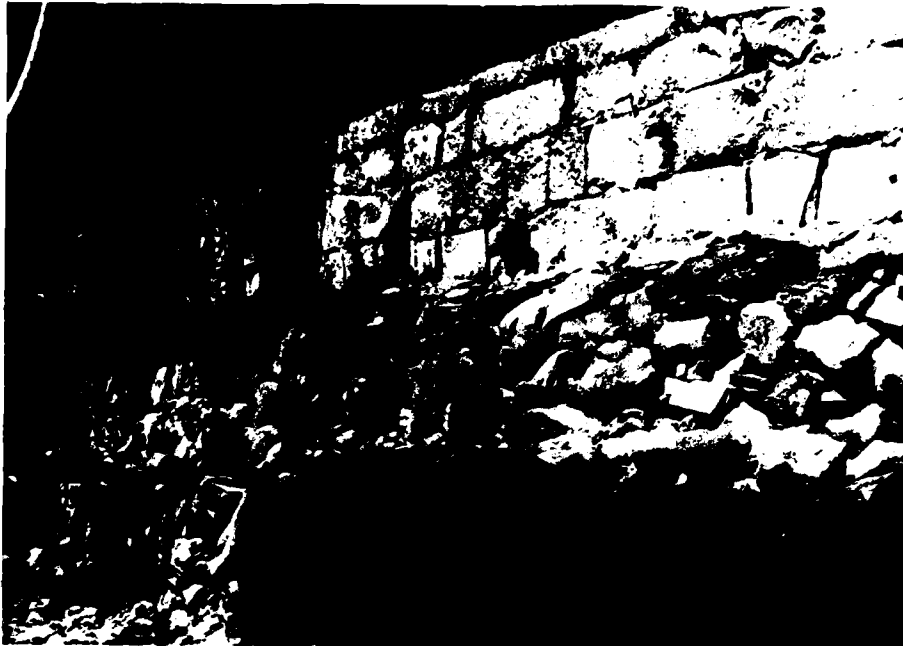
Some minor bulging and tilt were noted in the top part of the vertical dry masonry wall that is exposed above the rock berms on the downstream face of the dam.

Figure 4 - Looking southwest at the downstream face between gated outlet and southwest abutment, showing the top two berms and the vertical wall.
