CONNECTICUT RIVER BASIN  
CLAREMONT, NEW HAMPSHIRE

COY DAM

NH 00140

PHASE I INSPECTION REPORT  
NATIONAL DAM INSPECTION PROGRAM

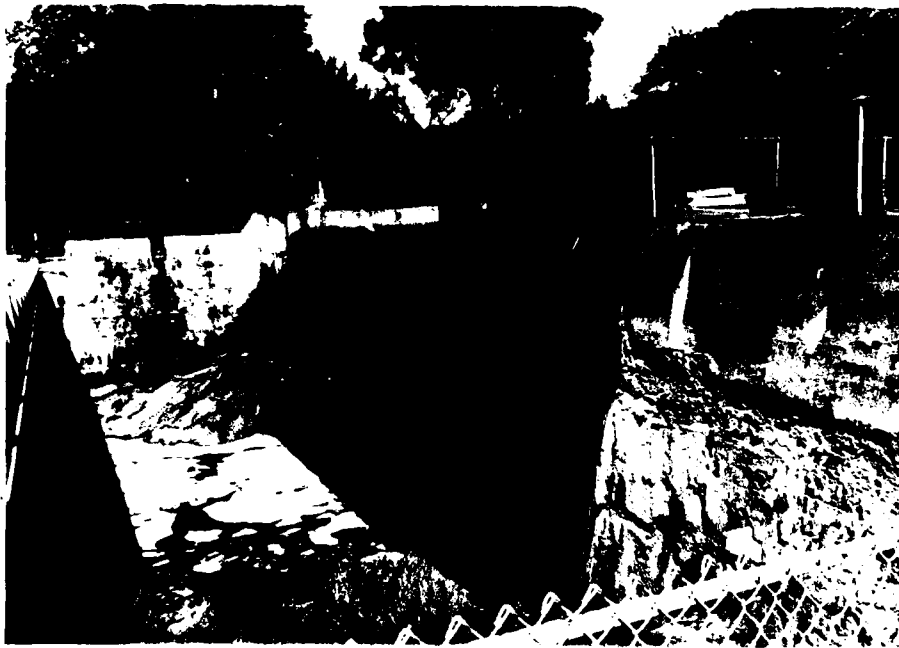
PHOTO NO. 7 - General view of spillway from left abutment.

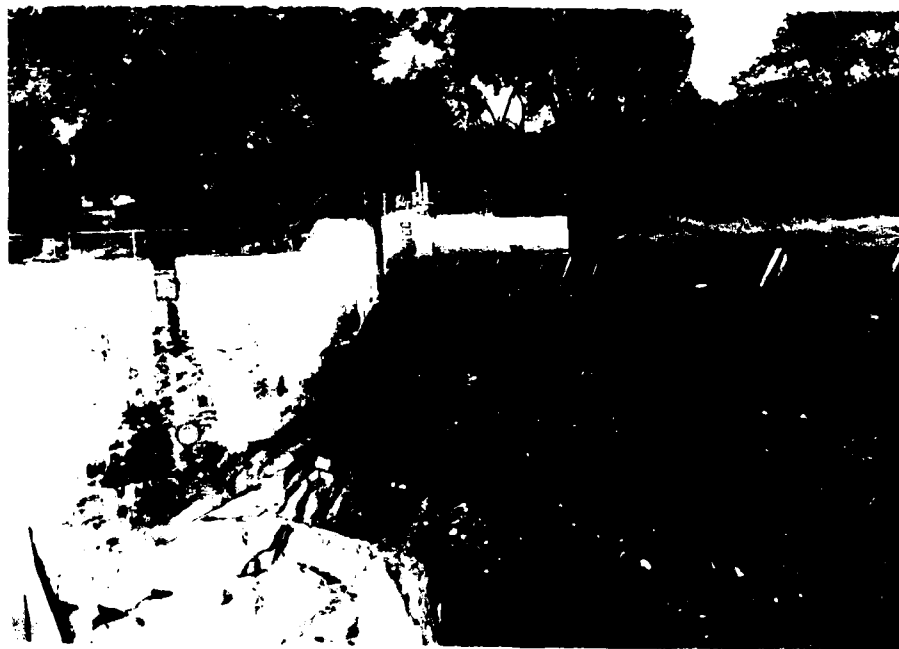
b. Dam. Coy Dam consists of a concrete gravity spillway section with concrete gravity retaining walls forming the right and left sections of the dam. Visual inspection of the dam did not disclose any findings indicating an immediate unsafe condition. Inspection of the downstream face of the spillway section, a major portion of the dam structure, indicates that the entire concrete surface is badly deteriorated and in generally poor condition. Scour depths up to and in some areas exceeding one foot were noted on the spillway section (Photo 10). Seepage through the dam's spillway section was also noted in two areas, 15 feet and 28 feet from the right training wall, both about 8 feet above the channel bottom. This seepage appears to be continuous and appears to be located at a construction joint. The spillway section is approximately 20 feet wide at this point. Photo 8 shows the general location of this seepage.

PHOTO NO. 8 - General view of dam seepage area.  
Photo take from roadway bridge.

(b) Design remedial measures for the badly scoured and deteriorated concrete spillway including the elimination of seepage and silt deposits.

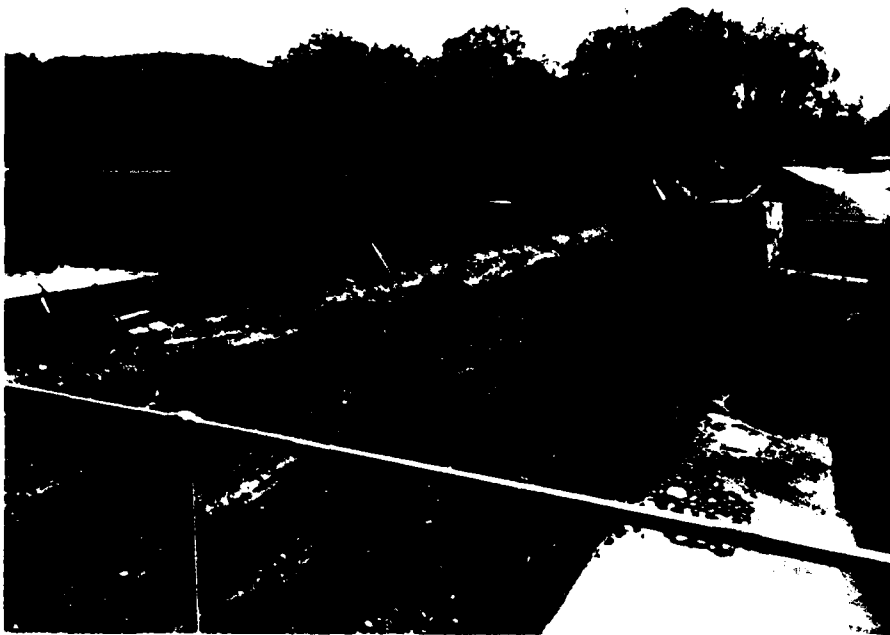
PHOTO NO. 6 - General view of spillway from process intake structure.

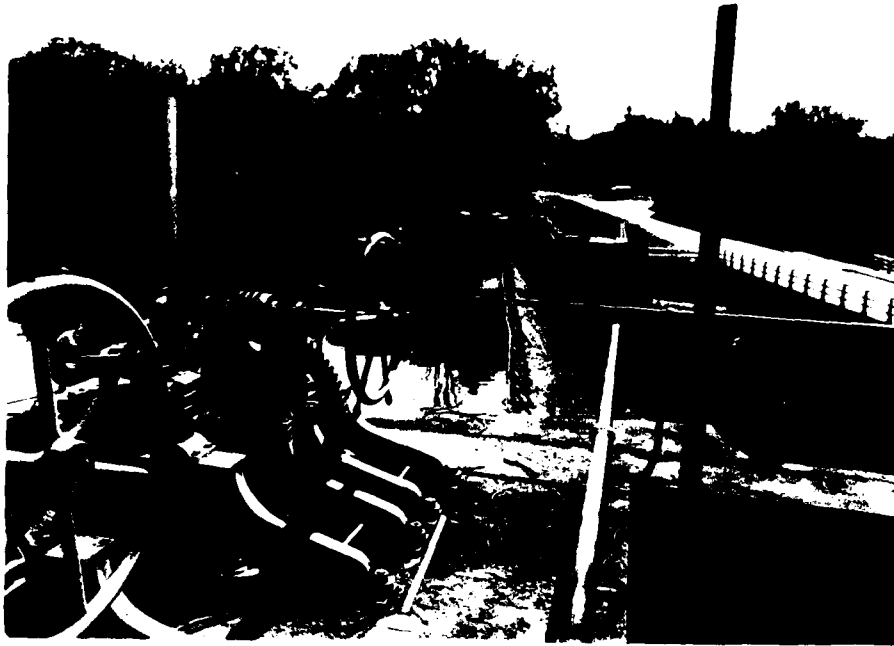
PHOTO NO. 3 - General view of dam and power intake structure from process intake structure.

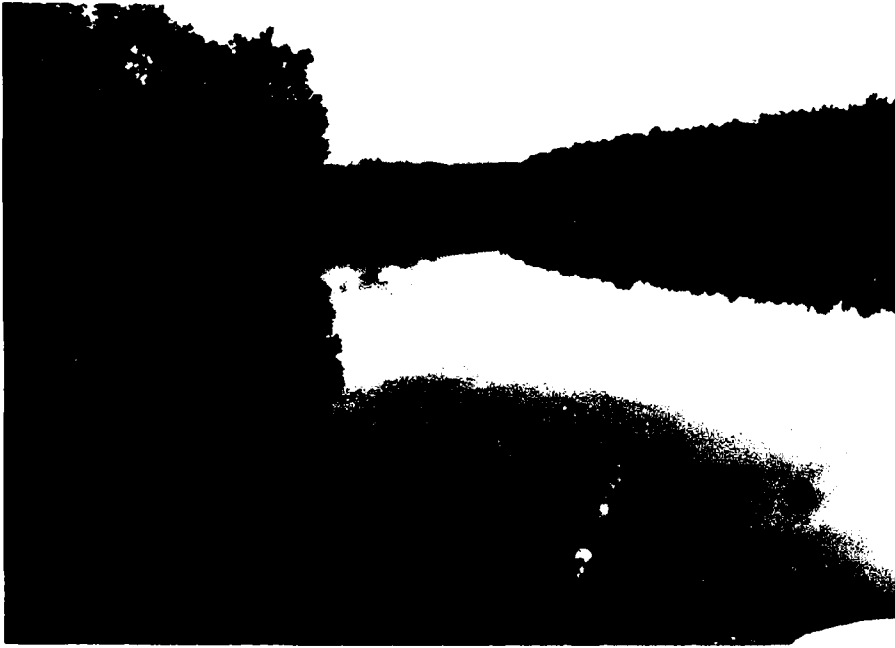
PHOTO NO. 1 - General view of reservoir from power intake structure.

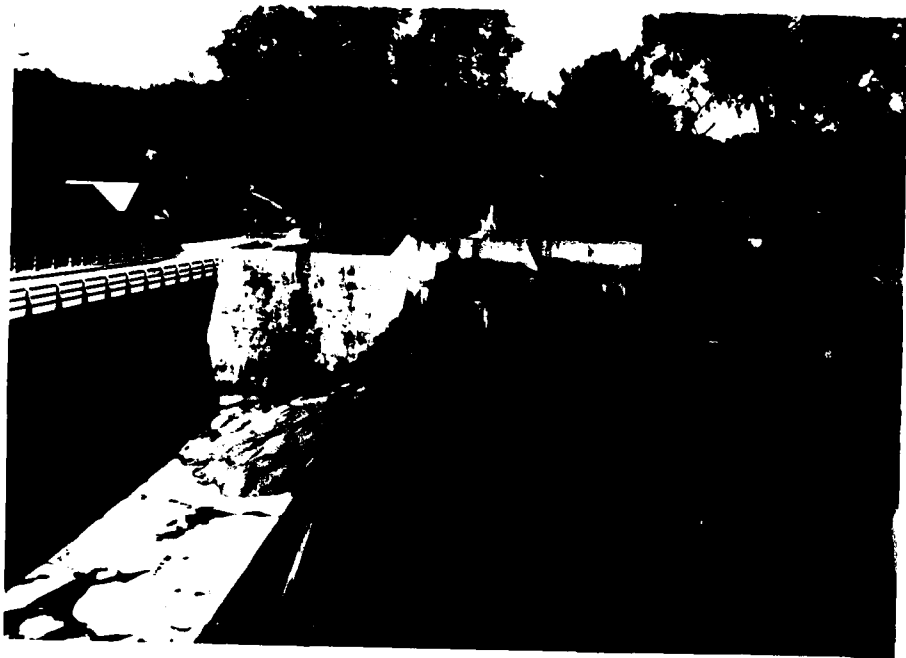
PHOTO NO. 2 - General view of dam and process intake structure from power intake structure.

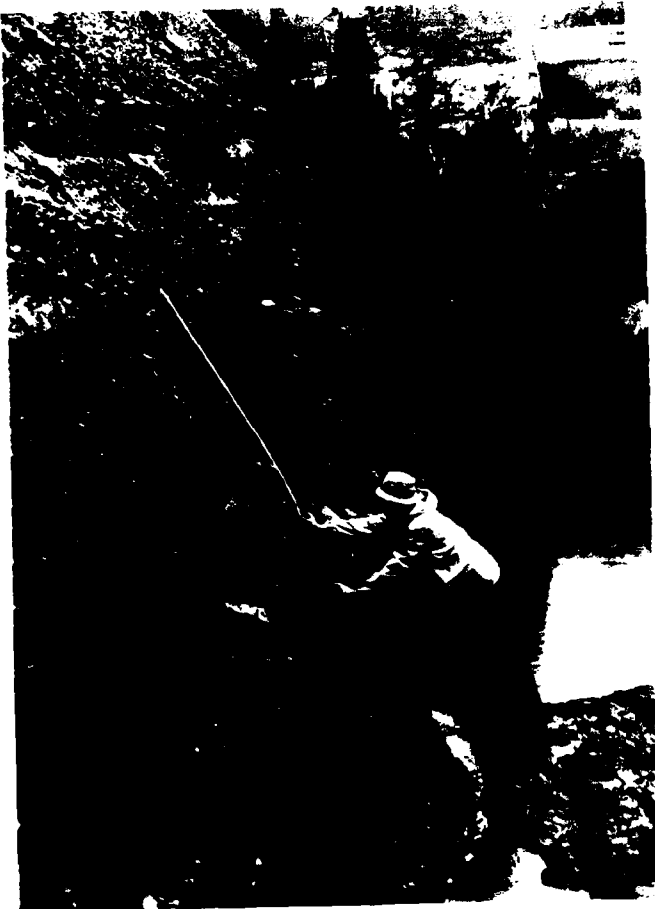
According to available construction specifications, the concrete used for the spillway construction consisted of approximately three bags of cement per cubic yard of concrete. Construction specifications also indicate that a 1 inch cement/sand mortar was used as a bonding material between construction joints. Visual inspection disclosed a silt deposit at the upstream face of the dam to a height approximately 2 feet below the crest of the spillway. Based on the present operational conditions and silt deposits, as above mentioned, it appears that the upstream face of the spillway section may be in tension. The presence of tension cracks in the upstream face of the spillway section could have a direct relationship to the water seepage through the spillway section.

PHOTO NO. 10 - Close-up view  
of spillway surface. Photo  
taken from downstream  
channel. Note distance  
between rule and face of  
spillway is about 12 inches.

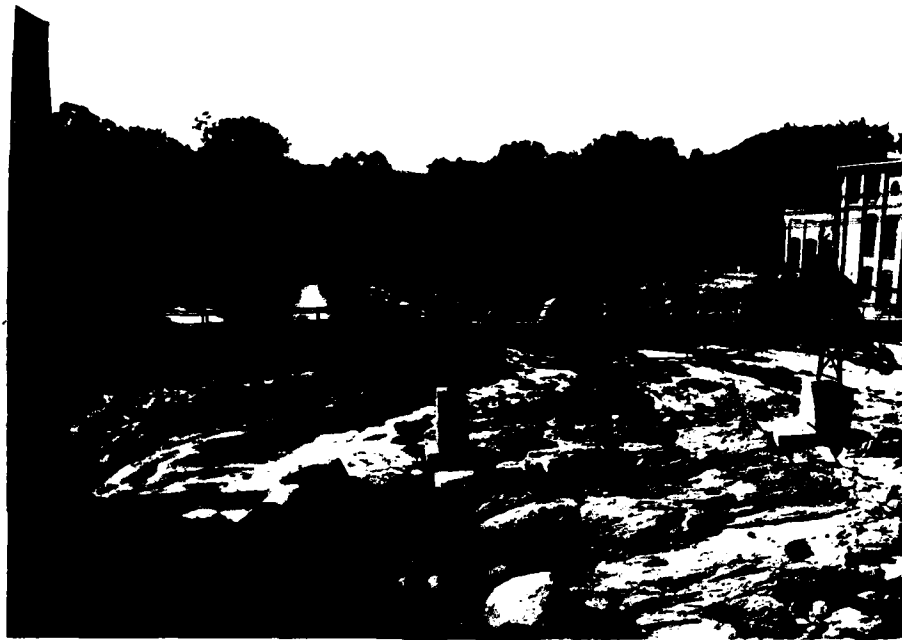
e. Downstream Channel. The downstream channel has a rock bottom and appears to be in good condition. A 70 foot reach, approximately 140 feet wide, downstream of the spillway, leads to a roadway bridge with a waterway opening width of about 136 feet. Below the bridge the channel passes between two buildings, both abutting the river channel. Crossing the river channel between the two buildings is a pedestrian walkway. Beyond the buildings, the channel is lined on both sides with trees.

PHOTO NO. 19 - General view of downstream channel.
