MASCOMA LAKE DAM

NH 00153

PHASE I INSPECTION REPORT
NATIONAL DAM INSPECTION PROGRAM

MAY 1979

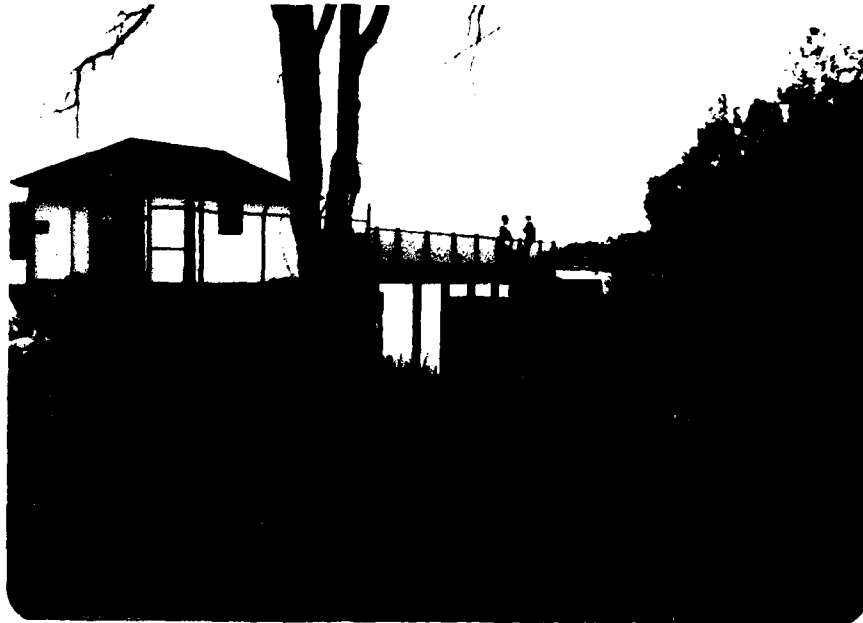
1. Mascoma Lake Dam: Gate House, Stop Log Section and Spillway.
Footbridge from Gate House to Spillway.

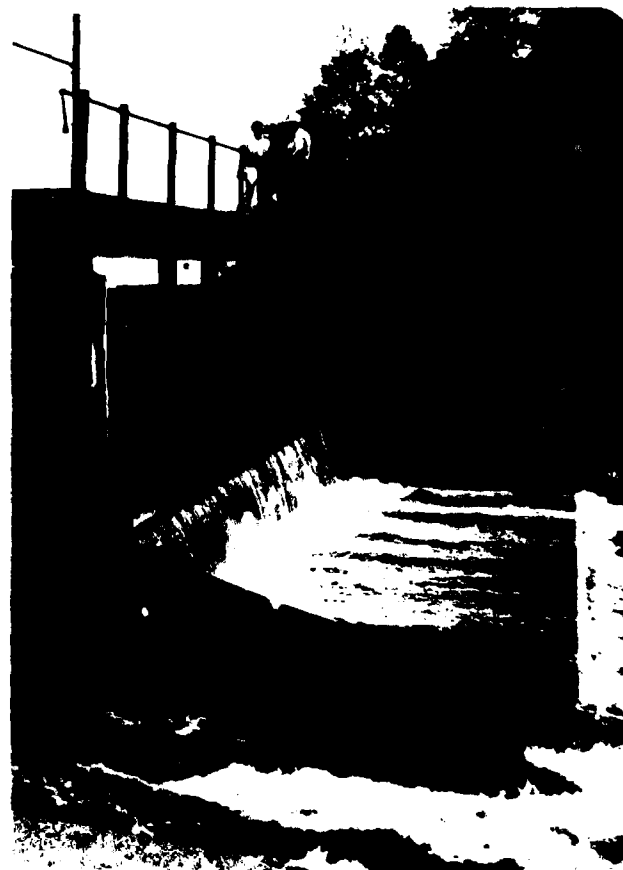
2. Stop Log Stanchions and
Outlet. Wooden Spillway
in Background.

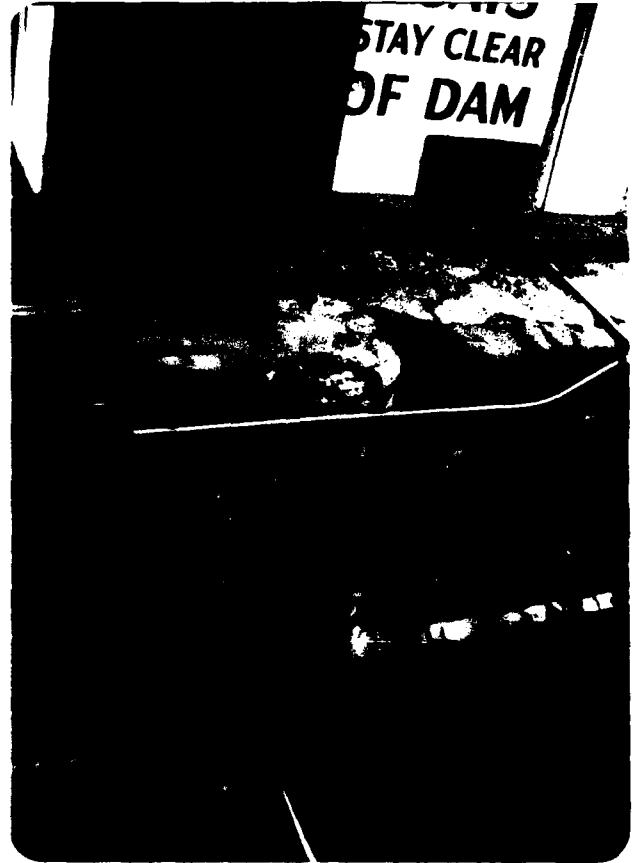
5. Intake Structure Looking from Footbridge Over Stop Log Section. Note Concrete Erosion and Surface Cracks.

- a. All concrete surfaces should be repaired, as continuous deterioration could develop into a serious problem.
- b. Proper grades of the settled area at the northwest corner of the gate house should be reestablished.

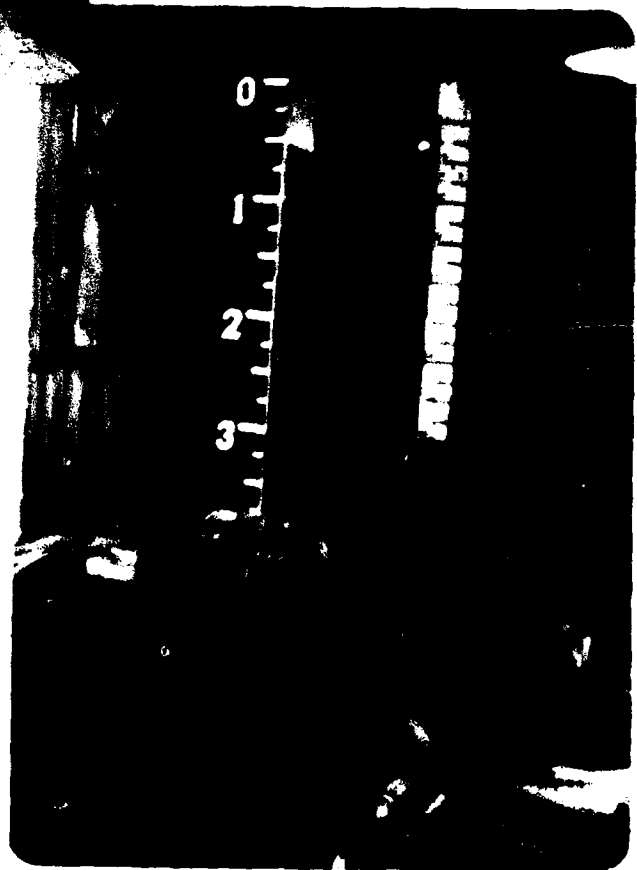
10. Inside of Gate House, Showing Operating Gear in Partially Open Position.
