**PLEASANT VALLEY RESERVOIR DAM
V T. 00064**

**PHASE I INSPECTION REPORT
NATIONAL DAM INSPECTION PROGRAM**

**DEPARTMENT OF THE ARMY
NEW ENGLAND DIVISION, CORPS OF ENGINEERS
WALTHAM, MASS. 02154**

JUNE 1979

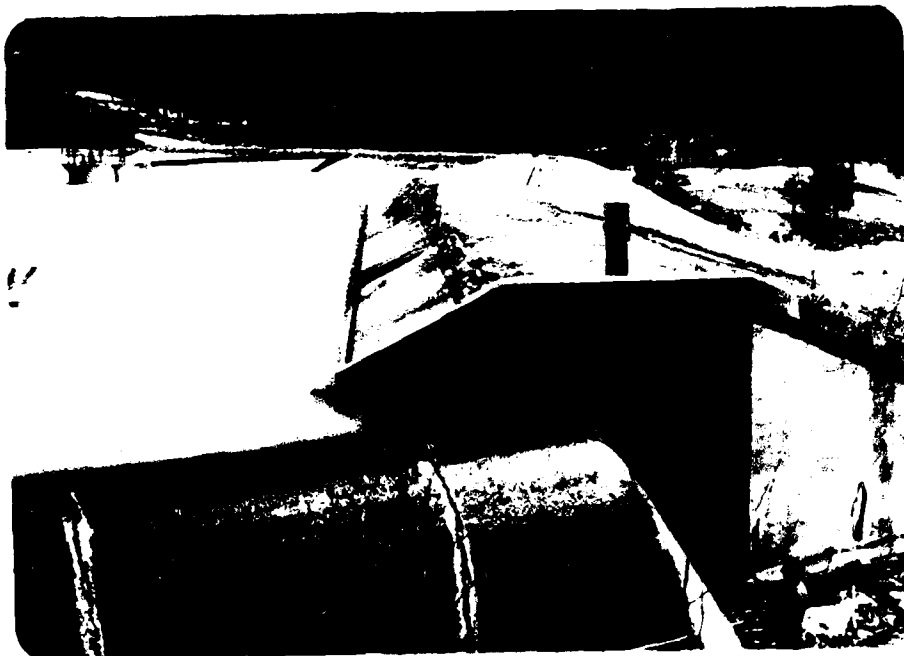
The upstream slope is protected by a concrete pavement which is in good condition as can be seen in Photos 1, 3 and 5. The concrete slab extends below the water surface to elevation 620. From that point downward along the slope is riprap. Joints in the concrete slabs have been patched with a sealant and kept in good condition.

The crest is grass covered and in good condition. It is 12 feet wide and incorporates an access road to the service bridge (see Photo 1).

#1. VIEW OF CREST OF DAM, SPILLWAY AND ACCESS
BRIDGE, FROM RIGHT ABUTMENT

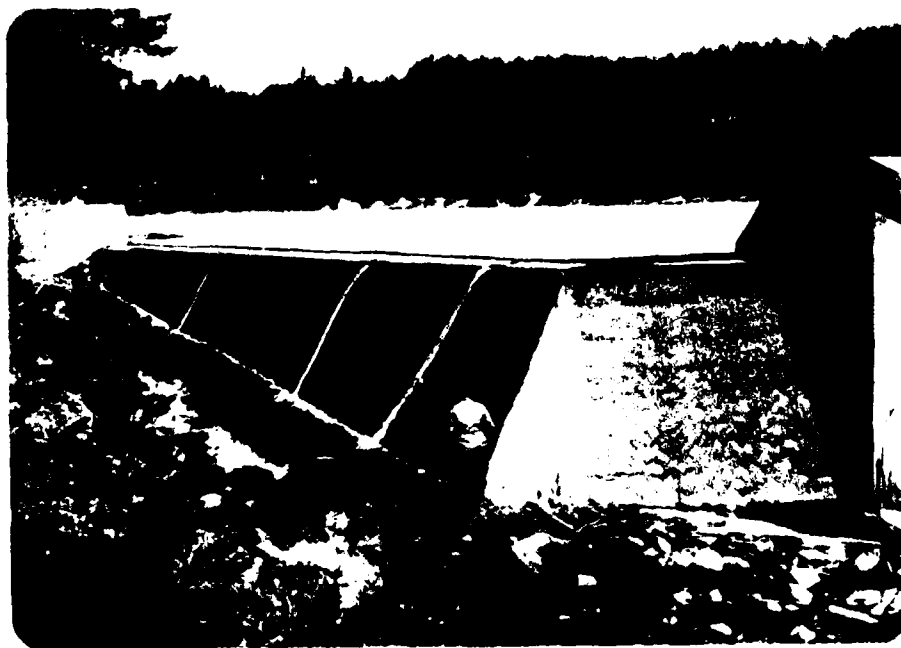
The concrete spillway (see Photo 2) located on the right abutment is 88 feet long and varies in height from 4 feet high to approximately 10 feet high. The exposed part of the upstream face of the spillway is in good condition and the joints in the concrete have been patched. The downstream face, however, has several construction joints in need of repair, as the water overtopping the spillway has eroded the sealant and the concrete at the joints has spalled as shown in Photo 1. The concrete apron immediately below the spillway has cracked and broken in several places.

#2. VIEW OF SPILLWAY AT RIGHT ABUTMENT

- a. Direct the repairs of the concrete spillway apron.
- b. Develop a plan for control and monitoring of seepage through the dam and its foundation. Discharge from the seeps should be analyzed and recorded on a regular basis for flow and suspended solids concentration. Special attention should be given during and just after a significant rainfall.
- c. Assess the capacity of the emergency spillway.

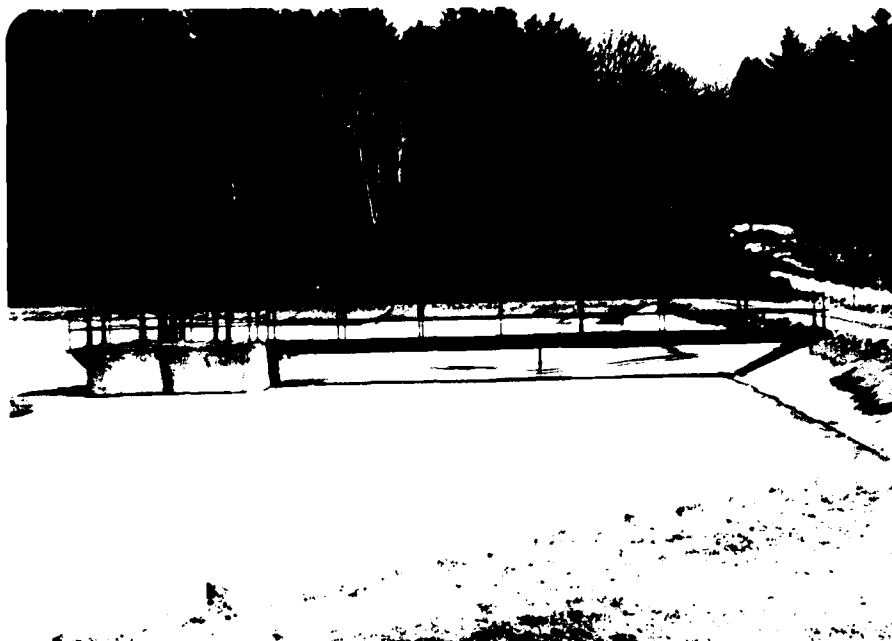
#3. VIEW OF CONTROL TOWER AND ACCESS BRIDGE
LOOKING TOWARD LEFT ABUTMENT

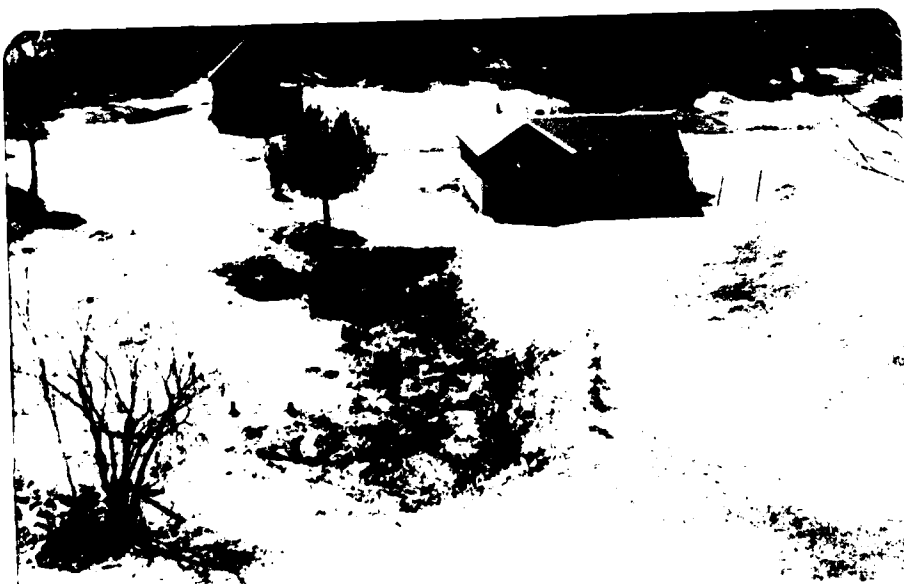
#4. VIEW OF CHLORINATION BUILDING IMMEDIATELY
DOWNSTREAM OF DAM

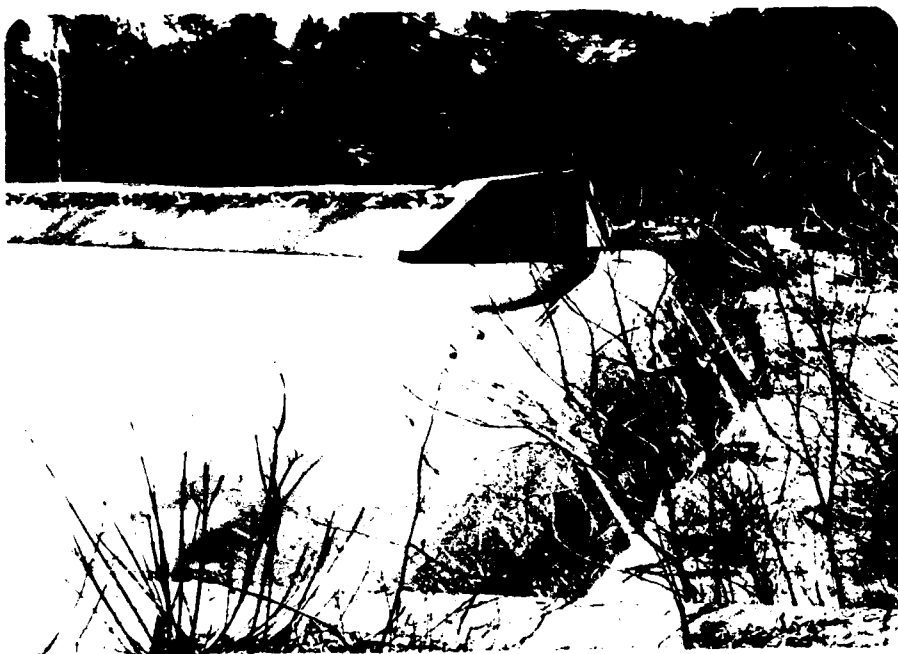
#5. VIEW OF SPILLWAY AND DISCHARGE CHANNEL

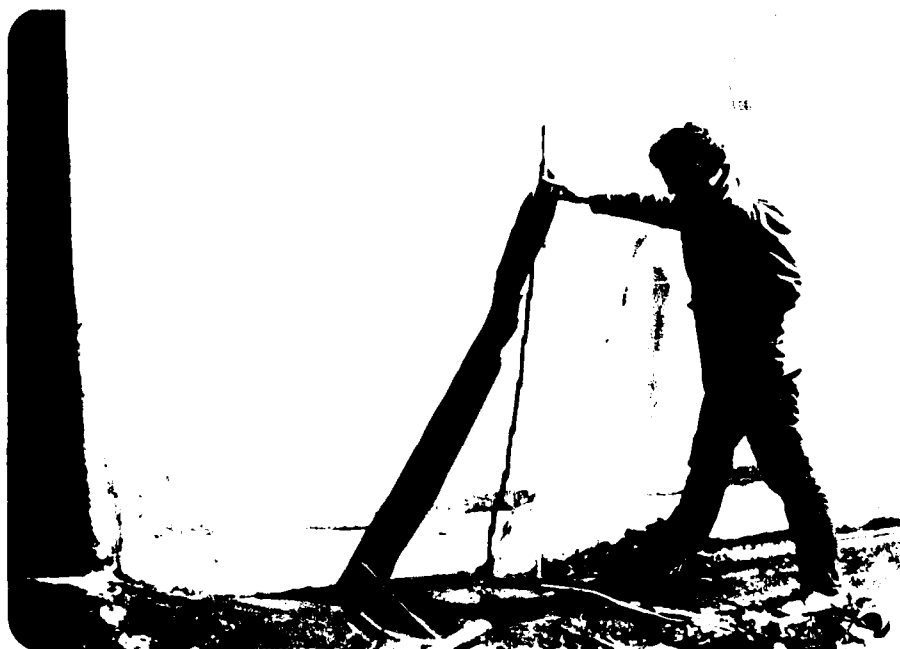
- c. The downstream face of the emergency spillway has cracking and spalling occurring along construction joints.
- d. Efflorescence has formed from 2 cracks in the spillway training wall.

The downstream training wall located at the left side of the spillway has 2 cracks of minimum width and approximately 5 feet long. From these cracks, a large amount of efflorescence has developed (see Photo 6). Continued leaching of the lime from the concrete could cause serious concrete deterioration and result in a collapse of the training wall.

#6. VIEW OF SPILLWAY TRAINING WALL SHOWING
HAIRLINE CRACKS AND EFFLORESCENCE

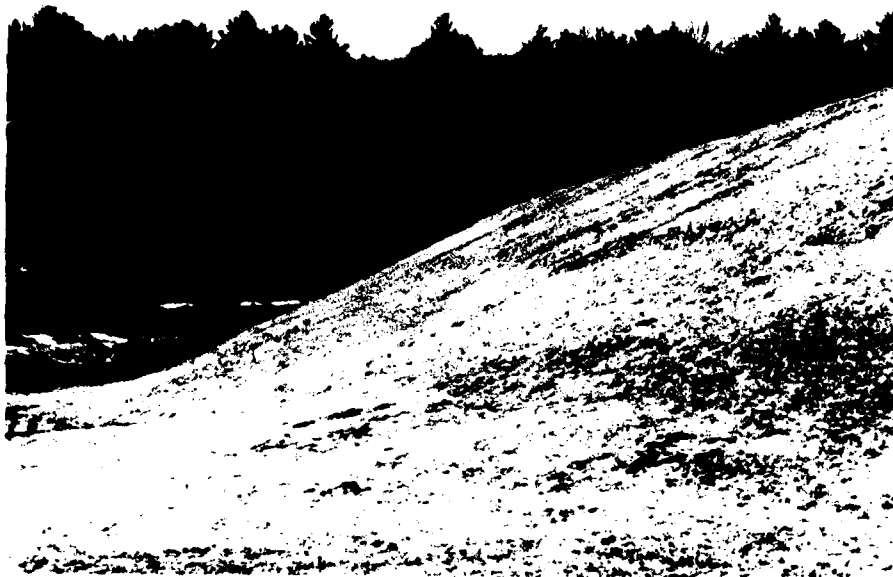
#11. VIEW SHOWING DOWNSTREAM FACE OF DAM

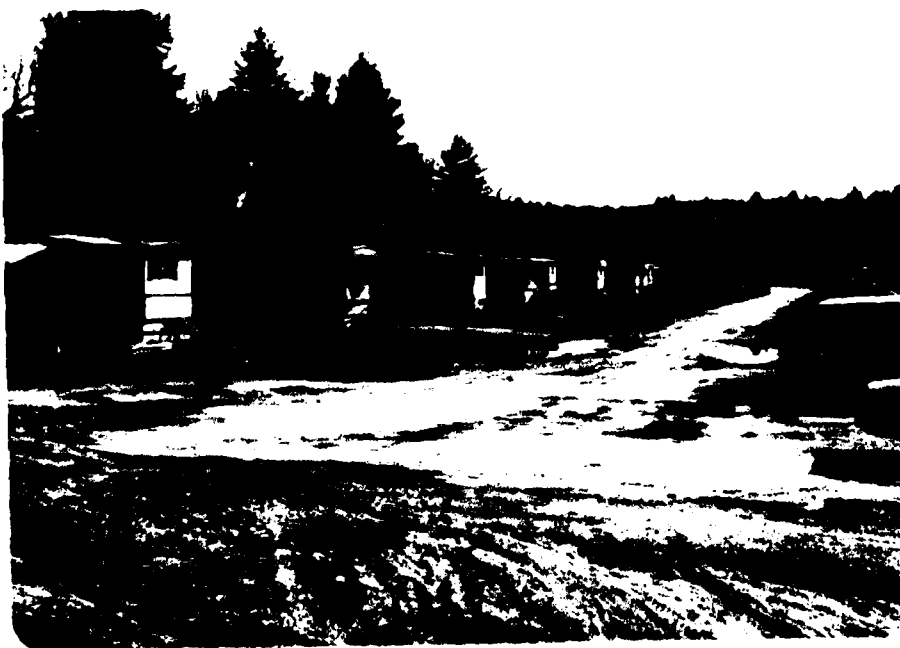
park consisting of approximately 60 trailers. The wave at this point would be 10 feet above the average ground elevation of the park. The majority of the trailer park would be destroyed. Therefore, the hazard classification for this dam is high.

#12. VIEW OF TRAILER PARK DOWNSTREAM OF DAM

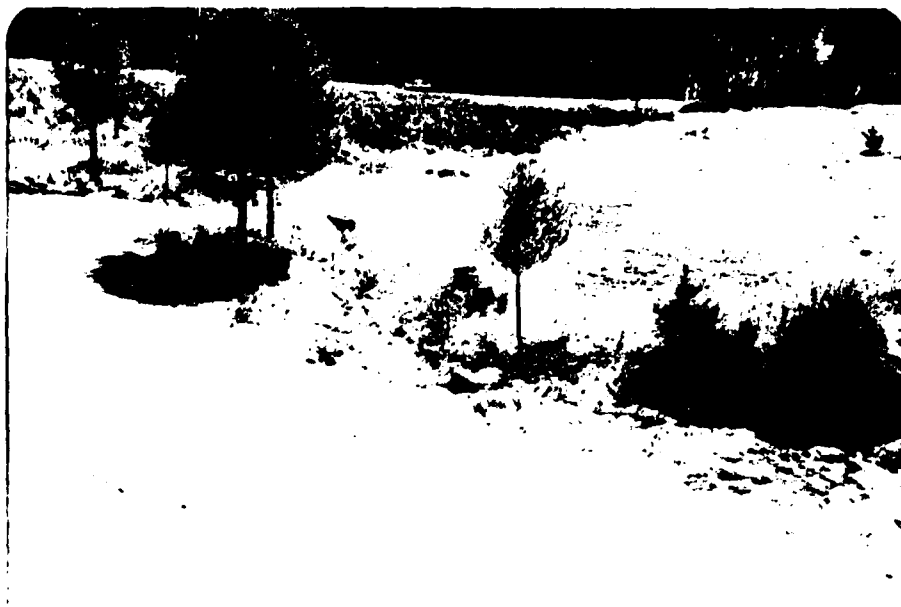
shown in Photo 7 as rust-colored water which corresponds to the location of a spring that existed under the new fill placed in 1954 when the dam was raised. This spring is located on the plan as spring #2. According to Mr. Orman Holden, Water Superintendent, 6-inch cast-iron pipe and french drains were used to relieve the water from this spring. Even though the outlet pipe was not visible a metal detector indicated its presence. The total flow from the seeps within the left part of the dam discharges through a corrugated metal pipe and into the discharge channel as shown in Photo #4. From the discharge channel to the spillway, the toe was wet for practically the full length of this section of the dam (see Photo 9). Near the spillway, as shown on the plan as spring #1, there is a 12-inch corrugated metal pipe outlet installed to relieve the water from another spring as located also in 1954. Photo 8 shows a close-up of the outlet and the rust-colored water which discharges into an outlet trench. A metal detector was used to trace the outlet pipe. Photo 9 shows the red jacket in the location to where the outlet pipe was traced. Another seep was present closer to the spillway, approximately 4 feet above the toe, on the slope also shown in Photo 9. This seep is believed to be in the same location as the old spillway site before the 1954 construction.

None of the seeps show visual indication of soil transport and therefore do not represent an unsafe condition at this time.

#7. VIEW OF DOWNSTREAM TOE SHOWING SEEP FROM
6-INCH C.I. PIPE AT SPRING #2 LOCATION
