NATIONAL PROGRAM FOR INSPECTION OF NON-FEDERAL DAMS  
WINDSOR UPPER DAM (VT.) (U) CORPS OF ENGINEERS WALTHAM  
MA NEW ENGLAND DIV SEP 78

WINDSOR UPPER DAM VT 00013

SEPT 1978

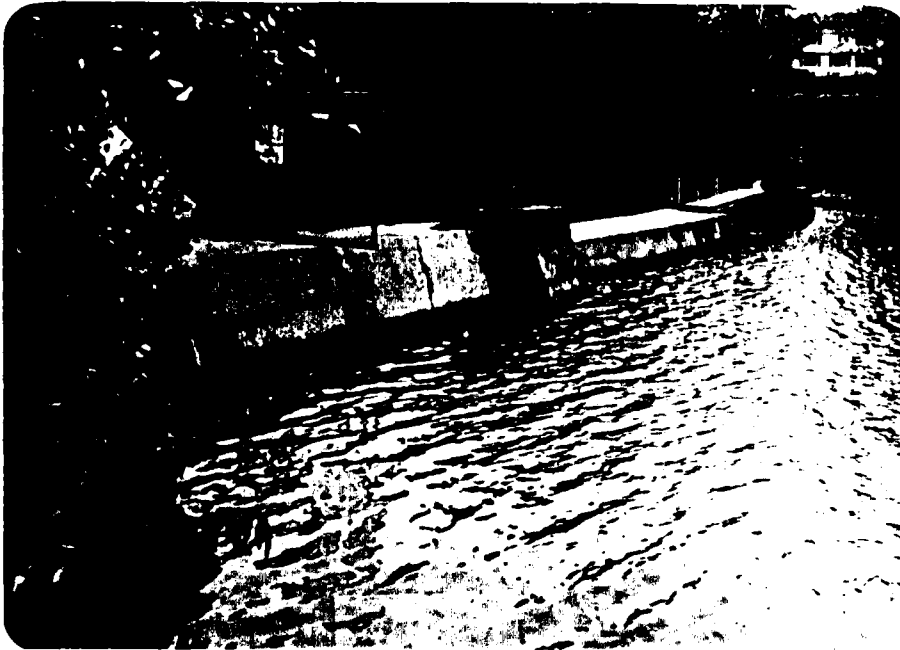
FIG. 1

Upstream face of dam as viewed from left abutment.

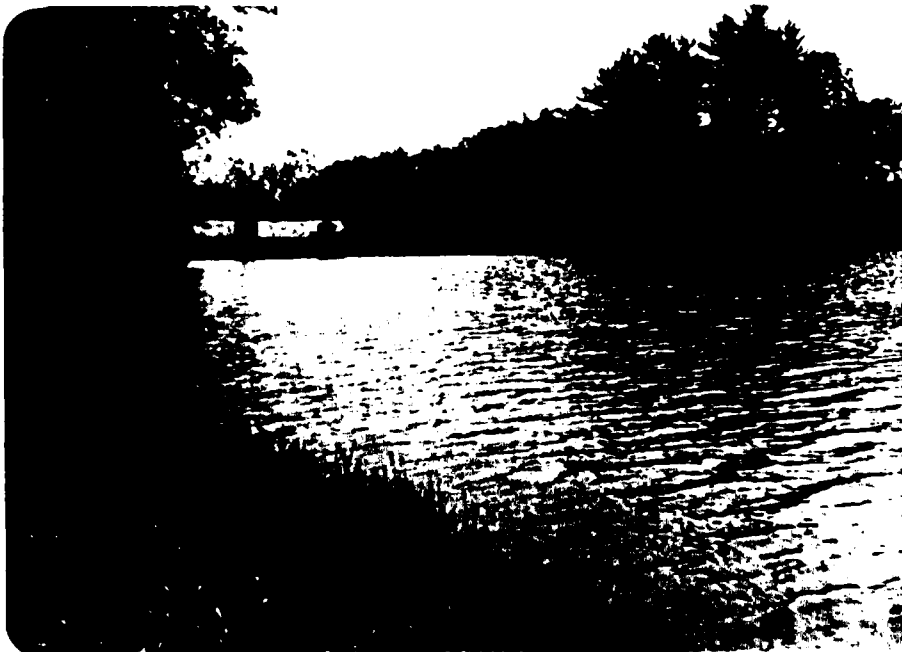
FIG. 2

Windsor Upper Dam as viewed from upstream.

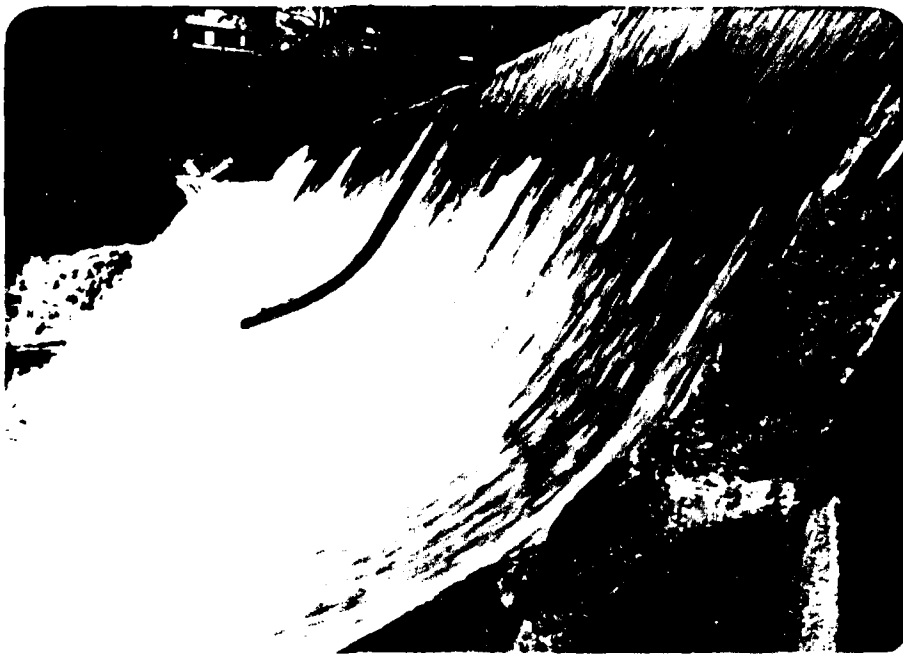
FIG. 5

Longitudinal view of spillway.

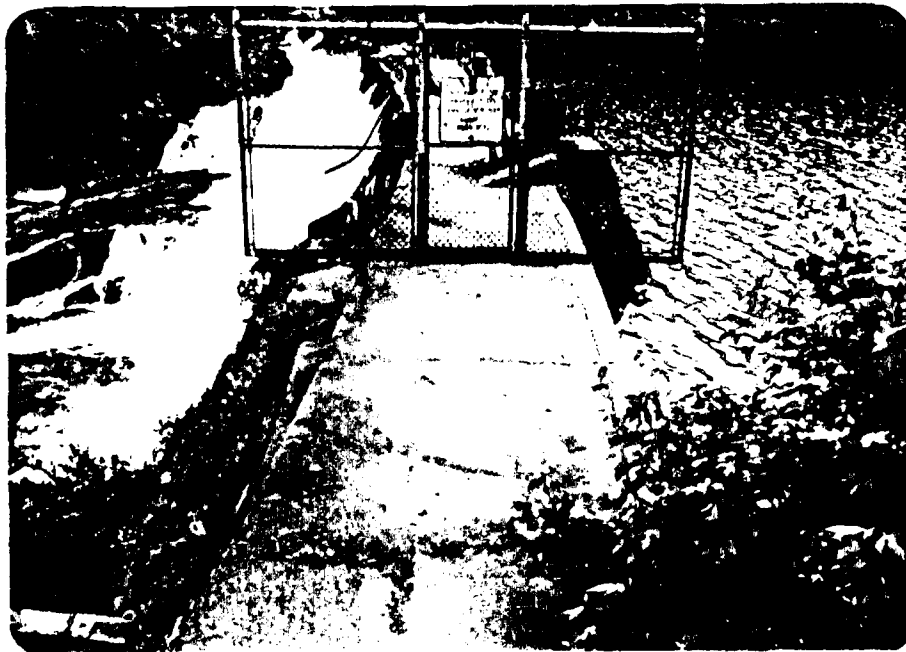
FIG. 7

Operators for penstock and sluice gates.  
(Penstock operator in foreground).

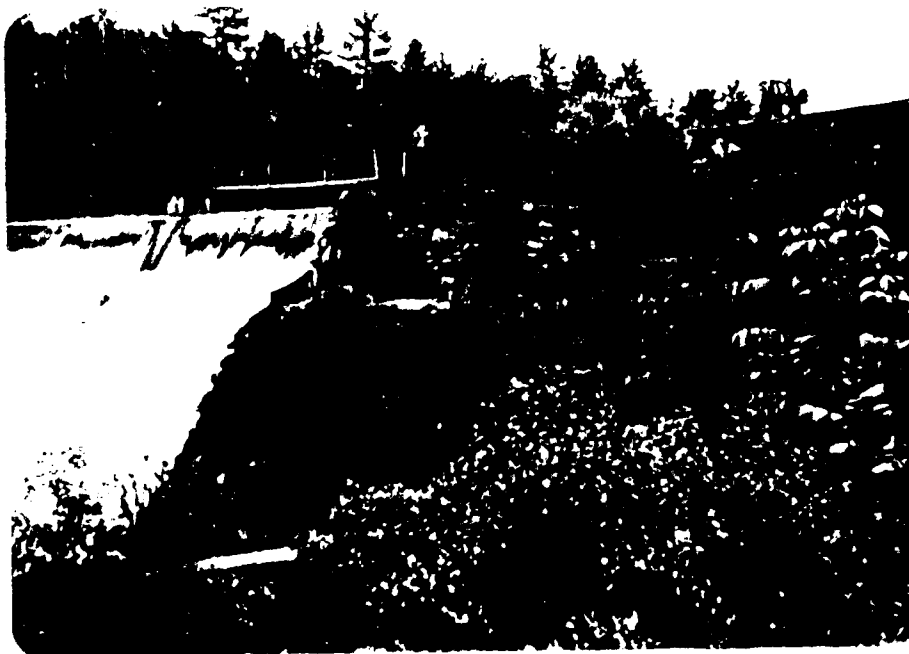
FIG. 8

In addition, the downstream face of the dam is overgrown with small bushes and trees. This condition could eventually cause leakage problems, if allowed to continue. The downstream face of the dam must be annually cleared of all brush.

Main spillway and auxiliary spillways as viewed from  
downstream. (Note vegetation on downstream face).
