NATIONAL PROGRAM FOR INSPECTION OF NON-FEDERAL DAMS
JAMES V TURNER DAM (R. (U) CORPS OF ENGINEERS WALTHAM
MA NEW ENGLAND DIV JAN 81

JAMES V TURNER DA111

JAMES V. TURNER
RESERVOIR DAM

NATIONAL PROGRAM OF
INSPECTION OF
NON-FED. DAMS

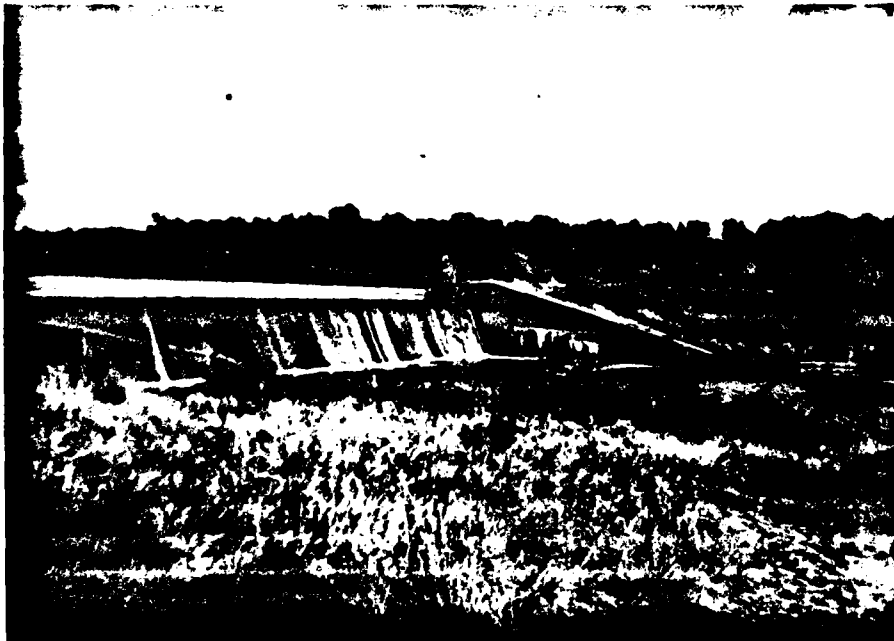
OVERVIEW FROM RIGHT SIDE OF CHANNEL
(10-8-80)

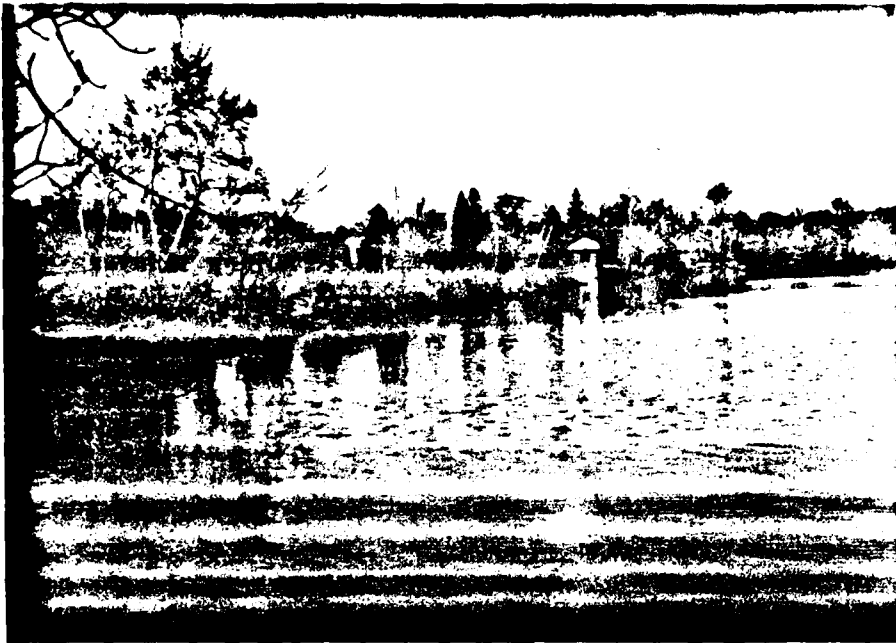
Top of Earth Dam - The grass cover on the dam is approximately 2 feet tall except for where trespassing along the top has worn a path. Some small trees and brush are also growing along the top (Photos 1 and 4).

Photo 1 - Upstream slope from left abutment.
(11-20-80)

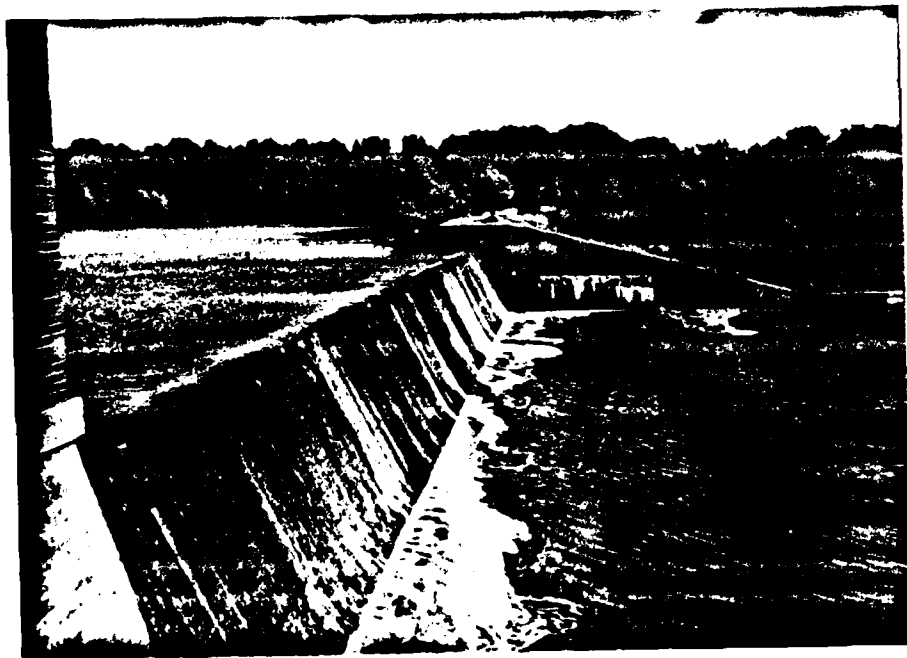
Spillway - Water was flowing over the spillway at the time of the inspection; therefore, the extent of the inspection was limited. The spillway crest shows no signs of irregularities (Photo 4). A concrete stilling pool extends from the toe of the spillway for a distance of about 30 feet. With water flowing over the spillway, the condition of the stilling pool could not be observed. Cracks up to 1 inch wide are present in the concrete training walls at construction joints and where the walls change slope or direction. The left wall has some spalling and deterioration on its face and above the drain outlet and the storm sewer outlet. The downstream end of the right wall is deteriorated and some minor spalling is present on the wall face (Photos 4,5,6).

Photo 4 - Spillway and earth dam.(11-20-80)

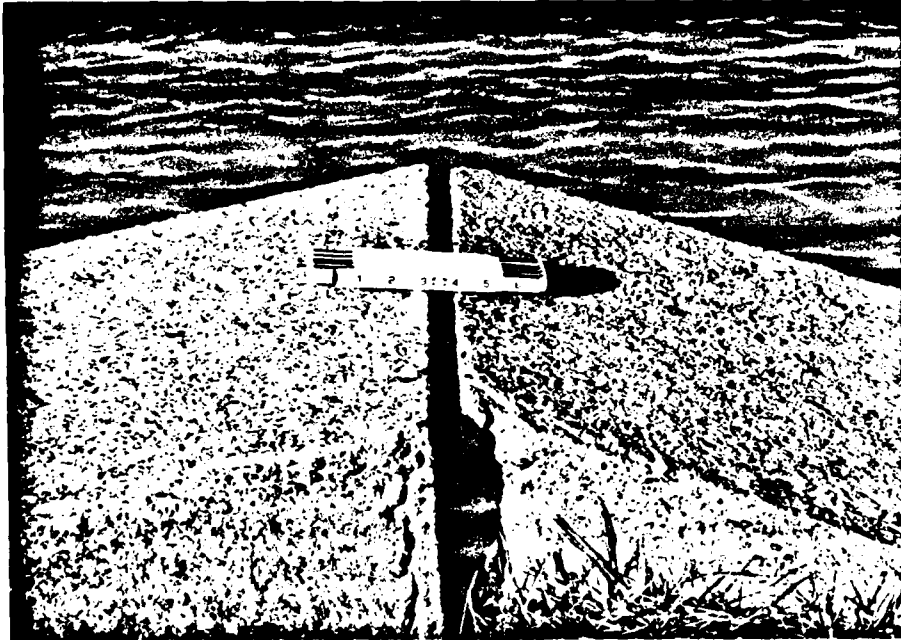
Photo 5 - Separation and displacement of left spillway training wall.(11-20-80)

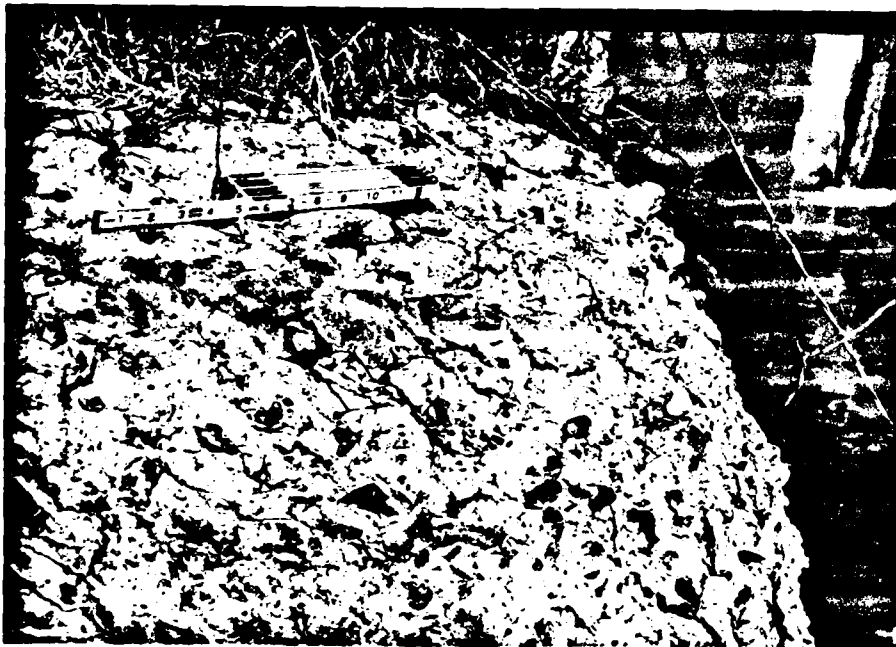
Photo 6 - Deterioration of downstream end of right spillway training wall.(11-20-80)

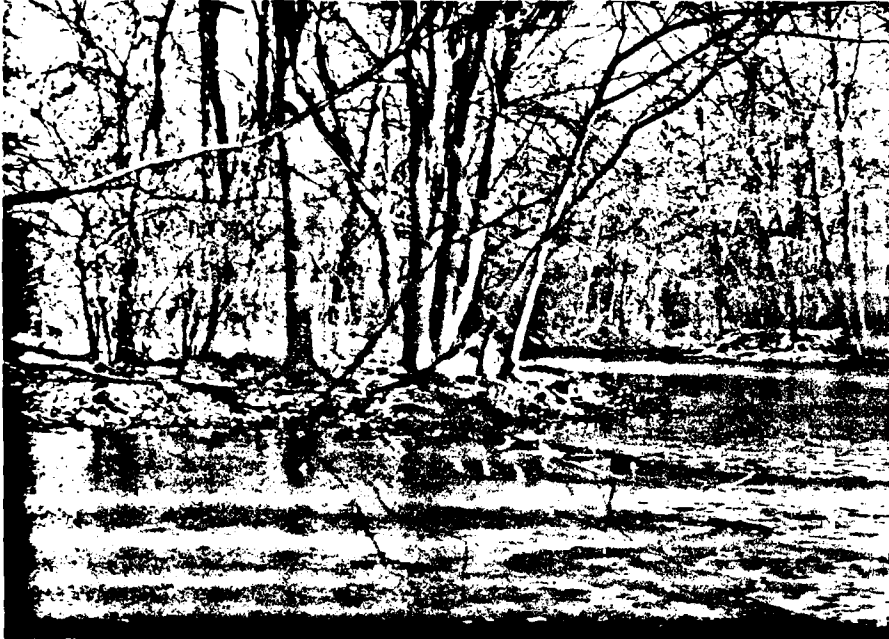
Photo 7 - Backchannel at toe of earth dam. (11-20-80)

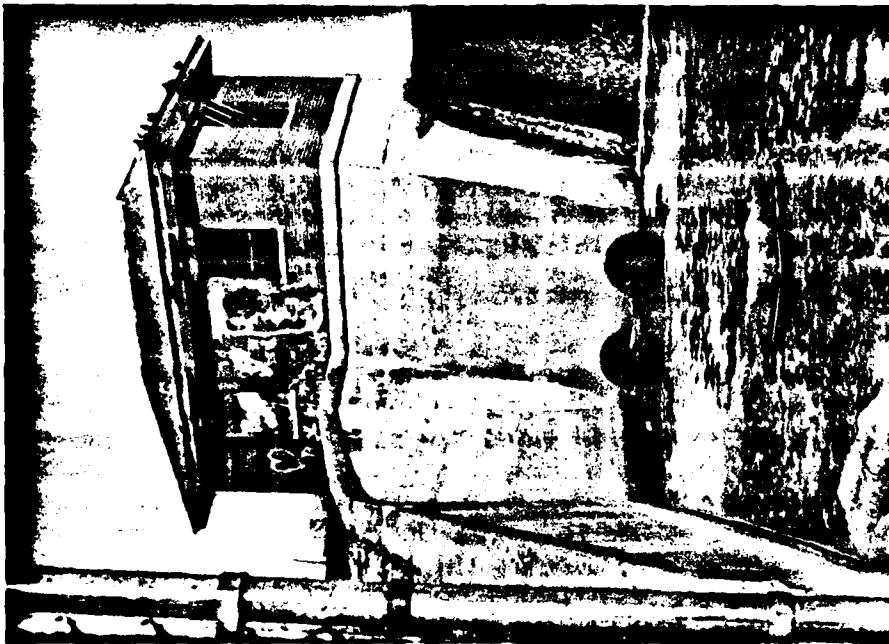
c. Appurtenant Structure - The brick gatehouse is in poor condition. All the windows are broken, graffiti covers the walls, wood trim is broken, roof shingles are torn off, etc. (Photo 8). The door has been removed and the opening sealed with concrete block and mortar. One window on the downstream side has been covered with a steel plate to prevent trespassing. The handwheels have been removed and stored by the East Providence Water Department to prevent vandals from opening the sluice gates. The low-level outlets could not be inspected because of the condition of the gatehouse. For all practical purposes the gatehouse has been abandoned.

Photo 8 - Gatehouse and outlet structure. (11-20-80)
