# DOLE RESERVOIR DAM & DIKE

NH 00143 & NH 00483

## PHASE I INSPECTION REPORT NATIONAL DAM INSPECTION PROGRAM

MARCH 1980

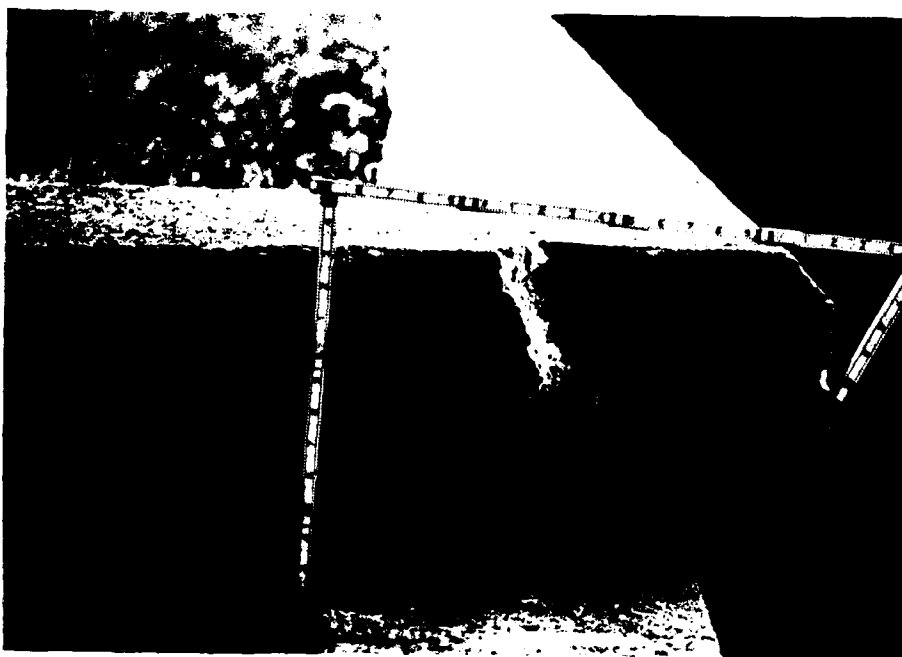
The left end of the embankment is retained by a concrete wall, 15 inches wide and about 7 feet high, which also acts as a training wall along the right side of the spillway discharge channel (see Plans and Details in Appendix B). This wall is partially undermined by erosion at its downstream end and is also about 4.5 inches out-of-plumb because it is tilted toward the west (see Photo No. 15). The embankment immediately adjacent to the wall appears to have subsided about 6-8 inches relative to the top of the wall. There is a 1/4-inch wide crack in the concrete and spalling at the corner where the training wall meets the embankment wall, due to this tilting (see Photo No. 17).

- (5) The poor condition of the concrete wall which retains the left end of the dike embankment and also acts as a training wall on the right side of the spillway discharge channel indicates the possibility that the wall may topple over and lead to breaching of the dike.

Photo No. 17 - Crack and spalling of upstream end  
of right training wall of spillway  
discharge channel.

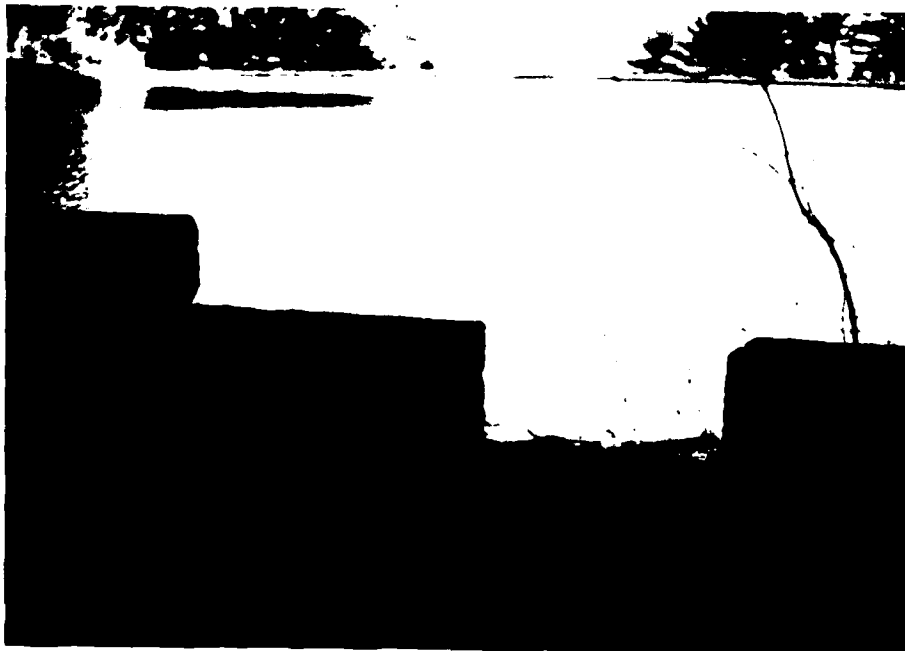
The principal spillway is located on the left abutment of the dike. It is a concrete spillway 14 inches thick, approximately 30 feet long, with a 1.0 foot deep by 3.0 feet long stop log bay. Except for loose brush in the discharge channel, the spillway is in good condition (see Photo Nos. 15 and 16).

Photo No. 16 - Closeup view of spillway stoplog section.

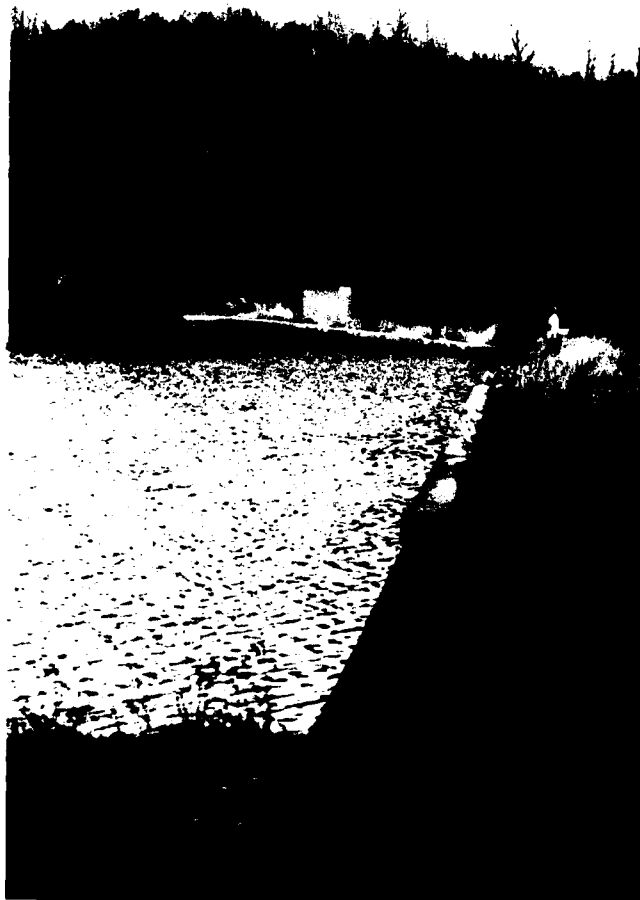
The crest of the dam is mostly covered with unmowed grass and coarse weeds (see Photo Nos. 2 and 3). The upstream edge of the crest is retained by a vertical concrete wall which is 12 inches wide at the top. The cap of this wall is spalling at several locations, and there is a 3-foot long and 1/8-inch wide horizontal crack exposing reinforcing steel on the front face of the wall by the gate house (see Photo Nos. 5, 6, and 7). Near the abutments, the embankment crest is at about the same elevation as the top of this wall, but in the deeper part of the valley, the crest of the embankment is generally 6-12 inches lower than the top of the concrete wall (see Photo No. 7). It is not possible to determine from the visual inspection the elevation of the bottom of this wall. The left abutment appears to be bedrock, and the right abutment appears to be soil (see Photo No. 4).

Photo No. 2 - General view of dam  
from right abutment
