CONNECTICUT RIVER BASIN
PALMER, MASSACHUSETTS

TEXTILE PRINTING CO. (UPPER) DAM
MA 00560

PHASE I INSPECTION REPORT
NATIONAL DAM INSPECTION PROGRAM

MARCH 1979

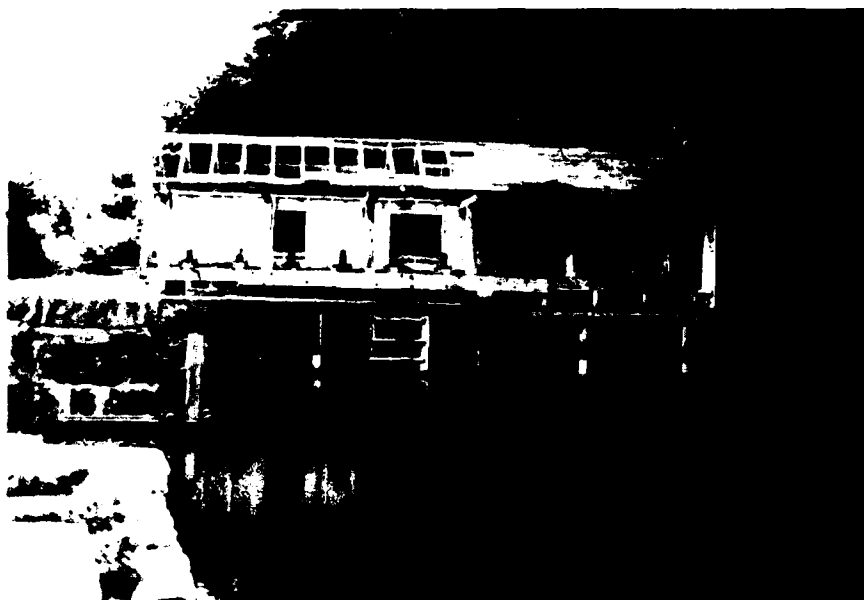
6. DOWNSTREAM FACE OF CANAL CONTROL STRUCTURE.
OVERFLOW WEIR AND CANAL DRAIN OPERATOR IN
LEFT FOREGROUND.

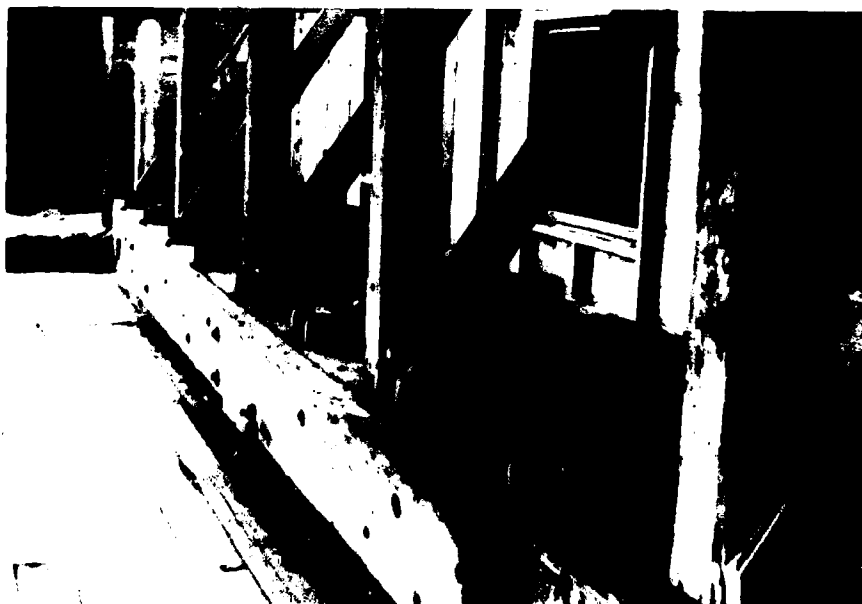
All gates appear not to have been used for sometime and it is doubtful that they are operable. Leakage was observed from both drain gates and in the upper regions of the gate control structure at the canal control facility.

7. CANAL CONTROL GATE OPERATORS.

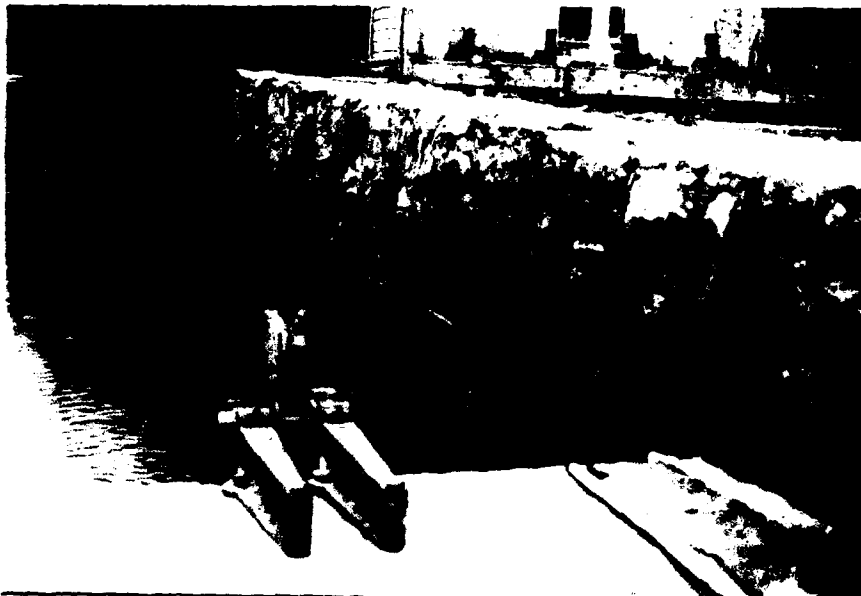
10. RIVER DRAIN GATE OPERATOR ADJACENT TO CANAL WALL.
