HOWE RESERVOIR DAM
NH 00095

PHASE I INSPECTION REPORT
NATIONAL DAM INSPECTION PROGRAM

MAY 1979

Identification No. NH 00095
Name of Dam: Howe Reservoir Dam
Town: Harrisville
County & State: Cheshire, New Hampshire
Stream: Howe Reservoir Offstream
Date of Inspection: May 18, and May 22, 1978

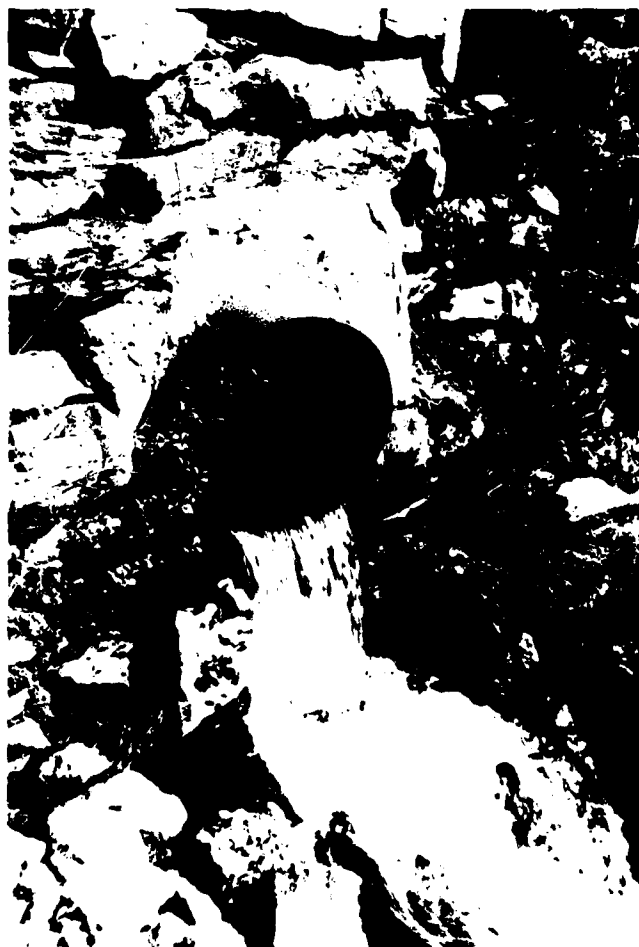
A 36-inch diameter steel outlet conduit was installed through the dam just beyond the northern limit of the spillway. This conduit is located at the lower portion of the dam, Invert Elevation 1259. The water flowing through this outlet conduit is controlled by a 42-inch cast iron circular gate operated manually from a bench stand. This reconstruction began July 25, 1924, and was completed September 4, 1924 (Photograph No. 4, Appendix C), and still is in operable condition.

4. The outflow pipe with the intake gate closed.

- d. The gate controlling the flow through the outlet conduit should be checked for damage and repaired, if necessary.
- e. Downstream outlet and discharge channel should be cleared of any debris.

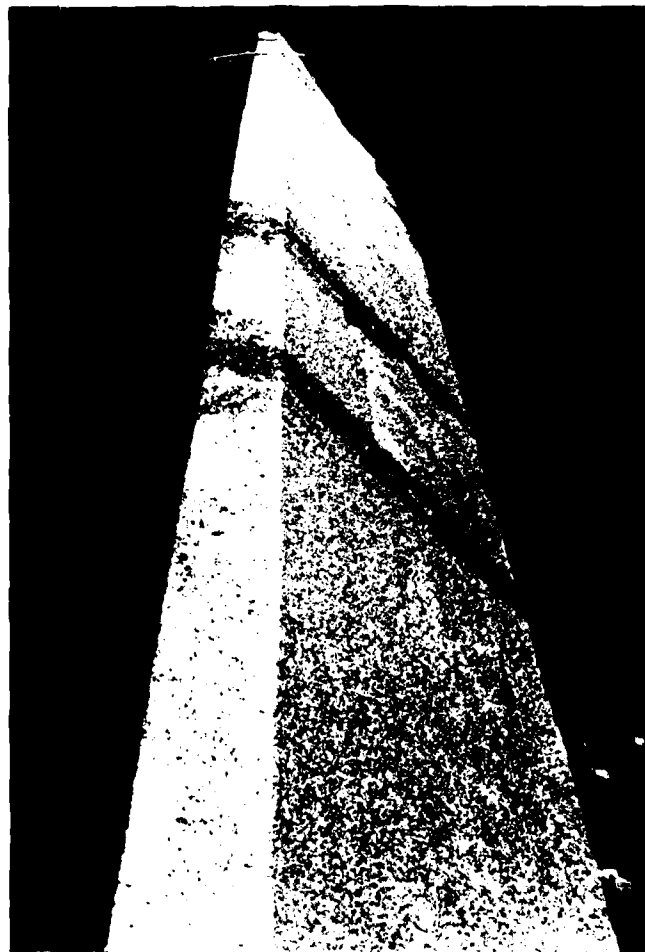
The intake structure (with gate), the outlet structure (with stop logs), the service footbridge, all within the new right abutment, are in excellent condition. The spillway weir, capped with concrete, shows several areas of erosion. In one area near the right abutment, some reinforcing is exposed (Photographs No. 7 and 8, Appendix C).

8. Erosion of concrete crest of spillway near its mid-length.

- b. All concrete surfaces should be repaired as continued deterioration could develop into a serious problem.
- c. Seepage areas should be monitored to determine the cause, and corrective measures should be taken.

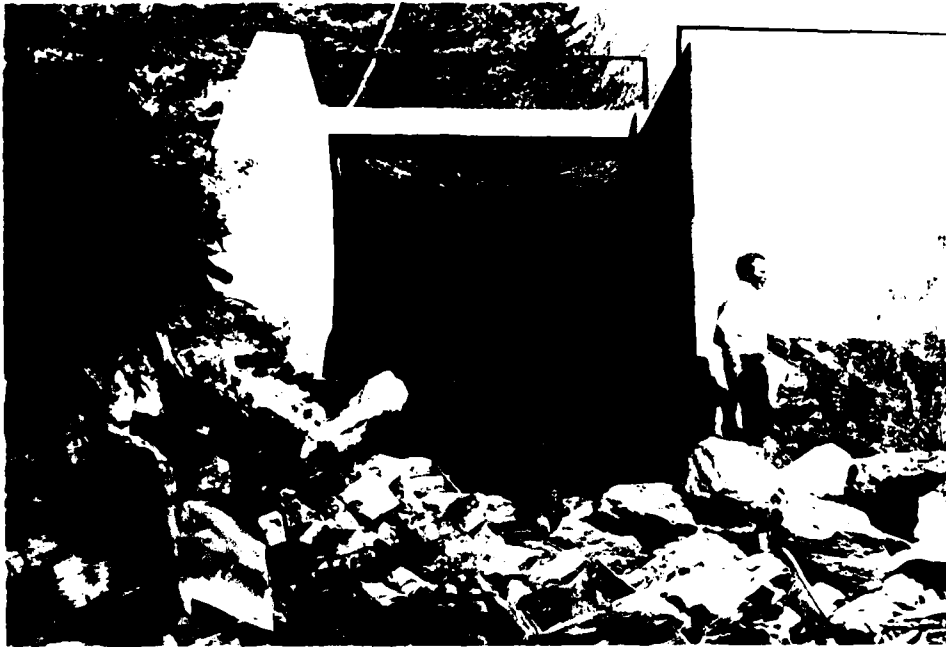
- (1) Outlet Channel - The outlet channel is in poor condition. The protective covering of the stone placed in this channel during the construction of the outlet structure in 1975 had been washed away. The channel bottom adjacent to the outlet structure is approximately 3 feet below the concrete lip. At the extreme northeastern portion of the channel, the interface of the concrete and rock foundation can be seen (Photograph No. 9, Appendix C).

9. Sluice gates with all stop logs in place.

Riprap should be placed in the outlet channel within 1 year of receipt of this Phase I report by the owner. All other remedial measures and recommendations enumerated below should be implemented within 2 years.
