CONNECTICUT RIVER BASIN  
HARRISVILLE, NEW HAMPSHIRE

SEAVER RESERVOIR DAM  
NH 00094

PHASE I INSPECTION REPORT  
NATIONAL DAM INSPECTION PROGRAM

JULY 1979

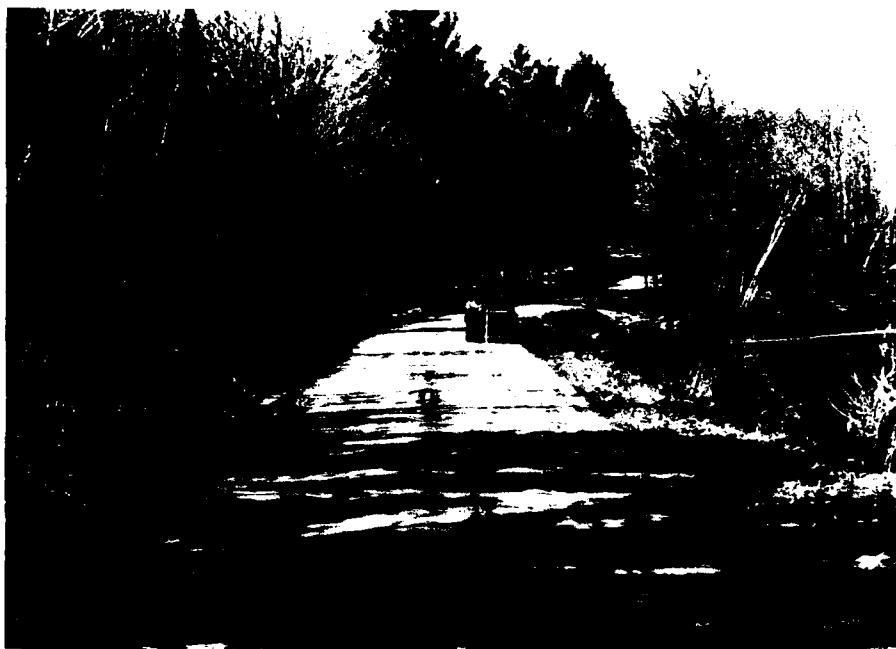
b. Dam. Seaver Reservoir Dam is an earth embankment with a hydraulic height of 28 feet, 325 feet long, and 30 feet wide at the crest. The crest of the dam carries a gravelled roadway. (See Appendix C - Figure 2.) No evidence of erosion of the crest was observed. The upstream face of the dam has a slope of approximately 2H:1V. Brush is growing on the upstream slope above reservoir level and there are a number of tree stumps, up to about 12 inches in diameter, on the upstream slope. (See Appendix C - Figure 3.) Riprap on the upstream slope extends from about 2 feet above reservoir level at the time of the inspection to an unknown elevation below water level. The downstream slope of dam is earthen and has a slope of approximately 1.5H:1V. A heavy growth of trees and some brush were noted on the downstream slope. Trespassing has resulted in significant erosion on the downstream slope in the vicinity of the spillway outlet pipe. Trash has been dumped at several locations on the downstream slope. The downstream toe is retained behind a vertical stone wall about 4 feet high at the discharge end of the spillway pipe. There is a major bulge in this wall and it appears to be on the verge of collapse. (See Appendix C - Figure 4.) Upslope from this wall, and directly above the alignment of the spillway discharge pipe, is a depression about one foot deep and 3 feet in diameter. (See Appendix C - Figure 5.)

April 30, 1979  
Figure 2 - Looking northwest across the crest of  
the dam embankment.

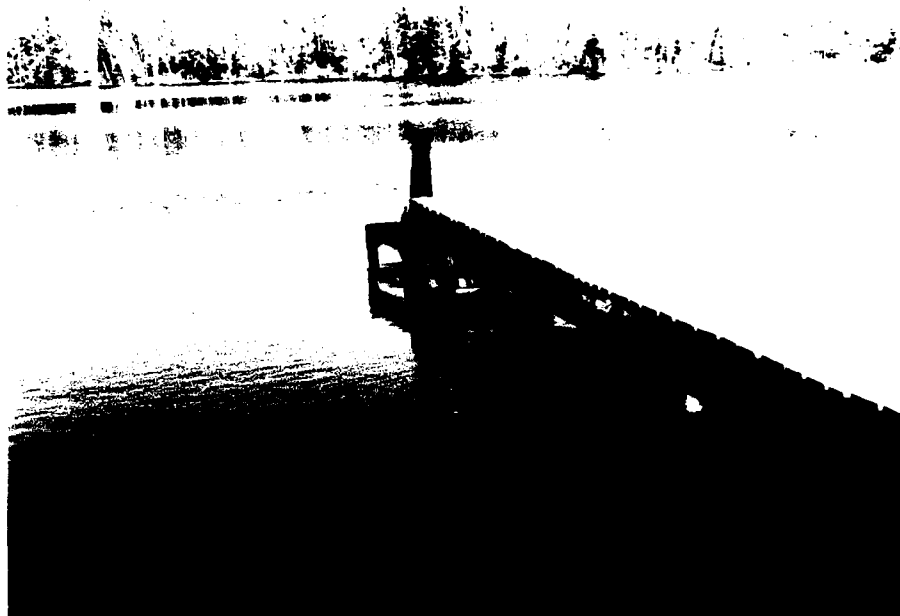
(2) Service Bridge. A 46-foot-long wooden bridge serves as access to the low-level gate operating mechanism at the drop-inlet spillway. (See Appendix C - Figure 6.) The two longitudinal members are pressure treated wood approximately 18" in diameter at the butt end. Each of these timbers was observed to be in good condition. Transverse wood decking is 2" nominal untreated wood plank. The wood planking was observed to be surface weathered with little evidence of structural deterioration. It is possible that during high flows the service bridge could become dislodged making the outlet mechanism inaccessible.

(1) Concrete Box Spillway Inlet. The principle spillway of Seaver Pond Dam is a concrete drop-inlet box located approximately 46 feet upstream of the dam. (See Appendix C - Figure 6.) The concrete box is 4-foot square inside at the crest. A low-level outlet operating mechanism is located on the top of the box. A visual inspection of the outlet box during low water condition revealed that the concrete is in good condition. The lower portion of the concrete box has been repaired recently by facing the outside walls with approximately 8 inches of new concrete. The lower portion is approximately 4 feet wide by 6 feet long. Approximately 10 feet below the top of the concrete box is a shallow stoplog facility and trashrack that is used to control a lower water level.

The concrete box was observed to be in good condition. The only visual evidence of deterioration was minor surface erosion of the concrete exposing some of the coarse aggregate. The steel grating covering the top of the box appeared to be in good condition with

April 30, 1979  
Figure 6 - Looking at drop-inlet riser and wood  
access bridge.
