MERRIMACK RIVER BASIN
TILTON, NEW HAMPSHIRE

TILTON TOWN DAM
NH 00151

PHASE I INSPECTION REPORT
NATIONAL DAM INSPECTION PROGRAM

JULY 1979

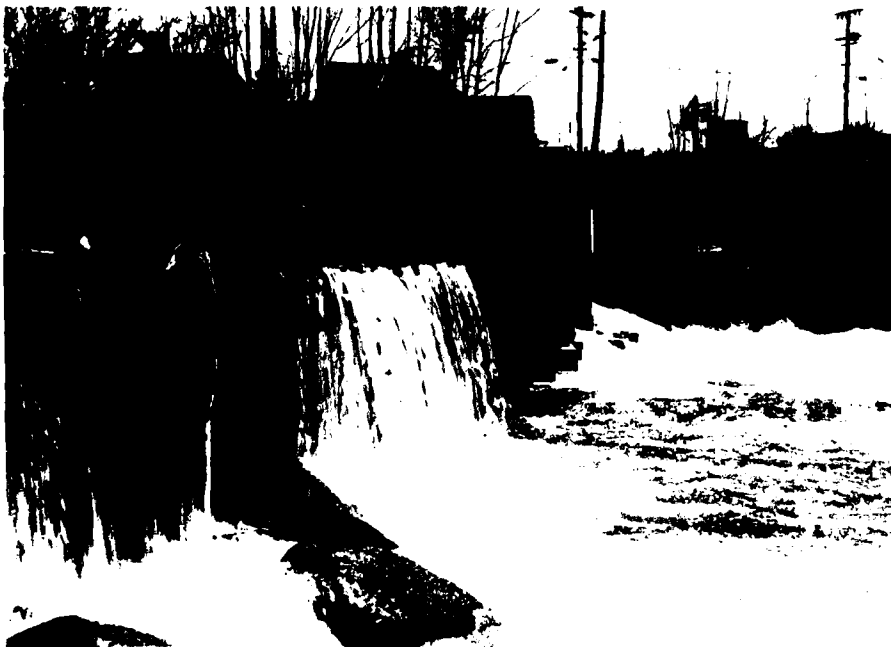
April 24, 1979

d. Visual Observations. The dam is in poor condition. The timber spillway has an uneven crest caused by some local support failures. The timber decking on the upstream face is in very poor condition.

The timber frame of the dam is, in part, in poor condition and badly deteriorated. Confirmation of some local support failures was made. (See Appendix C - Figure 5.) The timber decking over the upstream face is in very poor condition. (See Appendix C - Figure 6.) Major quantities of water are pouring through large holes in the decking and lesser quantities through leaks along the entire length of the spillway. (See Appendix C - Figure 5.) Near the south abutment is a hole several feet in diameter in the decking and a whirlpool several feet in diameter was observed over this hole. (See Appendix C - Figure 7.)

Figure 5 - Looking at the spillway where local support failures have occurred. Note the water discharging through the spillway through holes in planking.

The owner should engage a registered professional engineer to design and supervise appropriate repairs to the sinkhole over the masonry pipe in south abutment and to the existing structure such as masonry frame, decks, gates, lift mechanisms, etc. Attention should also be paid to the possibility that the silt collected behind the dam may contain pollutants which could affect the downstream reaches of the river.
