MERRIMACK RIVER BASIN  
SALEM, NEW HAMPSHIRE

**MILLVILLE RESERVOIR DAM**

PHASE I INSPECTION REPORT  
NATIONAL DAM INSPECTION PROGRAM

DTIC FILE COPY  
APRIL 1979

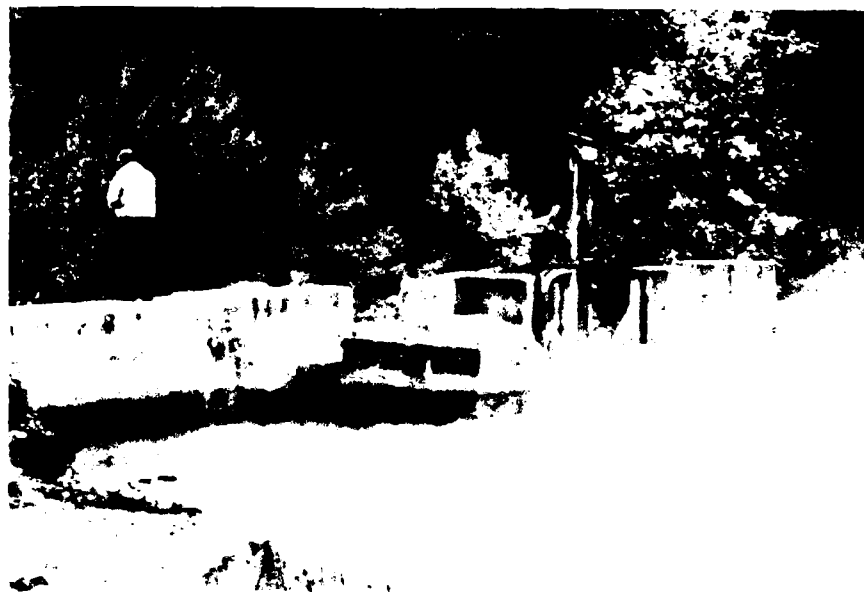
9. View of abandoned intake structure  
and upstream side of left spill-  
way end structure
