SAINT JOHN RIVER BASIN
Limestone, Maine

**DUREPO BROOK DAM
ME 00348**

**PHASE I INSPECTION REPORT
NATIONAL DAM INSPECTION PROGRAM**

DTIC FILE COPY SEPTEMBER 1981

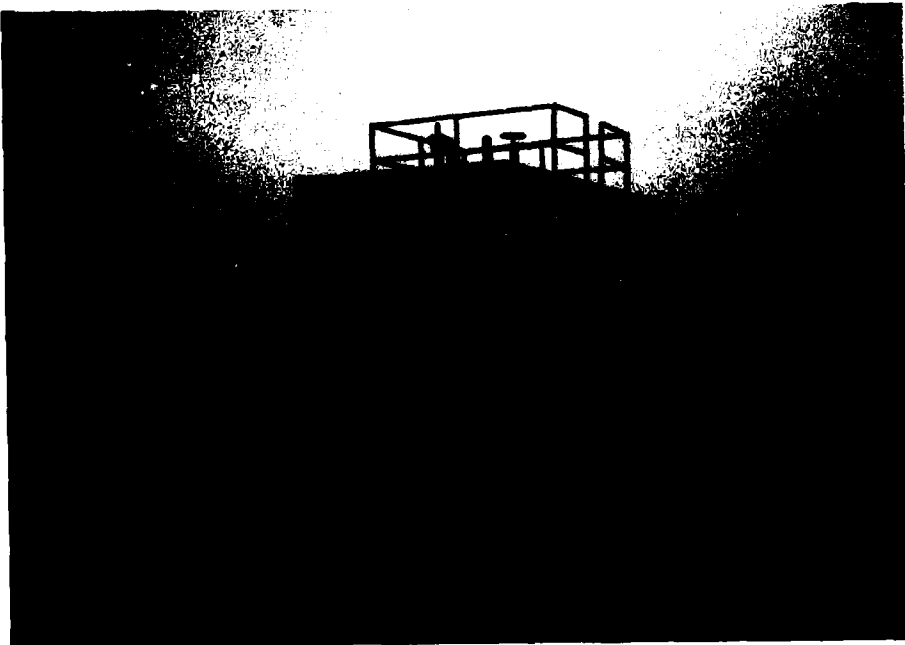
Photo 3
Principal Spillway

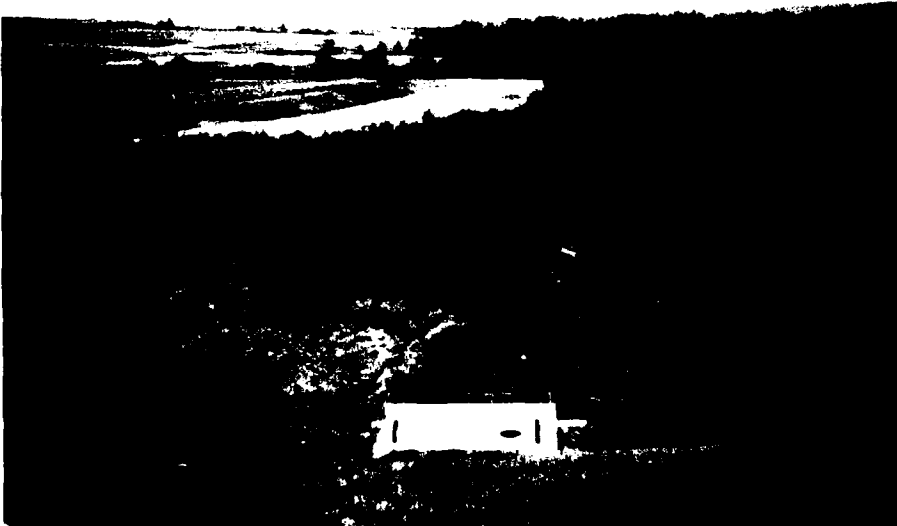
Photo 5

(4) Downstream toe - The downstream toe is generally dry with no boils or seeps observed. A small area of stagnant water was observed 50 yards to the left of the impact basin (Photo 5). No seepage was observed.

Downstream Channel

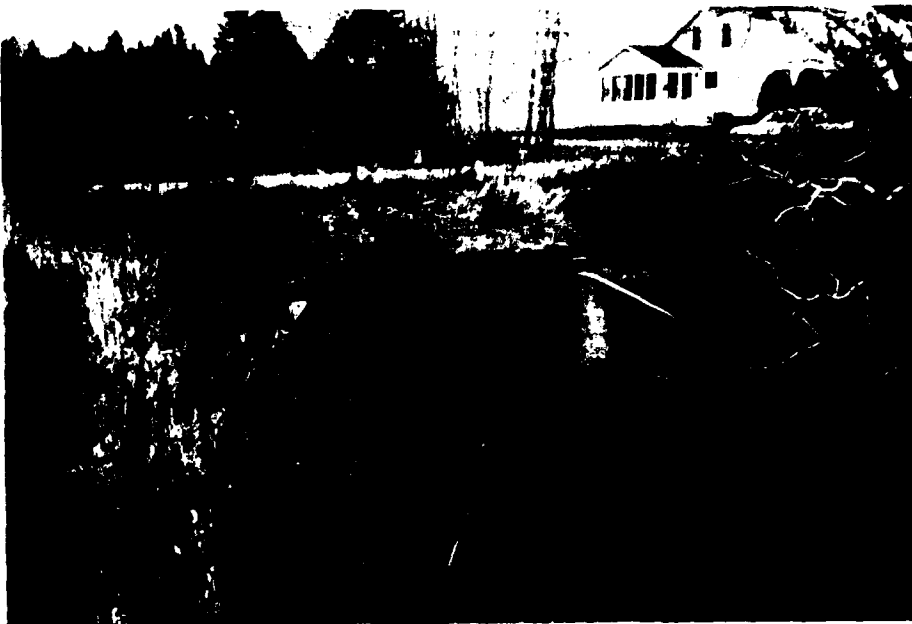
Photo 6

- d. Reservoir Area - No areas of potential or actual shoreline movement were observed.
- e. Downstream Channel - The downstream channel (Photo 6) was clear with no evidence of erosion.

Noyes Mill Road

Box Culvert
