MOUNTAIN BROOK DAM

PHASE I INSPECTION REPORT
NATIONAL DAM INSPECTION PROGRAM

DECEMBER 1979

Identification No.: NH 00099
NHWRB No.: 124.17
Name of Dam: MOUNTAIN BROOK DAM
Town: Jaffrey
County and State: Cheshire County, New Hampshire
Stream: Mountain Brook, tributary of the
Contoocook River
Date of Inspection: August 22, 1979

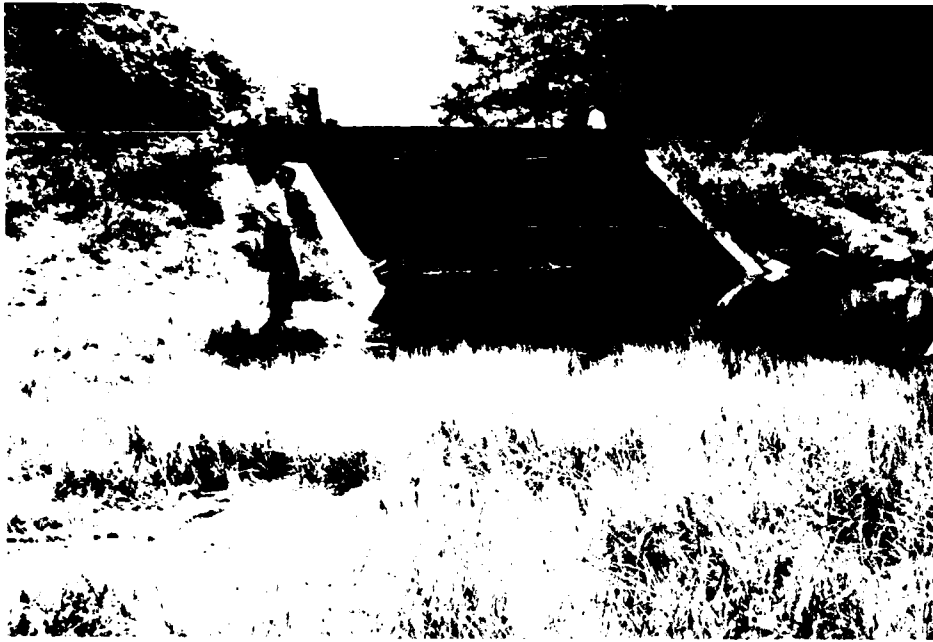
Overview from left upstream side

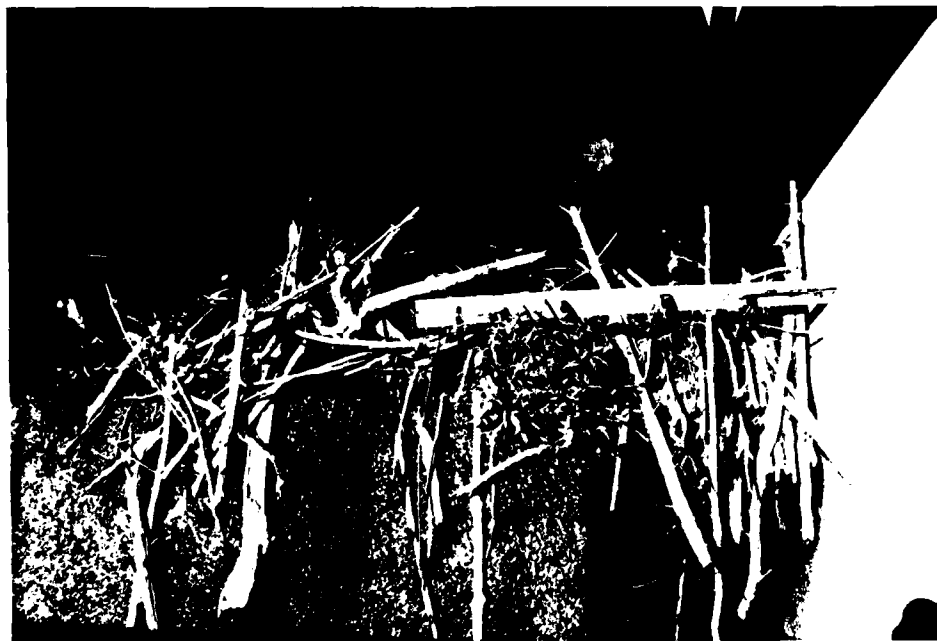
10. Crest of spillway showing remains of pin boards and debris
